# Engineering Application and Key Technologies of CIPP Rehabilitation for Natural Gas Pipelines

The in-situ rehabilitation section of the natural gas pipeline has a design pressure of 0.8 MPa. The pipeline body is a DN250 mm 20# seamless steel pipe, manufactured in accordance with the standard Seamless Steel Tubes for Fluid Transportation (GB/T 8163). The section has a total designed length of 800 m and an average burial depth of 1.5 m. Its corrosion protection system combines three-layer polyethylene (3LPE) reinforced insulation coating with sacrificial anode cathodic protection. Due to terrain constraints along the route, multiple factory-prefabricated hot-bent elbows are installed at horizontal and vertical turning points. These elbows have a curvature radius of  $R=5D$ , are made of the same material as the main pipeline, and comply with the requirements of Steel Induction Heating Bends for Oil and Gas Transportation (SY/T 5257).

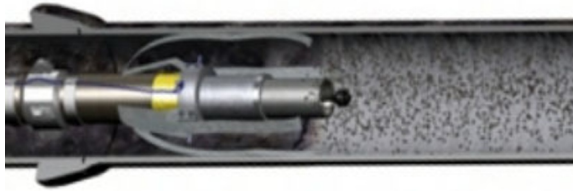
Prior to rehabilitation, the upstream and downstream ends of the pipeline section to be rehabilitated must be plugged. Before plugging, forced ventilation and hazardous gas detection are conducted to ensure compliance with safety standards. Cleaning employs abrasive blasting, using compressed air to propel brown fused alumina (aluminum oxide grit) at high velocity onto the inner pipe surface (see Figure 1). The blasting nozzle rotates at a uniform speed under a spraying pressure of 1 MPa to ensure full coverage of the pipe wall, effectively removing surface sludge, loose deposits, and other contaminants, achieving complete derusting and producing a uniformly roughened surface. Simultaneously, the blasting and vacuum recovery systems operate in tandem, with the vacuum system continuously recovering dislodged debris in real-time. The process continues until the pipe wall is fully exposed, achieving 100% derusting and surface roughening, thereby providing a sound foundation for subsequent liner bonding.

**Fig. 1.** Pipeline Abrasive Blasting Cleaning

Upon completion of cleaning, a CCTV inspection system equipped with panoramic color imaging, defect annotation, and frame-by-frame playback capabilities was employed to record the entire interior surface of the pipeline before and after cleaning. The camera shall feature 360° rotation and zoom functionality with a resolution of no less than 460 TV lines to ensure image clarity. Using image analysis software, CCTV footage was subjected to grid-based sampling to calculate the percentage of the pipe wall area exhibiting exposed metallic luster after cleaning. Acceptance criteria strictly follow the Technical Specification for Trenchless Rehabilitation and Renewal of Urban Gas Pipelines (CJJ/T 210), requiring 100% derusting coverage, with the pipe wall displaying uniform metallic coloration and no localized residues.

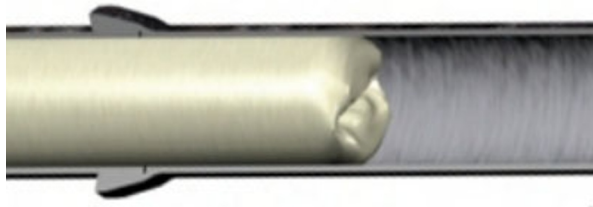
On-site, the air compressor unit is activated to invert the liner hose from the drum into the existing gas pipeline using compressed air, as shown in Figure 2. The hose continuously advances under air pressure, during which the inversion drum temperature must be maintained below 20°C to prevent premature resin curing. The outer surface of the inverted liner is coated with adhesive, ensuring full adhesion to the original pipe inner wall under air pressure.

**Fig. 2.** CIPP Installation

Cured-in-place pipe (CIPP) lining technology demonstrates excellent bending performance, enabling it to traverse 90° elbows with a curvature radius greater than three times the pipe diameter ( $R > 3D$ ) in a single, wrinkle-free pass. This confirms its full suitability for rehabilitating the curved sections of this project. However, given the presence of multiple consecutive bends in the repair segment, real-time monitoring of the inversion process is essential to ensure construction quality. Inversion speed must be strictly controlled within 2–3 m/min, while air pressure should be maintained between 0.05–0.1 MPa. These parameter settings align with the recommended ranges for similar projects documented in references [4–5], contributing to the stability and reliability of the rehabilitation process. Upon completion of inversion, the resin-impregnated liner hose shall extend beyond both ends of the pipeline by more than 1 meter to provide sufficient allowance for subsequent end treatment.
