# Analysis of Seismic Damage Characteristics and Rescue Strategies of Buildings in Tibet Earthquake

**Abstract.** On January 7, 2025, Dingri County in Tibet's Shigatse City was rocked by a 6.8-magnitude earthquake. The quake struck with a focal depth of 10 kilometers, in an area where the average altitude reaches 4,300 meters within a 5-kilometer radius of the epicenter. Drawing from detailed field investigations, this analysis delves into the earthquake's impact on buildings and the effectiveness of emergency response measures. It highlights the stark contrast between traditional earth-wood structures, which suffered severe damage and were the main contributors to casualties, and modern reinforced concrete frames that showed remarkable resilience. The paper puts forward specific rescue strategies, like leveraging multi-source remote sensing, bolstering aviation rescue capabilities, and refining rescue force distribution, to guide future earthquake responses in similar high-altitude, frigid environments.

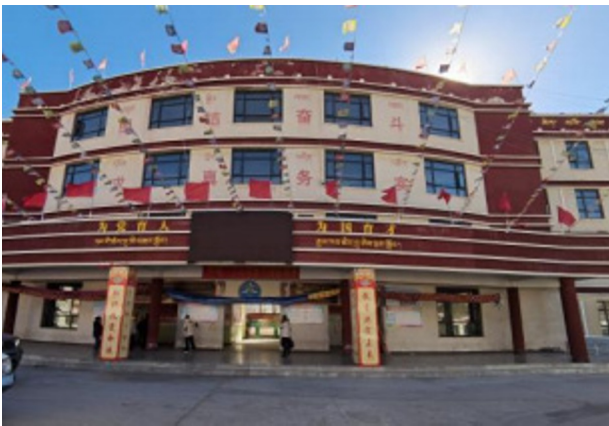
Fig. 1. Public buildings picture

Buildings constructed after 2000, built to code with reinforced concrete frames,mostly stayed intact structurally.However,the finishing suffered,partition walls cracked,ceiling tiles fell,and fixtures shifted.Most damage was superficial,but in some cases,it was more severe. As shown in Figure 1, the school is stayed intact structurally.

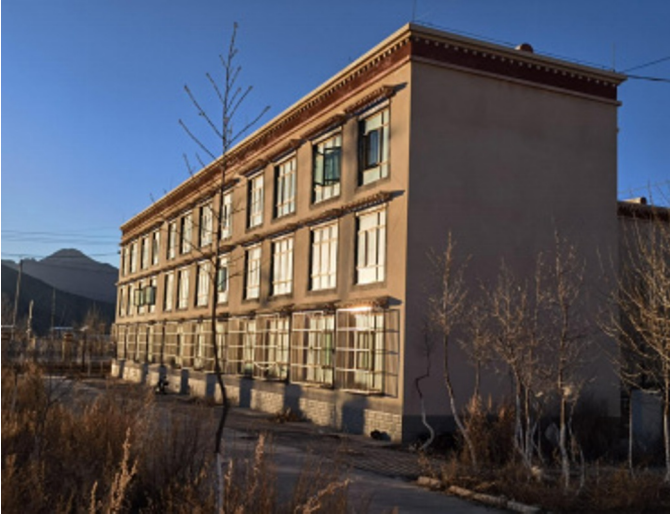
**Fig. 2.** Residential buildings picture

The county's residential building, a professionally designed brick-and-concrete structure, remains largely intact. The two-story reinforced concrete frame structure also stands strong, with only minor cracks in filling walls and some parapet damage (As shown in Figure 2).

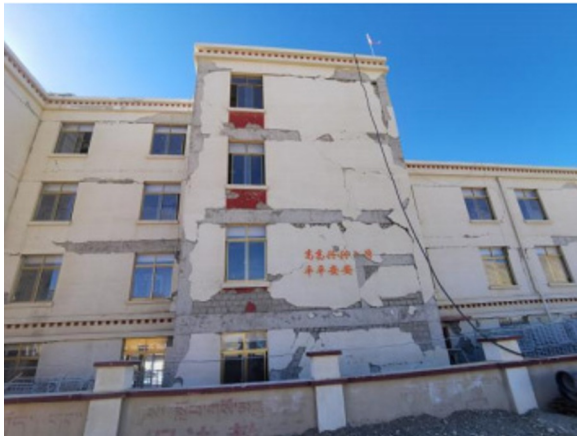
**Fig. 3.** Rural buildings picture

Survey data from eight settlements reveal clear trends. Post-2008 frame structures had infill failure rates near 80% but structural damage under 5%. 1990s brick buildings saw 60% wall deformation, with two partial collapses. Proper column-beam connections saved frames, weak mortar caused wall failures (As shown in Figure 3).

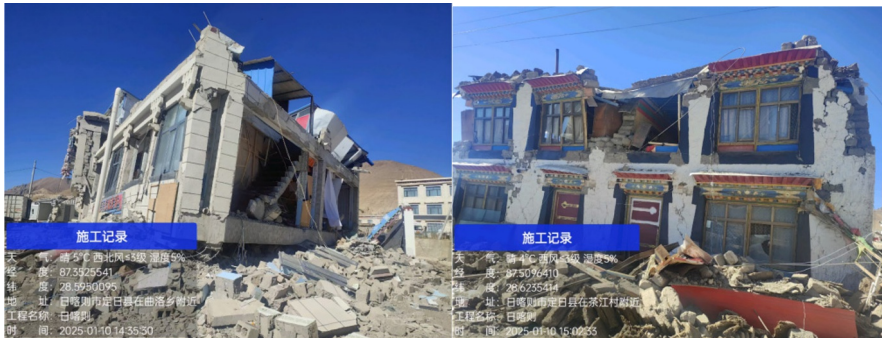
Fig. 4. Self-built housing Pictures

Traditional pastoral homes are built with local materials,featuring adobe walls and wooden pillars.These two-story buildings rest on rough stone foundations.The ground floor,with its thick stone or adobe walls,is mainly used for storage,acting as a raised platform for the upper level.Daily activities occur upstairs,where partitioned spaces are common.Large rooms contain multiple wooden pillars supporting beams,sometimes re-inforced with steel,creating a partial wooden framework.Purlins densely support the beams and are anchored to the adobe walls opposite,forming a mixed load-bearing system that combines traditional and modern elements (As shown in Figure 4).

This earthquake shows traditional homes cause most casualties. It's advised to assess their seismic performance in plateau areas, create tailored retrofitting plans, and promote simple reinforcement methods to boost resilience. Meanwhile, targeted education campaigns should raise seismic safety awareness, enhancing local earthquake preparedness.
