# Operational Feasibility Analysis of Propane Storage Tank Due to Subsidence

**Abstract.** During hydrostatic testing, an 80,000 m<sup>3</sup> propane storage tank exhibited subsidence, causing deformation of its outer shell. This necessitated an evaluation of the tank's operational viability and fitness for service, guided by API 579-1/ASME FFS-1 procedures. The assessment started with Level 1 and Level 2 analyses using distortion measurements, and if needed, progressed to Level 3 for detailed numerical analysis. Results from Levels 1 and 2 indicated acceptable out-of-roundness ( $RSF \geq RSFa$ ) and out-of-plumbness ( $1/200 h_{\text{tank}}$ ) but not bulging, leading to further analysis through elastic-plastic finite element simulation at Level 3. Although stresses exceeded yield strength, the tank was deemed fit for service under plastic collapse and local failure criteria, maintaining buckling stability. Operational recommendations include addressing wind, seismic, and pressure loads and reinforcing and regularly monitoring the shell to ensure ongoing safety and structural integrity.

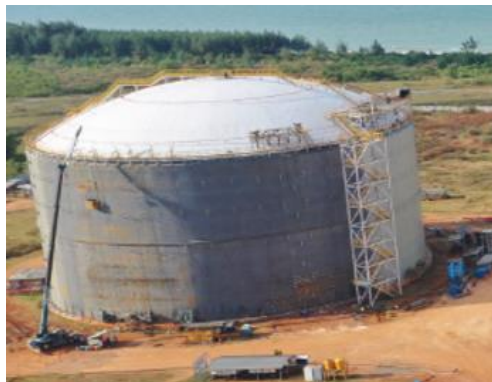
The storage tank T-201 under study was designed according to the API 620 code and standard. It has a height of 30.1 meters and a diameter of 64 meters. It contains liquid propane with a nominal capacity of 80,000 cubic meters, as shown in Figure 1.

**Fig. 1.** Propane storage tank T-201 under construction

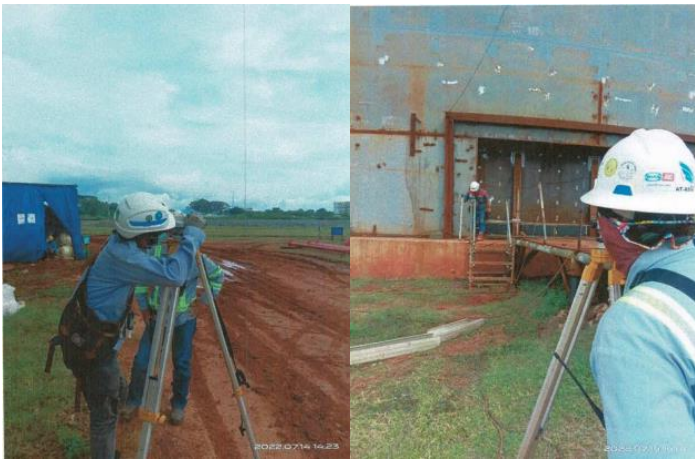
Due to the tank's weight during construction, ground settlement, commonly referred to as subsidence, occurred. A hydro test was then conducted to test the tank's resistance to leakage. However, during the hydro test, the tank experienced further subsidence. The ground continued to settle for several hours following the initial subsidence. The extent of ground settlement was measured using a theodolite, as shown in Figure 4 presents the subsidence data for the tank, measured in the field using the theodolite.

Fig. 3. Theodolite measurement on to the propane storage tank T-201

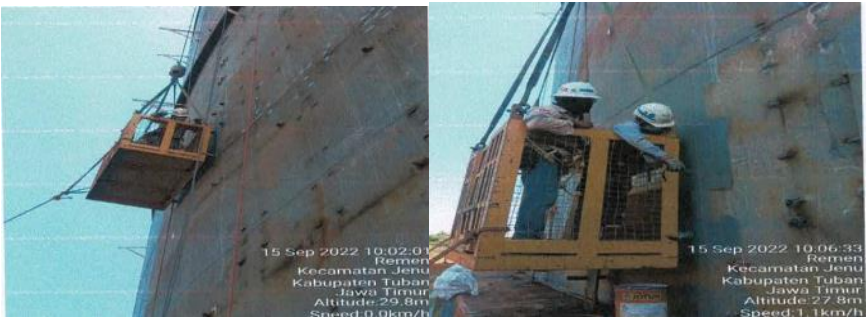
The subsidence condition caused distortion in the storage tank walls. The outer tank wall was measured using a string line and a laser drone 3D scanning method. A string line is a tool similar to a spirit level, capable of measuring over longer distances with a string, the string line measured radial deformation on the outer tank wall. Figure 5 illustrates the measurement process using a string line on the storage tank wall.

Fig. 5. Propane storage tank T-201 shell measurement using string line
