# Evaluation of Lifeboat Maintenance on the KM. Sejahtera 36 to Ensure Crew Safety in Emergency Situations

**Abstract.** Lifeboat readiness is a critical element of shipboard emergency preparedness because failure of life-saving appliances may delay evacuation and increase risks to crew safety. This study evaluates the implementation of lifeboat maintenance on board KM. Sejahtera 36 and assesses its conformity with the requirements of SOLAS Chapter III and the Life-Saving Appliances (LSA) Code. A descriptive qualitative approach was applied using direct observations during routine maintenance and drills, semi-structured interviews with the Master, Chief Officer, Second Engineer, Quartermaster, and Oiler, and review of maintenance records and shipboard documentation. The findings indicate that lifeboat maintenance on KM. Sejahtera 36 had not been fully implemented in accordance with applicable requirements. Weekly inspections, quarterly operational tests, and annual maintenance were conducted, but monthly inspections and five-year maintenance were not consistently carried out. In addition, a dedicated lifeboat maintenance checklist and logbook were not available. Technical problems

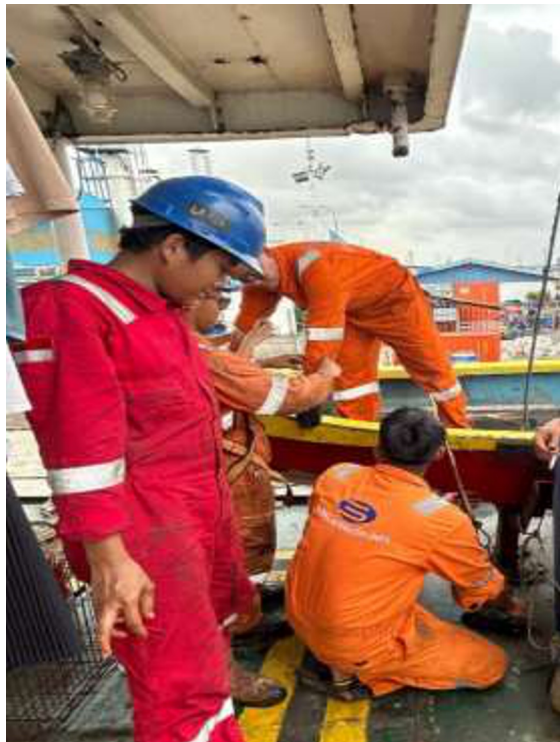
Based on the research, the maintenance of the lifeboats on the KM. Sejahtera 36 does not comply with the LSA Code. Maintenance on the KM. Sejahtera 36 only includes routine inspections and periodic maintenance. Routine inspections and maintenance are carried out weekly on the KM. Sejahtera 36 usually inspects the lifeboat's physical condition for cracks, corrosion, or leaks. Additionally, oil and fuel levels must be checked. This routine maintenance is usually carried out by the Bosun and crew on duty.

**Figure 1. Cleaning and checking the physical condition of the KM. Sejahtera 36 lifeboat**

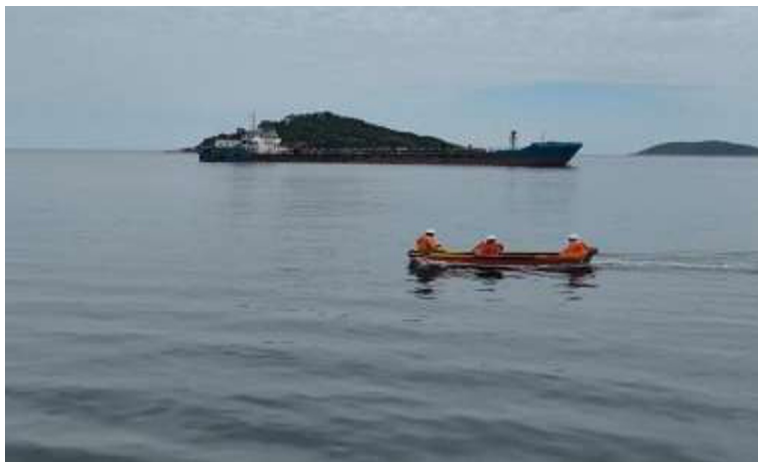
In addition, routine inspections and maintenance are also carried out every three months. The lifeboat is usually lowered into the water by a designated crew. The designated crew members include the first officer, the second engineer, the bosun, and the crew. Upon lowering into the water, the lifeboat's engine is started and driven around for three minutes. This is to check engine performance and oil pressure. It also

ensures the lifeboat's lifting and lowering system is running smoothly and without interruption. Grease is also applied to the wire and the lifeboat's retaining pin.

**Figure 2. Lifeboat drill on the KM. Sejahtera 36**
