Highwall Mining Stability

Baotang Shen^{1,2}

¹CSIRO Energy Flagship, Pullenvale, Brisbane, Australia

This paper provides an overview of the highwall mining technology. A detailed case study on a panel failure is also presented.

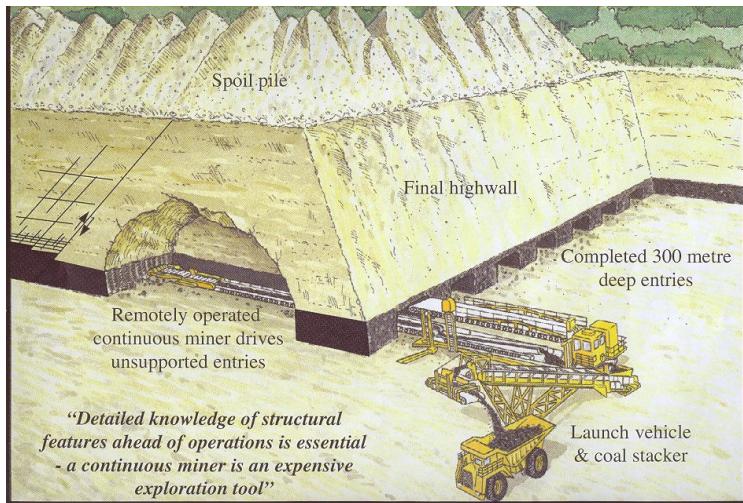
Figure 1. A schematic image of highwall mining operation.

Highwall mining is a remotely controlled mining method which extracts coal from the base of an exposed highwall, typically via a series of parallel entries driven to a significant depth within the seam horizon (Figure 1). The method allows recovery of coal from surface pits that have reached final highwall position, or in areas where coal has become sterilized in, for example, service corridors. Highwall mining is a hybrid system capable of accessing these reserves for substantially less capital cost and lead time than a full underground mine, while being able to produce over 1 million tonnes per year per system. Highwall mining also has a significant operating cost advantage over underground mining, because it is less labour intensive.

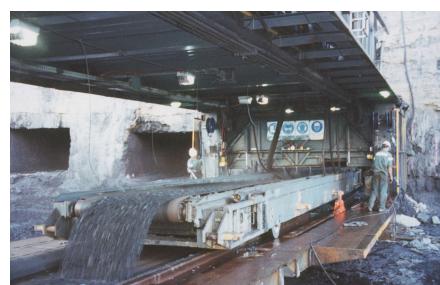
Figure 2. A Continuous Highwall Mining System (CHM) in operation.

Two types of highwall mining systems have been used. They are the Continuous Highwall Mining System (CHM) which mines rectangular entries usually about 3.5m wide (Figure 2) and the Auger System which creates individual or twin circular holes of various diameters (Figure 3). The CHM has been much more widely used than augers because of its advantage in productivity and recovery rate. In one of the Australia coal mines, a CHM system has routinely reached 500m penetration distance into the coal seam from the base of the highwall and has achieved a maximum production rate of 124,000 tonnes per month. In comparison, an Auger system can often reach 200m penetration and produce up to 60,000 tonnes per month. However, its disadvantage in recovery rate and productivity is offset by its tolerance of difficult geological conditions. This makes it more suitable for highwall mining of a pit with unfavourable roof and floor conditions.

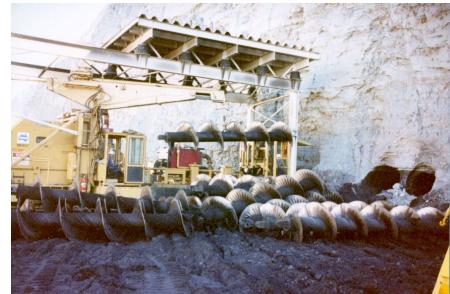
Figure 3. An Auger System in operating strength.

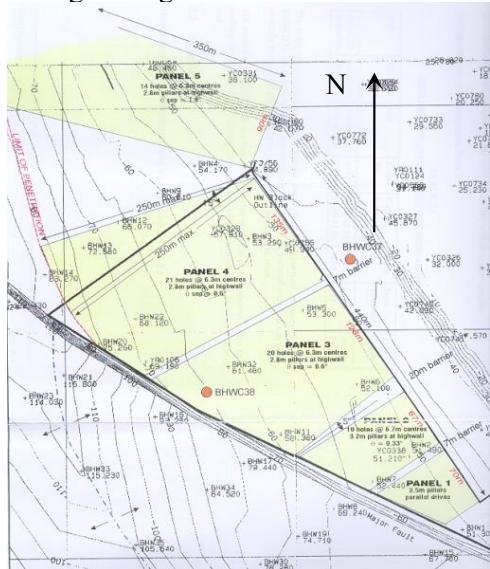
Figure 4. Highwall mining panels and design specifications, Pit B, Mine A.

Highwall mining operations started from the southern end of the pit and progressed to the north. The whole reserve was mined in four panels (see Figure 4). Panel

5 shown in Figure 4 was not mined. The pillar size and layout as designed and used in each panel are listed in Table 1.

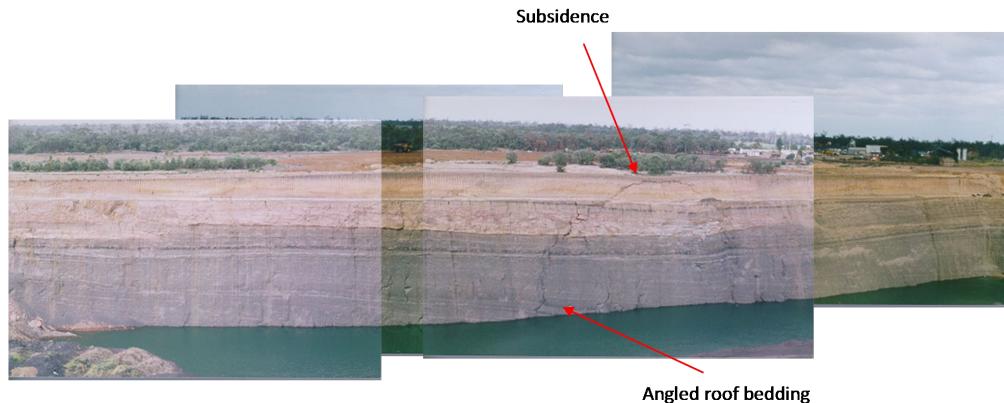
Figure 5. Highwall face and a panel failure at the mid section of the highwall, Pit B. Angled roof bedding planes are noticed at the area of failure

On the 12th of January 1999, a localised panel failure occurred in the middle section of the pit (Figure 5). The failure extended about 80m along the highwall and 50m into the highwall. The whole process of failure took about 5 minutes. The subsidence was fully developed in a period of two weeks.

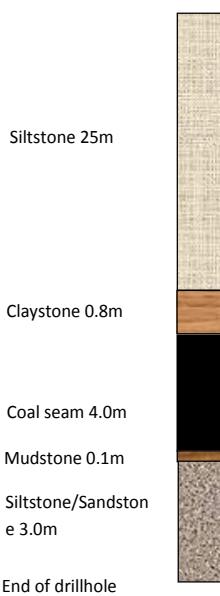
Figure 6. A simplified core log of the roof and floor geology in Pit B.

Limit Equilibrium Method was used to evaluate the FOS of the panel. In the numerical models, the simplified geology shown in Figure 6 was used, except that the thin mudstone floor was modeled as a weak interface.

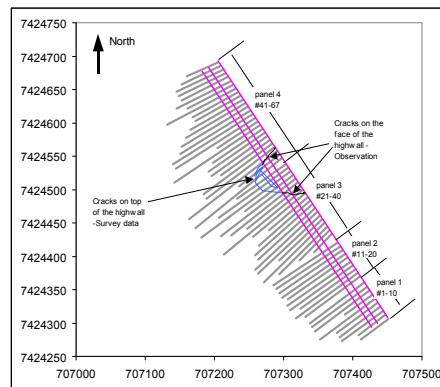
Figure 7. Highwall mined entries, and the surface cracks after subsidence based on survey and observation

A total of 67 entries were mined. The penetration depths of the entries are shown in Figure 7. Frequent roof falls

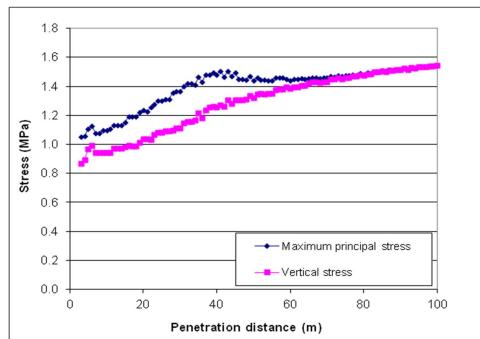
Figure 9. Numerically predicted vertical stress and maximum principal stress in the coal seam in the vicinity of the highwall.

The stress model is shown in Figure 8. The predicted vertical stress at the mid-height of the seam is plotted in. The maximum principal stress is also plotted in the figure. At the toe of the highwall, a vertical stress of 0.87MPa and a maximum principal stress of 1.05MPa are predicted. The maximum principal stress is predicted to be higher than the vertical stress within a penetration distance of

70m. The vertical stress appears to be increasing gradually with the penetration distance, whereas the maximum principal stress reaches a local peak of 1.5MPa at 40m, where the vertical stress is 1.25MPa. At penetration depths greater than 70m, the two stresses are generally the same, indicating that the disturbance to stress field due to the highwall excavation diminishes away from the highwall. Because the maximum principal stress is not in the 2D vertical cross section, its effects on the results obtained by a 2D study are uncertain. To consider the unknown effect from the out-of-plane principal stress on the results of a 2D

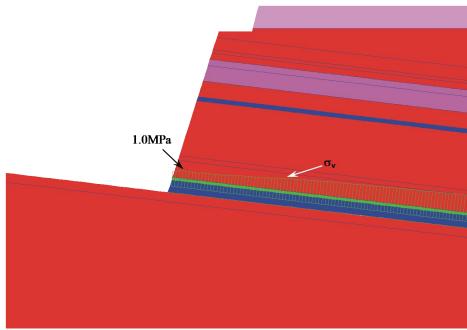
Figure 8. A 2D model to study the stresses near the highwall. The vertical stress is plotted.

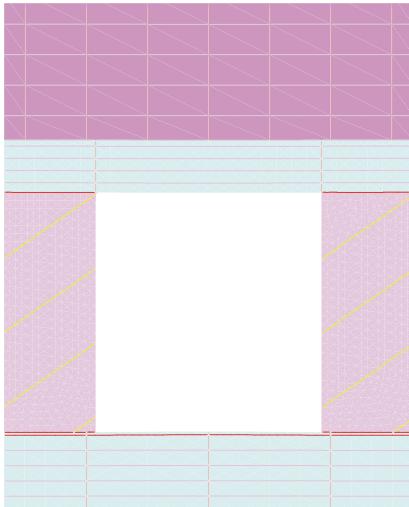
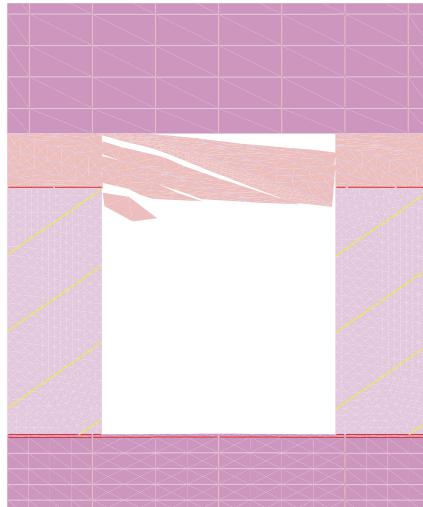
(a) Horizontal roof bedding

(b) Inclined roof bedding

Figure 10. Stable and unstable spans for horizontal and angle roof bedding, numerical predictions.

Figure 10 shows a comparison of modelled roof stability for the two cases. When the bedding planes are parallel to the seam, the layers act as fixed-end or simply supported beams after delamination. The beams mainly under-

their self-weight are predicted to be stable, and hence the span is predicted to be stable. When the bedding dips toward the seam at an angle, the layers behave as cantilever beams, and in this case the span is predicted to be unstable.

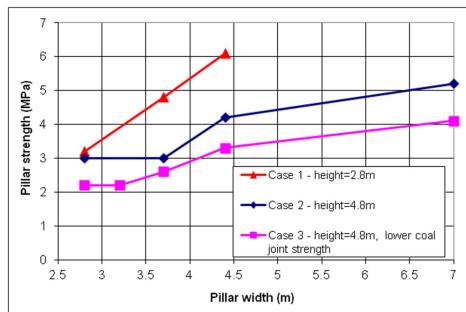
Figure 11. Variations of pillar strength with pillar width for three different cases.

strength conditions. More than one year after mining, particularly after the entries were flooded, the coal joints would be expected to have lost their cohesion and their friction angle might have been reduced. A zero cohesion value and a friction angle of 30° were used in Case 3. A number of pillar sizes were modeled for all the three cases. The results are summarised in Table 4 and plotted in Figure 11.

2.8m for Case 1 to 4.8m in Cases 2 and 3, the pillar strength for a given pillar width ($>3.0\text{m}$) is found to reduce significantly (compare the three curves in Figure 11.) In Case 2, a pillar strength of 3MPa is obtained for pillars $\leq 3.7\text{m}$ wide. This strength is equal to the mass coal UCS used in the modeling. This result suggests that the effect of the coal joints with the particular strengths that were assigned have only a minor effect on pillar strength. In Case 3, which was formulated to simulate the effects of time and water, the calculated pillar strength is found to reduce by up to 30%, based on the assumed reduction of the strength of the intensive coal joint. This reduction is significant and based on purely theoretical considerations requires a minimum design FOS of 1.4 to achieve a medium term pillar stability.

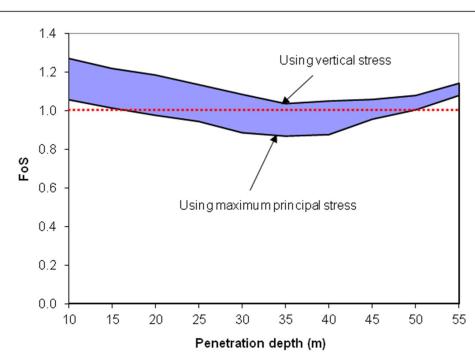
Figure 12. Variations of Factor of Safety (FoS) with penetration depth in the subsided area

Figure 12 presents the FOS variation with penetration distance for the failed panel for Case 3 conditions. It shows that the FOS reaches a minimum at a penetration

The results are summarized in Table 5 and plotted in Figure 12. Table 5 provides ranges of actual stress values that were

distance of 35m, and the minimum FOS is predicted to be in the range 0.87-1.03. At a penetration distance of 15-50m, if

the maximum principal stress is used, the FOS is predicted to have fallen below 1.0. Judging from the plot of FOS presented in Figure 12, it is believed that the subsidence started at about 30-40m inbye, which is just behind the top bench of the highwall. The failure propagated both toward the highwall and deeper into the panel. But due to stronger confinement deeper in the reserve, the extent of the subsidence was further toward the highwall than into the panel.

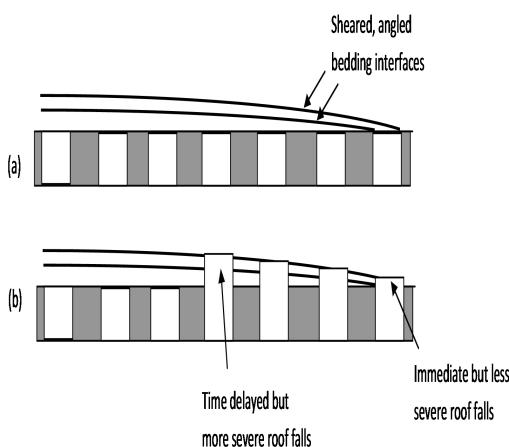
Figure 13. A sketch drawing of roof fall mechanism. Roof falls of different sizes occur at different locations due to angled roof bedding.

For the analyses of Case 3 a pillar height of 4.8m was used. It is believed that the maximum increase in height of the pillars occurred only in the subsided area due to extensive roof falls. In the subsided area, the steeply dipping bedding planes led to the roof falls. The mining records reported that the worst roof falls experienced during mining occurred in Entry 43, towards the northern end of the subsidence zone. The locations of roof falls experienced during mining may

reflect the intersection between the angled roof layers and the seam. It is possible that more severe roof falls may have occurred in the area behind the intersection after mining, given that the immediate roof is sheared. It is postulated that some form of progressive failure took place. This mechanism is demonstrated in Figure 13. In Entries 33-42 where the subsidence occurred, although no major roof falls were reported during mining, it is possible that extensive roof falls occurred after mining, which eventually caused the failure.
