Analysis and Research on the Quality Detection of the Structural Entity of Civil Engineering Division in Lujiang's Gymnasium

Abstract. The detection results in the article are gained through tests on the material strength, reinforcement location, scantling design and slab thickness of civil engineering division of Lujiang's gymnasium. As for the substandard parts, treatment proposals are put forward to ensure the project quality.

Project Overview

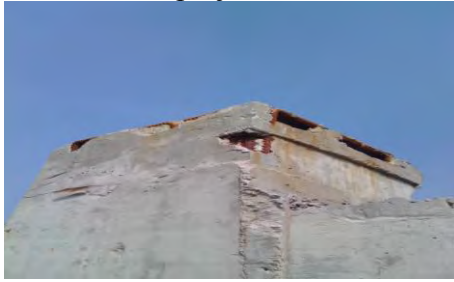
Fig. 2 Stigma

- (1) Serious cases of boxwork, pitting surface, reinforcement exposure and corrosion have been detected in parts of the top-column joints.
- (2) Between the pre embedded steel and the top of the top columns, breakoff phenomenon, slits of uneven width, reinforcement exposure and corrosion have been detected.
- (3) Uncompacted concrete, reinforcement exposure are general phenomenon at the top of the static pressure box structure pole.
- (4) Reinforcement exposure and corrosion have been detected at the bottom of some beams.

- (1) The breakoff between the pre embedded steel and the top of the top columns makes it detrimental for top column to bear the upper load of steel structure.
- (2) As for the boxwork and pitting surface in column joints, high strength mortar is suggested to be used.
- (3) Rust cleaning in column joints and reinforcement exposure is necessary, which should be accompanied by the use of high strength mortar.
- (4) As for the big danger hidden in the loose junction between the static pressure box structure pole and beams, high strength micro expansion mortar can be wiped in the junction to avoid corrosion of the tensile reinforcement. Meantime, the boom should be reinforced to enhance the reliability of the upper and lower end of connecting node.

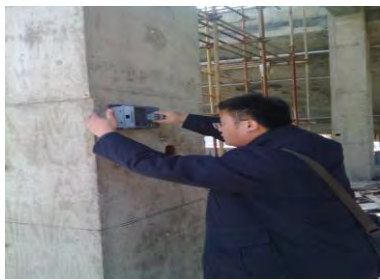
The test is authorized by the Bureau of Housing and Construction of Lujiang County. The strength of beams, boards, columns and concrete, the thickness of boards, the sectional reinforcement allocation and the thickness of cover have been tested through applying device of ZBL-S210 digital concrete resiliometer, ZBL-U510 nonmetal ultrasonic detector, SW-180 reinforced position detector, NJJ-95B concrete radar detector, ZBL-T720 slab thickness tester and steel tape.

Fig. 5 Using the Concrete Rebound Hammer to Test the Concrete Strength
