Microstructure and Electrical Contact Performance of Wires in Corrosion Air

Abstract—The high contact resistance of the corrosion products is more likely to cause contact failure. Based on service condition and natural environment of transmission and transformation equipment, the deterioration mechanism of electrical wires was investigated from the view of corrosion. The surface morphology of specimens after corrosion is observed by stereoscopic microscope and scanning electron microscope (SEM). Chemical constitution was examined by X-ray energy spectrum. The contact resistance was measured by four-point method. The experiment results show that the corrosion is mainly electrochemical corrosion. Humidity and air pollutants are the main factors of effecting the corrosion. The corrosion products formed on the surface layer of testing specimens is loose and uneven, and easy to fall off in the role of external force. The inner corrosion layer is dense and combined closely with the substrate. The EDS analysis results there is large quantity of O and S, and Cu oxide and sulfide are probably existed. The corrosion and pollution which come from the surrounding environment can increase the

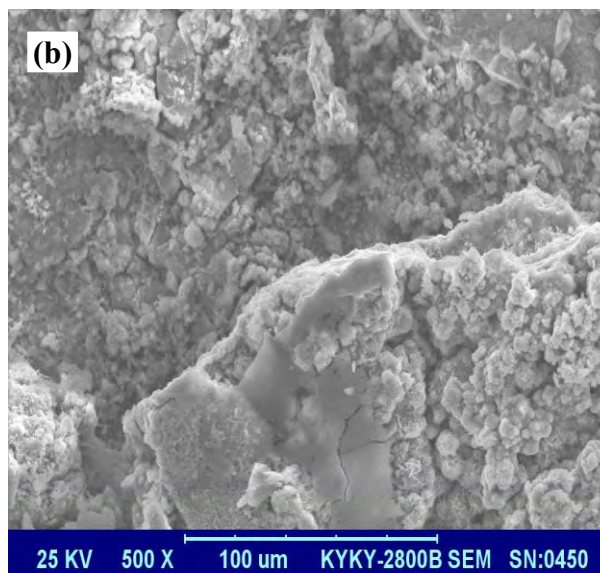
Figure 1. Morphology of wire clips corroded: (a) OEM morphology; (b) SEM morphology;

The stereoscopic microscope and SEM were used to observe the surface topography of result of wire clips, as shown in Fig .1. It can be seen that the corrosion products formed on the surface layer of testing specimens is loose and uneven, and easy to fall off in the role of external force. The inner corrosion layer is dense and combined closely with the substrate.

The corrosion products formed on the surface layer of testing specimens is loose and uneven, and easy to fall off in the role of external force. The inner corrosion layer is dense and combined closely with the substrate. The EDS analysis results there is large quantity of O and S, and Cu oxide and sulfide are probably existed. The existing of elements of S can be attributed to the facts that there are a number of chemical plants and steel mills nearby substation. Exhaust emissions from these plants contain large quantities of sulfide. The corrosion and pollution come from the surrounding environment can increase the static contact resistance obviously, and the maximum value can reach to about 2000mΩ.

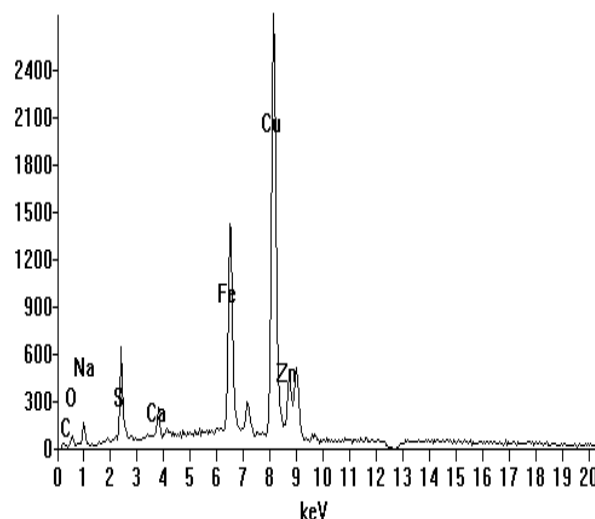
Figure 2. Energy spectrum of wire clips corroded

The chemical constitution of this corrosion product is listed in Fig .2 and Table I. There is large quantity of O and S, and Cu oxide and sulfide are probably existed. It is indicated that element of Zn is etched off and the corrosion degree is serious. The existing of elements of S can be attributed to the facts that there are a number of chemical plants and steel mills nearby substation. Exhaust emissions of these plants contain large quantities of sulfide. Study shows that SO₂ pollution is the most important factor in corrosion of zinc. The combined effect of humidity and SO₂ pollution will accelerate the corrosion of zinc corrosion. Pollutants or particulate pollutants, as the rainfall of rain, snow, fog or hail fell on the surface of wires and fittings. Sulfide dissolves in the water which becomes electrolyte solution. Zinc life is directly proportional to the thickness of the zinc coating. Although the galvanized surface may extend the life of wires and fittings, however, due to relatively thin zinc, as soon as the zinc layer is damaged, the zinc layer and the substrate will be accelerated corrosion. When water droplet forms on the pore region, pollutants dissolves in the water which becomes electrolyte solution. In addition, the existence of impurities in base metals promotes the occurrence of corrosion and provides channels into the substrate. Electrolyte solution penetrates into the pore and reacts with either zinc or copper. The substrate possesses much lower electric potential than zinc and the zinc plating becomes the cathodic portion during the corrosion reaction. The corroded products will grow and the reaction continues. The concentration of sulfide is higher enough to corrode the surface layer. The corrosion made the base metal to expose to the corrosion air. Due to changes in temperature, moisture and oxygen content, the corrosion reaction is further aggravated.

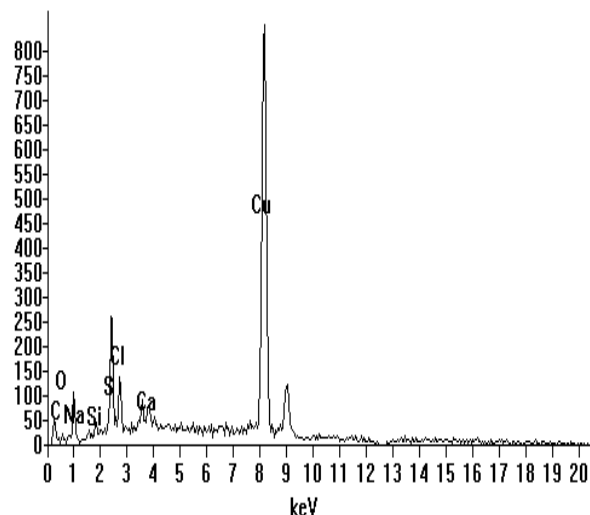
Figure 4. Energy spectrum of wires corroded

shown in Fig .3 (b). The results of EDX analysis of the wires are shown in Figure 4 and Table II. The results show that a large number of S, Na, Ca elements are exist on the surface or gaps of Cu wires. The presence of the corrosion will result in high resistance, which will produce overheating phenomenon. Overheating of electrical contact is a very common phenomenon during the service of transmission and transformation equipment. The overheating defects are always a serious problem in electric network. The overheating of electrical contact not only increases wastage, bus also causes a transformation accident. With the increase of running load, the overheating defects of electrical contact become more frequency and serious. Copper is easily corroded by halogen, sulfur, selenium. Atmospheric haze containing much hydrogen sulfide is very harmful to the safety of electrical contact, especially, the electrical contact of switch equipment which is used in petrochemical factory, paper manufacturer and sewage treatment works.

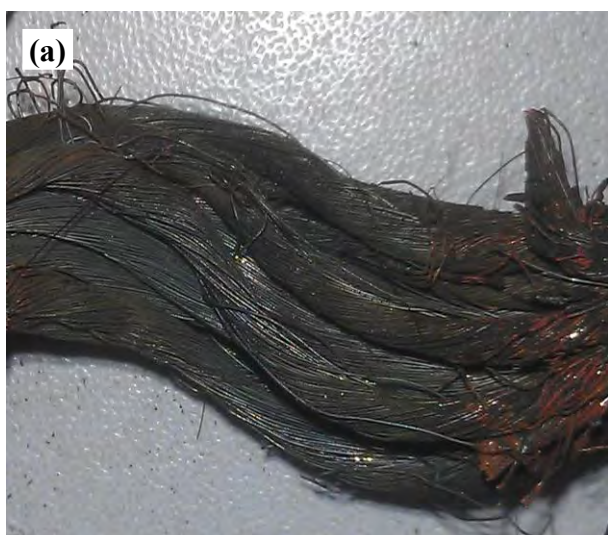
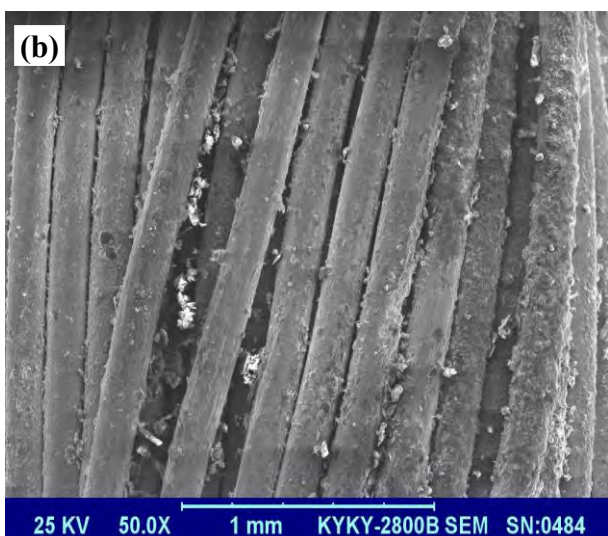
Figure 3. Morphology of wire corroded: (a) OEM morphology; (b) SEM morphology;

The Fig .3 shows that the morphology of wires after 10years service. It can be seen that the wires are dark and some of them are broken, which indicates that the wires are oxide seriously, as shown in Fig .3 (a). Some Cu wires are wrapped by the corrosion products and pollution, and these corrosion products are exist between the wires, as

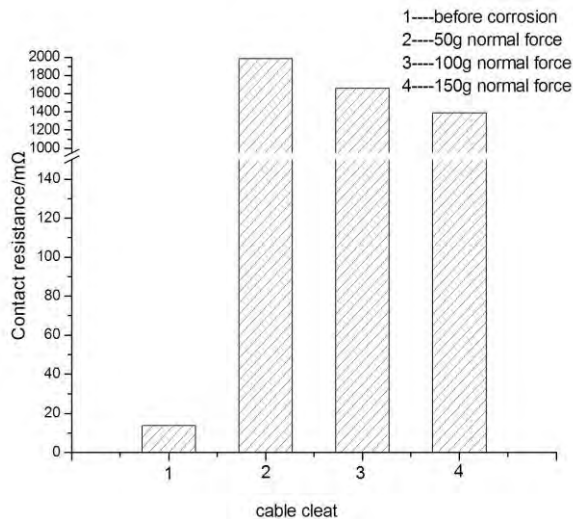
Figure 5. Contact resistance of wire clip

Contact resistance is measured on the specimens after corrosion by four-point method. The constant current is 20mA and the normal force is set at 50g, 100g and 150g respectively. Contact resistance is measured for every 0.1m along a straight line through the corroded products. The contact locations are controlled by a micron micrometer.

The experiment results show that the contact resistance is about 10mΩ before corroded. For the corroded wire clip, the contact resistance is found changing from outside point to inside point through the corrosion area. The resistance values are increased rapidly in certain test points and the maximum value can reach to about 2000mΩ, so it can be concluded that the high contact resistance points are the field of corrosion products. The relationship between contact resistance of wire clip specimen corroded and normal force are shown in Fig 5. The resistance decreased with the change of force from 50g to 150g. When the force decreased to 50g, the contact resistance value is 1945 mΩ. The resistance test results show that the contact resistance became high and unstable due to the corrosion.
