Application Research on PVA-ECC in Repairing Airport Pavement

Keywords: Airport Pavement; PVA-ECC; Bond strength;

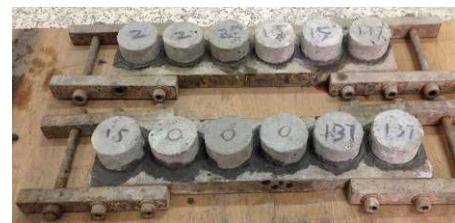
Fig. 2. Specimen of Underlie Concrete

pavement [4], the mixture ratio of concrete in this test were shown in Table 3. The diameter of cylinder specimen was 73.5 mm, and the height was 36.5 mm, there were eight groups of specimen which each group of three (shown in Fig.2). Curing under standard conditions for 28 days, then surface of specimens were roughed to bond with repair material easily. In order to prevent the influence of the test results, specimens were soaked in water so that moisture in repair material PVA-ECC could not be absorbed.

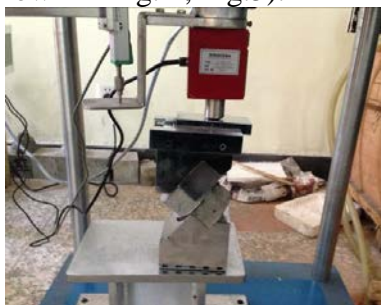
Fig. 4. Interface Performance Tester JMS-1

Bond strength was determined by interface performance tester JMS-1 and the data collector CJY-F1 (shown in Fig. 4, Fig.5).

The load acquisition range was 0-50KN, loading speed sustained 10-50 mm/min, the deformation acquisition range was 0-30 mm, resolution was 0.01 mm. Put the new and old concrete cylindrical specimen cut separately on the electro-hydraulic servo universal testing machine to measure their compressive strength, the maximum load was 600 KN, the loading rate was 0.1 mm/s.

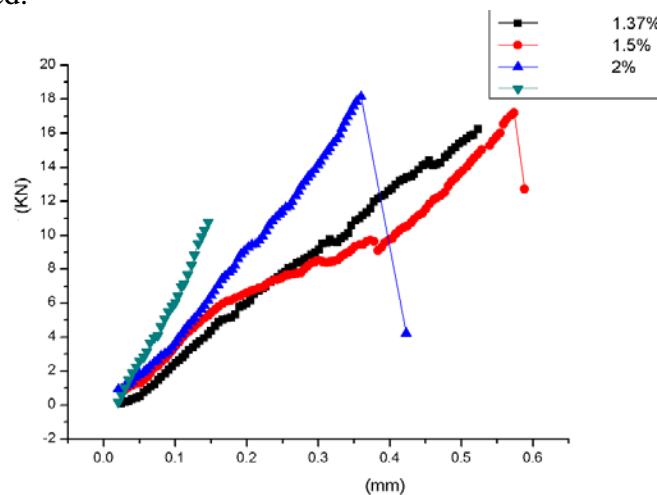
Fig. 7 Shear Stress-Strain Curve of Bonding Specimens

Bond strength-displacement curve measured in experiment for old and new concrete was shown in Fig. 7. It showed that shear stress of the specimens increased with the increase of strain, and the linear increased straightly. Once the adhesion surface was damaged, specimens separated immediately. Maximum failure stress of PVA-ECC specimen was about twice as that of specimen without any fiber. It describes that fibers improved bond strength significantly. In addition, the shear stress - strain curve of PVA - ECC specimen flattened out, it indicated that shear deformation and toughness were enhanced.
