Application of Laser Ultrasonic Visualization Detection in the Detection of Cylinder Sleeve

Abstract— This paper introduces the detection of laser ultrasonic visualization. It describes the working principle of cylinder sleeve and the formation causes of defects. It bases on the use of LUVI technology to check the defects by experiments of cylinder sleeve, and the experimental results are analyzed. Finally it points out the application field of the laser ultrasonic visualization nondestructive testing and development prospects.

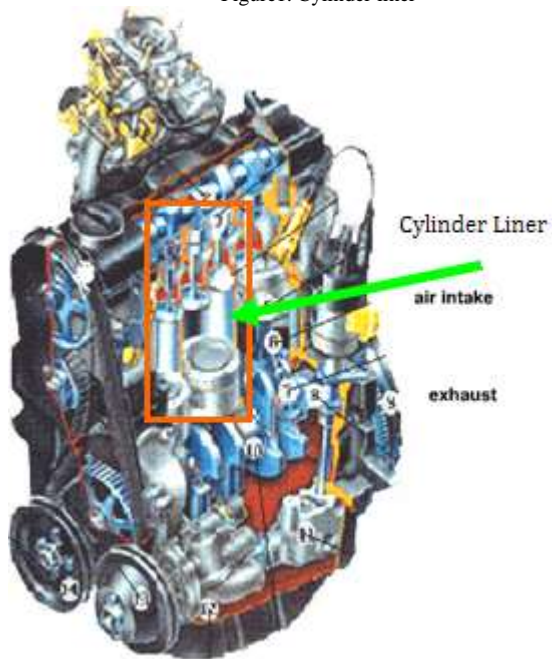
Figure2. The positions of the cylinder liner in machinery

Cylindrical parts of cylinder liner in internal combustion engine cylinder embedded in it, and the piston and piston ring cylinder components together, the cylinder fuel combustion pressures into mechanical energy to work through the crank connecting rod mechanism is one of the key parts in the worst working condition of the engine. The cylinder sleeve and the cylinder,

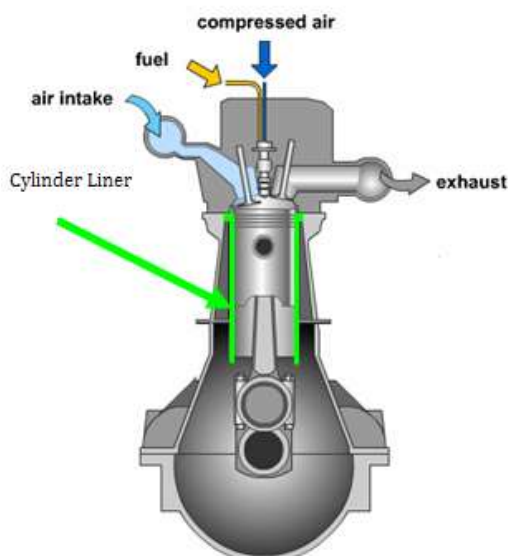
Figure3. Cylinder liner with other components of the assembly

cylinder head, cylinder pad directly assembly mating, itself has the larger assembly stress. It works continuously by the vibration, bearing large impact, damage. Cylinder hole under constant friction and corrosion, easily to be damaged, and the damage may be caused by failure of cylinder liner cylinder. The failure of cylinder sleeve is the engine, and it does not work.

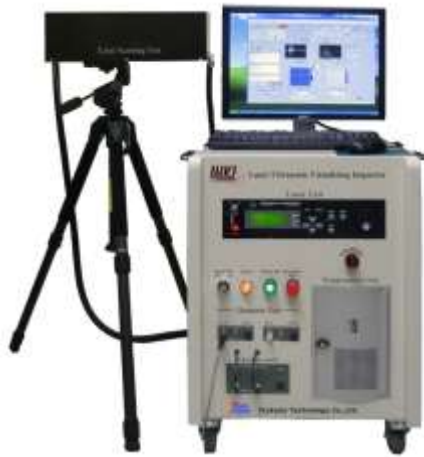
Figure4. LUVI-SP2 detector

1) *The instrument used detection:* the LUVI-SP2 test instrument.

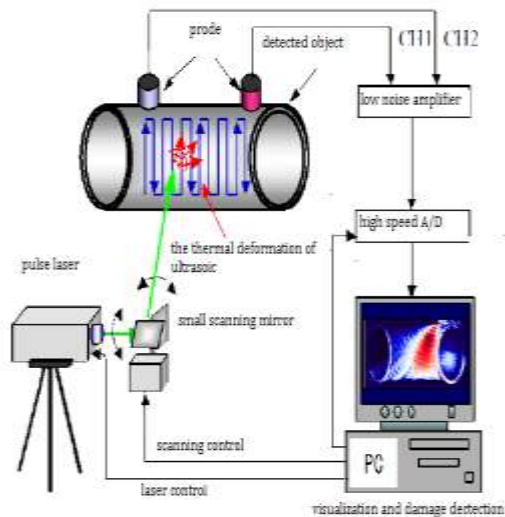
Figure5. LUVI - SP2 and testing a wiring diagram

the cylinder sleeve is the premise to ensure work safety of cylinder sleeve.
 3.LUVI-SP2 tester and testing parts of the connection diagram

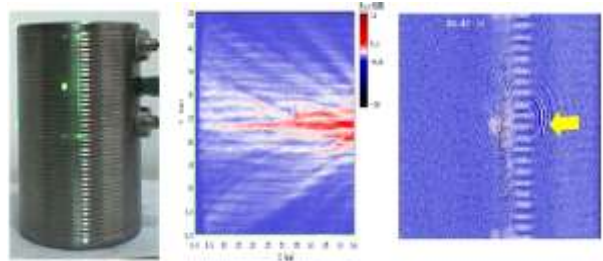
Figure6. Cylinder liner Figure7.Amplitude Figure8.Animation

1) *Detection of external longitudinal crack*

From the above three experimental phenomena, we know that, in Fig .7, Fig .10 defects strong signal red appearance, the more serious the defects of maximum amplitude red signal is also larger; in Fig .8, Fig .11 in the ultrasound propagation animation display, in the yellow arrow pointing to the site showed that echo is, specimen damage here, not in the normal wave propagates, echo more obvious, suggesting that the defects are also more serious. Corrosion hole in Fig .11 will be detected after amplification, our naked eye can see. If the hole is difficult to be found in the cylinder sleeve, it is easy to cause the failure of cylinder sleeve.

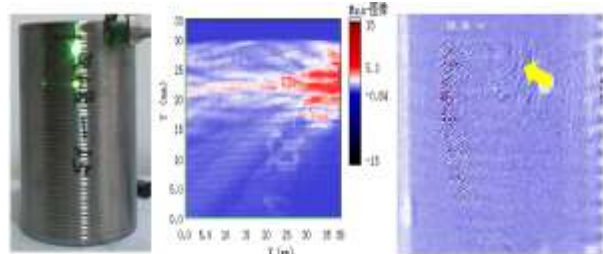
Figure9. Cylinder liner Figure10. Mplitude Figure 11.Animation

2) *Cross section of the pipe wall inner hole detection*

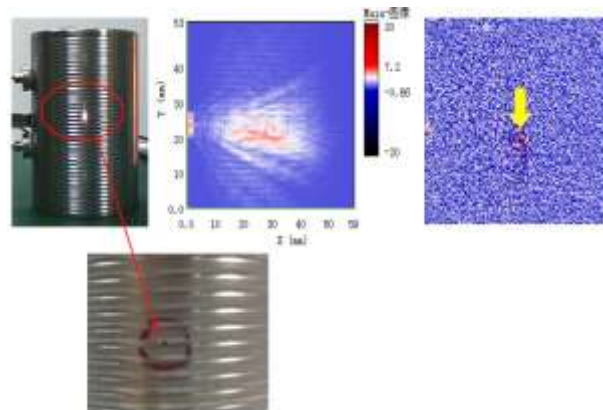
Figure12. Corrosion of Amplification

3) *External hole (phi 0.8) test results*
