# Analysis on Fracture Reason of 20CrMo Driving Shaft

**Abstract**—The fracture reason of a driving shaft used motorcycle engine was analyzed by means of macroscopic examination, chemical analysis, fracture analysis, hardness testing. The results showed that the fatigue fracture mode was determined and incomplete hardening of the axis and increasingly growing load were the main reasons which accelerated the fatigue fracture of the driving shaft.

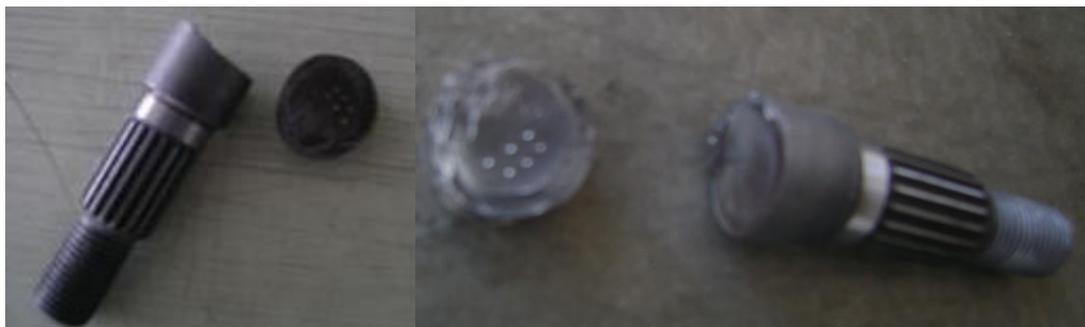
Figure 1 Appearance of fractured driving shaft

The macro-morphology of the broken pieces is shown in Figure 1. From the fig.1 we can know there is obvious plastic deformation in the fracture and the fracture surface include fatigue source region, fatigue crack growth area and instantaneous fracture zone[7]. So, we judged that the fracture was fatigue fracture.

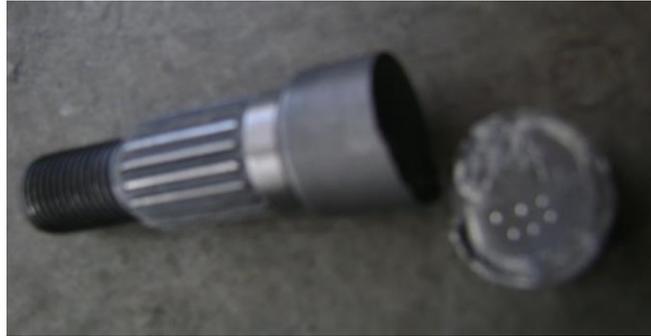
Figure 2 Spectroscopic chemical analysis

Spectroscopic chemical analysis on sampling near the fracture driving shaft was carried on as shown in Figure 2. The spectrometer is model of OBLF-750 and made in Germany. The result of analysis is shown in Table 1. Compared with the standard material

composition, the chemical composition of the driving shaft is in line with the provisions of GB3077-88 of 20CrMo steel. So the chemical elements of raw materials are qualified.

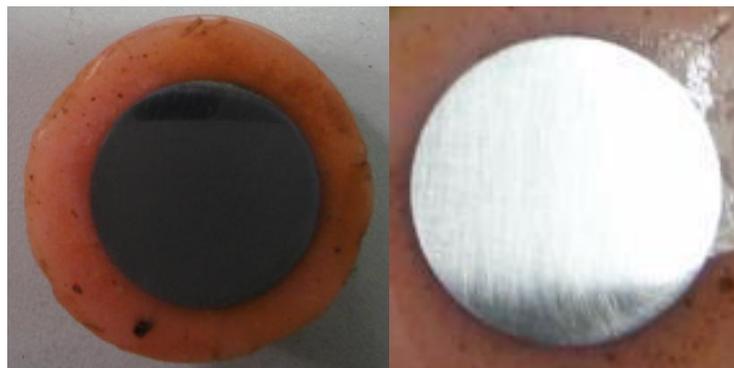
Figure 3 Sample of Metallographic examination

The heat-treatment of the driving shaft includes carbonitriding, quenching and tempering. The sample was gotten near the fracture source region. The cross section of the sample was used to prepare the observed surface and the inlaid sample was milled in the 200-1200 number of sandpaper. After finished sample grinding, the sample was rough polished fine polished until the sample was looked bright as a mirror without any minor scratches, as shown in fig.3. Using alcohol with 4% nitric acid solution eroded the surface of the sample, then the erosion good sample was observed using Carl Zeiss

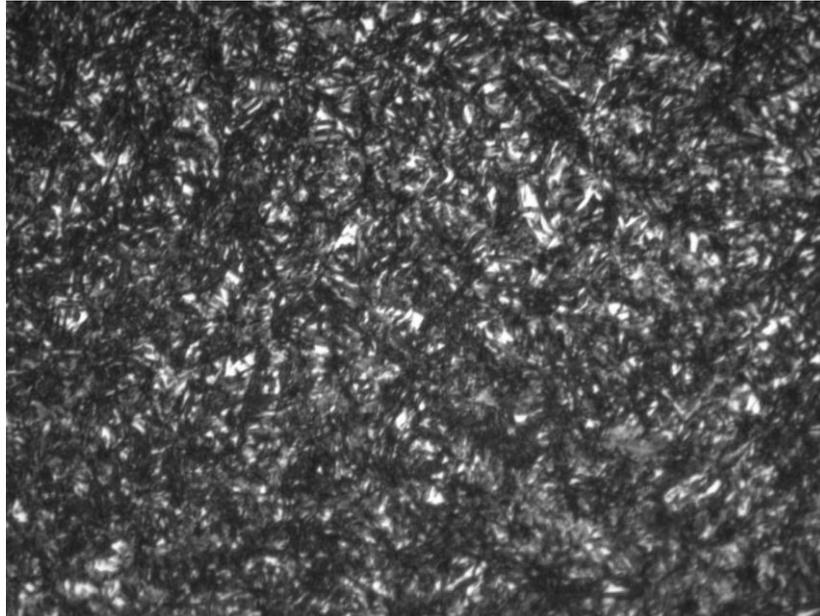
Figure 4 Surface texture of fracture driving shaft: tempering M+A' ~540X

inverted microscope which model was Axiovert 40 MAT. The sample of fracture shaft was observed microstructure of the surface layer and the core section, as shown in Figure4 and Fig .5. The surface structure of specimen was shown in Figure4 and core tissue sample was shown in Figure5. From the fig.4 we can learn that the surface microstructure was tempered martensite (tempering M) and a small amount of residual austenite (A ') and the structure was normal; from the fig.5 we can learn that the core part was ferrite microstructure (F) and pearlite (P), and the structure of core is the balance organization[8-10].

Based on the above physical and chemical test results, the chemical composition of the driving shaft is of qualified. Viewed from the microstructure, hardness of sample core matched with the microstructure match. The heat-treatment process includes carburizing quenching and tempering. We can know from the design drawings that the heat-treatment process of the fracture shaft was carried on carbonitriding, quenching and tempering. But the hardness of core part is lower than the demanded value. In cording to the demanded hardness value, the core texture should include higher hardness tempered martensite and tempered troostite texture.
