# Sodium Sulfate Corrosion of Metro Tunnel Lining Concrete Strength Test Curve of Impact Study

**Keywords:** Salt corrosion; Rebound method; Tunnel lining concrete

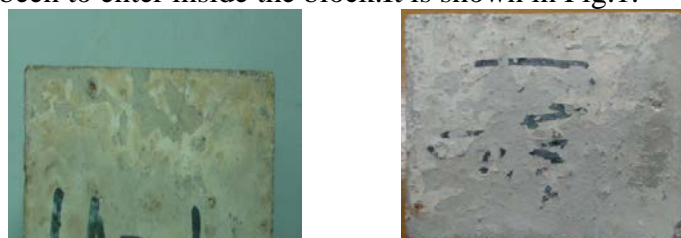
Preliminary stage of corrosion, several white crystalline precipitate dry-wet circulation block, block surface appear white marks. As the test progressed, expand the area of white trace, explain the corrosion solution has been to enter inside the block. It is shown in Fig.1.

Fig.1 Preliminary-stage test phenomenon of corrosion

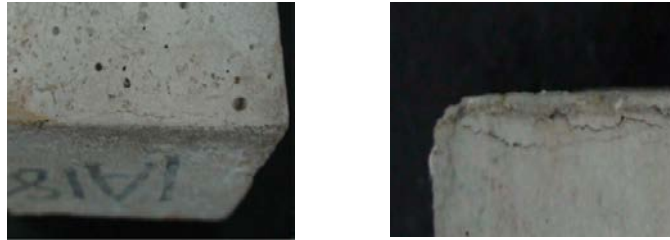
To continue with the corrosion test, in the test medium, after some dry-wet alternate cycle, the color of test block to deepen. The edges can already see the collapse, the mortar off situation. As the corrosion to continue, microfractures expand gradually, and gradually formed obvious cracks. It is shown in Fig.2.

Fig.2 Mid-stage test phenomenon of corrosion

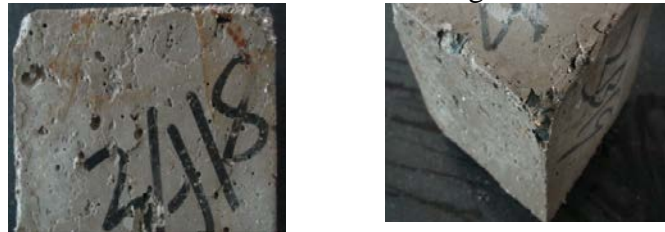
Late corrosion, the internal erosion that corrosion solution to the concrete makes the test block color turns to yellow. The middle of the crack has been generating obvious cracks. Some sand lose the effect of cementation and fall off, causing uneven surface, and surface hardness is decline seriously. Test block corner interface shape is irregular, and some performance index both are decline. In the end, the outer layer of the test block is get to crisp, and integrity is suffered heavy damage. Illustrate sulfate corrosion is more obvious. It is shown in Fig.3.

Fig.3 Late-stage test phenomenon of corrosion

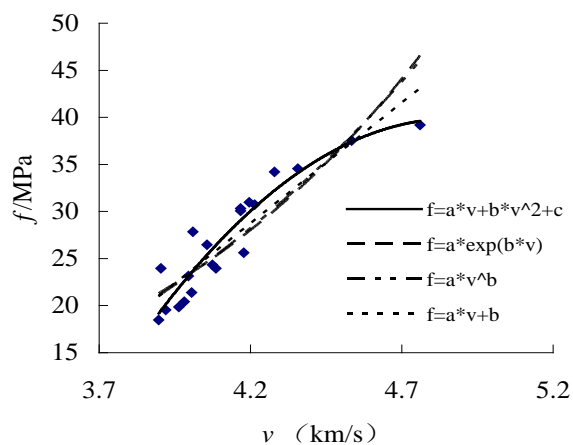
Fig.4 Regression formula of compressive in ultrasonic method

Fig.4 shows that polynomial function, linear function, power function and exponential function regression formula, and correlation coefficients were 0.94, 0.91, 0.89, 0.94. The average relative error ( $\delta$ ) is 6.40%, 8.57%, 9.05%, 9.37%. The relative standard deviation ( $e_r$ ) is 8.49%, 9.64%, 10.31%, 10.72%. It is shown in Table 4.

Polynomial function regression formula is better, second type linear function and exponential function regression formula, so it is recommended to use polynomial as ultrasonic measurement curves after the tunnel lining concrete under sulfate corrosion.
