Experimental research of the influence of differential settlement on the upper frame structures

Keywords: foundation; differential settlement; frame structure; experimental study

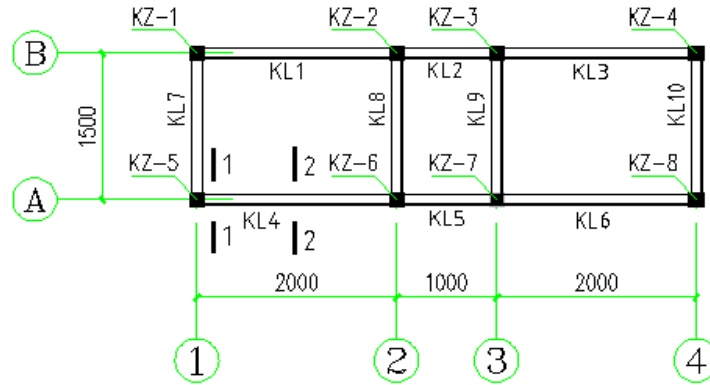
Fig. 1. The floor plan of model structure

The research object was the four layer office building(the grade of concrete is C30), which was reinforced concrete frame structure with 6×3 span. The longitudinal spans were all 4.5m, the transverse spans were respectively divided into 6m, 3m, 6m, the height of the first floor was 3.6m, and the height of the others were 3m. According to the similarity theory, this test established the 3:1 model which selected a longitudinal bay for the first floor of the office building. the floor plan of model structure is shown in Fig. 1. Based on the similitude theory, the size and reinforcement of the specimen were scaled. The cross-sectional dimensions of the frame columns were 150mm×150mm, and the cross-sectional dimensions of the frame beams were 100mm×150mm in the test component. The frame beam and frame column reinforcement are shown in Fig. 2. In order to ensure the transport and the specimens during the test has stabilization, setting the ring beam in the bottom member. Ring beam, beams and columns were connected to form a space frame structure, but settling column and ring beam were not connected. The loads of test structure were composed of frame, floor, wall and live loads, and they converted into equivalent sand according to the similarity principle to be added to

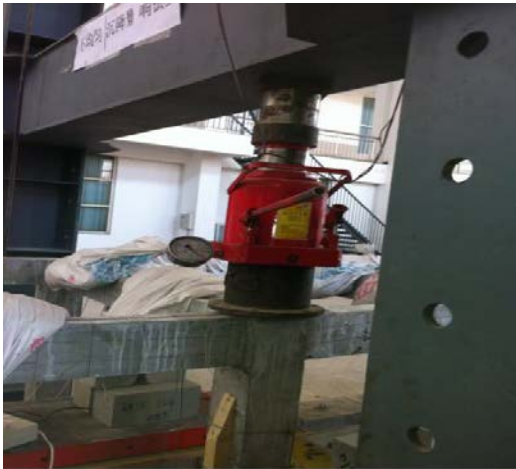
Fig. 3. Test equipment

the corresponding frame beam. Two frame specimens were produced respectively. One is working condition S1 used to make settlement test of side column KZ-5. The other is working condition S1 used to make settlement test of middle column KZ-6. In the process of test, the horizontal displacement of settling column was constraint and only the vertical displacement can occur [9]. Jacks on the top of corresponding settling column exerted anti pressure on the specimen, in order to produce the vertical displacement of settling column and achieve the effect of differential settlement of foundation. the test equipment are shown in Fig. 3.

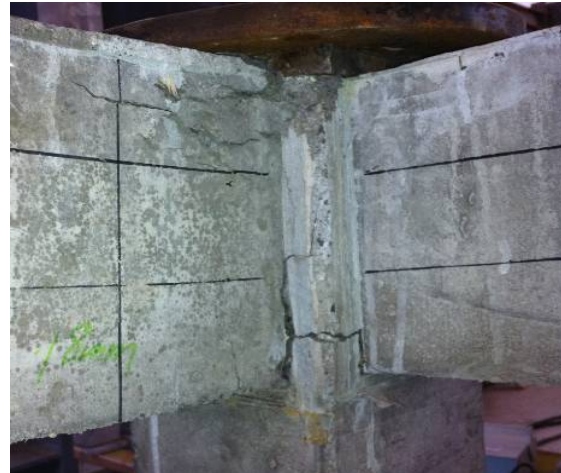
Fig. 4. In condition S2, cracks of settling column-beam joints

In condition S2, with the development of settlement, the failure discipline of each beam was as follows in turn: First on the top surface of beam KL5 away from the end of settling column appeared

micro-cracks. Then on the top surface of beam KL4 and beam 8 away from the end of settling column appeared the first lateral micro-cracks. At the bottom of beam KL5 away from the end of settling column appeared tiny cracks, and at the bottom of column KZ-7-beam KL5 node appeared micro-cracks. The first crack of KL8 away from the end of settling column keep on developing, and at the same time appeared the second micro-crack. Settlement was continuing, and the top crack of beam KL5 away from the end of settling column was developed to 1/5 of beam height along the horizontal quickly. Meanwhile, beam KL5 appeared several tiny cracks at the central bottom and near the end of settling column, and at the bottom of KL4 near the end of settling column also appeared a tiny crack. With the development of settlement, the top crack of beam KL5 away from the end of settling column was developed rapidly along the horizontal and the width of crack was greater than 5 mm. In the meantime, the surface concrete at bottom loosed and peeled off. Settlement was continuing, at the bottom of KL5 near the end of settling column appeared cracks, and the top concrete loosed slightly. At the central bottom of KL8 appeared cracks, and the width of crack of KL8 away from the end of settling column had developed to greater than 5 mm. Settlement was continuing, at the bottom of beam KL4 40cm distant from KZ-6 column appeared a through crack that width was 1 mm -3 mm. Settlement was continuing, the bottom concrete of beam KL5 away from the end of settling column was crushed. The crack of beam KL5 away from the end of settling column was developed to 2/3 of beam height, and top crack of beam KL8 away from the end of settling column was developed to 2/3 of beam height along depth. The bottom concrete of beam KL5 away from the end of settling column peeled off severely, and the bottom of beam KL5 near the end of settling column was separated from column about 4 mm. Column KZ-6 was separated from the bottom of all joints connected to beam, and the structure was destroyed. Cracks of settling column-beam joints are shown as Fig. 4.

As to side column settlement, cracks first appeared on the top surface of side beams away from the end of settling column; The main cracks appeared at the underarm parts of beam-column joints, the mid-span top of middle beams, the end away from settling column of beams next to settling column and so on; The RC members were broken for concrete spalling of side beam at bottom away from the end of settling column. As to middle column settlement, cracks first appeared on the top surface of middle beam away from the end of settling column; The main cracks appeared at the top of the end away from settling column of side beams, the mid-span bottom of middle beams, the bottom away from the end of settling column of middle beams. The RC members were broken for concrete spalling of middle beam at bottom away from the end of settling column.
