## Application of Correlation Analysis in Concrete Infrared Thermography Detection

**Keywords:** Infrared Thermography, Concrete, Non-destructive Testing, Correlation Analysis.

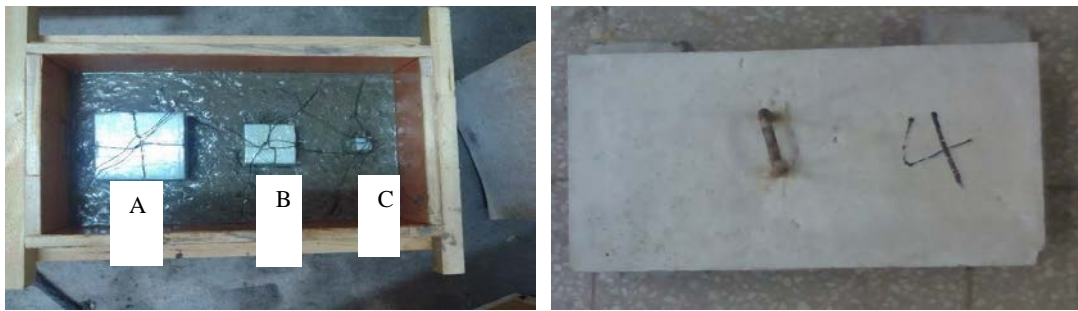
Fig. 1 Concrete sample

**Preparation of sample and heating equipment.** Prepare the concrete sample. The sample is 480mm long, 240mm wide and 160mm high with neat surface. The concrete grade is C40. Embed 3 foamed plastics to simulate the internal defects. The depth of the defect in the sample is  $H=60$ mm, the thickness of the defect is  $h=40$ mm, and the side lengths are 20mm, 60mm and 100mm respectively. Make and position the defects accurately. Set a rebar lifting ring on the side without rebar. Refer to Fig. 1.

(a)The artificial defects (b) Visible-light image

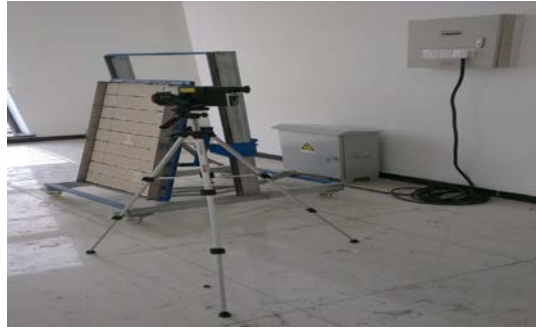
Fig.2 Heating device and InfRec R300 infrared thermal imager

The concrete IR thermal imaging NDT heating device is formed by 45 ceramic radiators in 9 lines and 5 rows. The surface average thermal power density of the ceramic radiators is  $16 \text{ kW/m}^2$ . The heating equipment is shown in Fig. 2.
