## Maintenance and Reinforcement Design of Relics Steel Arch Bridge

The steel arch bridge built in 1936 was recommended to be Zhejiang provincial cultural relics protection construction in 2005. It is a single-span half-through three-hinged steel arch bridge with a span of 97.552m. The general arrangement drawing is shown in figure 1. The main rise-span ratio is 1/6.6 and the arch axis is a circle-arc line with a radius of 86.349m. The original width of bridge was 20.17m, widened to 25m in the overhaul in 1994. There are a total of 12 suspenders on the bridge whose center distance is 7.925m except few intermediate suspenders. The arch rib is box section which consists of a roof, two webs, a middle diaphragm, a bottom plate, and several connection angles. The suspender is H-section made up of a web and four angles, which are respectively riveted on arch rib and beam on both sides. The bridge deck system, which originally consisted of vertical and horizontal steel beams and concrete slabs, was changed to orthotropic steel bridge deck system in the overhaul in 1994. The substructure is made up of two hollow box abutments and some inclined pine piles.

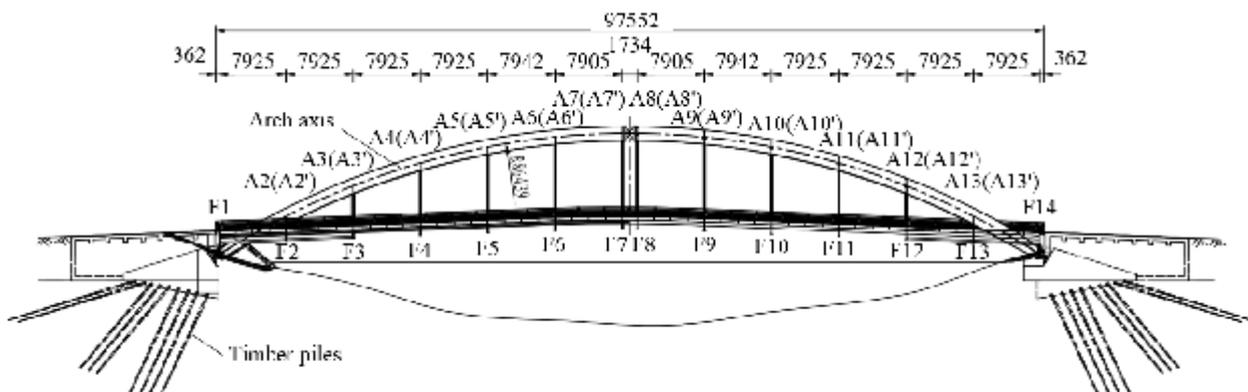
Fig.1 The general arrangement elevation drawing of status quo

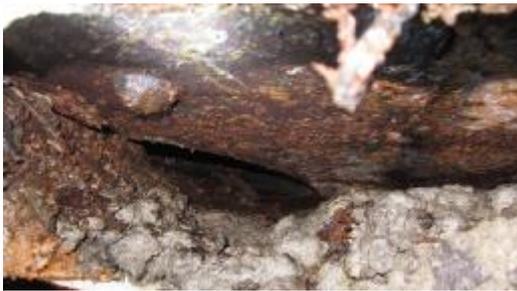
position measurement of the arch ring, the traffic investigation, etc. The detection results showed that: Firstly, the arch rib existed many craters. Many parts of the coating had failed. The sealing measure of the deck and arch had been invalid. There was a large amount of water in arch rib box leading to serious corrosion, as shown in figure 2(a). Secondly, many suspenders' surface corrosion was serious. The anticorrosion paints mostly degenerated, as shown in figure 2(b). Thirdly, the bottom of some bridge brackets had been collided by boat repeatedly leading to obvious deformation and damage. Many longitudinal beams had the diseases of cracking and sealing-off, as shown in figure 2(c). Fourthly, a large area of bridge deck and many stiffening ribs were fractured, causing waterproof function failure of bridge deck. Many plates of bridge deck were corroded seriously, as shown in figure 2(d).

(a) Serious corrosion of arch rib box

The general section of the old arch rib is shown in figure 4(a). In this reinforcement design, to maintain the integrity of the old structure, the roofs, webs, and some undamaged connection angles of the old arch ribs should be retained and internally reinforced with steel flitches. Only the internal damaged members can be replaced so as not to change the old structure appearance. Firstly, each arch rib web will be reinforced with three pieces of steel flitches at the top, bottom and central axis in order to strengthen the top and the bottom, which are the key positions of the maximal bending stress, and the central axis, which is the key position of the maximal shearing stress. The riveting between flitches and webs should use the original rivet holes as much as possible. Secondly, the internal middle diaphragms, bottom plates and their flitches will be replaced to new components with the same size. Thirdly, after the demolition of middle diaphragms and bottom plates, if the connection angles of the roofs and the webs are removed, the old arch rib will be overall scattered and difficult to restructuring. So the reinforcement of roofs should not adopt the flitches inside the roof plates, but add new longitudinal diaphragms at the top of the arch rib with angles riveted on the web. The new reinforcement arch rib section is shown in figure 4(b). The dark regions are all new reinforcement components. The thickness of each flich of the web is 20mm and the length of the flich at the central axis is 300mm. The upper longitudinal diaphragm is 30mm thickness, whose angles are 160\*160\*14mm. The middle diaphragm is 10mm thickness as original, whose angles also use the size of 70\*70\*10mm.

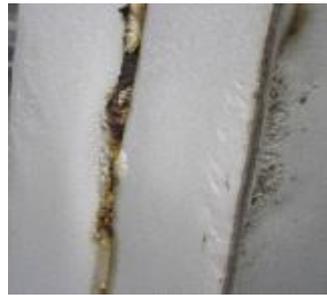
(b) Serious corrosion of suspenders' surface

**Reinforcement of portal-frame and suspender.** The portal-frames and the suspenders don't exist serious damages that endanger the safety of the structure. And the bearing capacity can meet the relevant calculation requirements in the current design criteria[9]. To maintain the integrity of the old structure, in this reinforcement design, the portal-frames will be reused after straightening and derusting, and reconstructed in situ according to the original riveting. The undamaged angles and webs of the suspenders will be retained and the serious corrosion damaged angles and webs will be replaced with the original size.

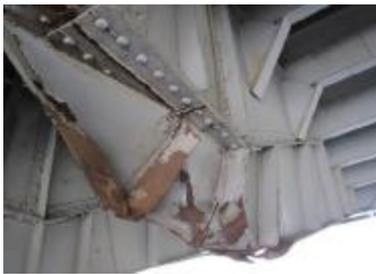
(c) Deformation and damage of bracket

As shown in figure 3(b), the reinforcement brackets of 1994 were welded with the angles riveted on old brackets. This connection didn't have enough intensity, causing serious tear of the old bracket in ship collision accidents(see figure 2(c)). In this reinforcement design the new bracket web will be riveted with the old cross beam web and the new cross beam web by splice plates, as shown in figure 3(c), to ensure enough strength of the connection between new bracket and cross beam.

In this reinforcement design the bracket must be reconstruct to reduce the beam height and increase the clearance to avoid ship collision accidents. As shown in figure 3(c), to protect the integrity of the original structure, all of the old vertical and horizontal beams will be retained. Among them, some serious deformation components will be repaired with the method of mechanical correction. The reinforcement brackets of 1994 will be replaced to new I-section brackets, whose web thickness is 12mm as the old cross beams' web thickness so that they can splice each other. The thickness of lower flange in the horizontal section is 30mm and in the oblique section is 16mm. The box edge stringer will be replaced according to the size of the original 402mm\*476mm.

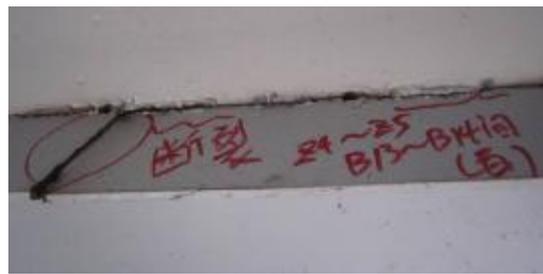
(d) Open stiffening ribs fracture

The open stiffeners of orthotropic steel bridge deck reinforced in 1994 didn't have enough strength and there were many welding defects, resulting in serious crack of bridge decks and vertical and horizontal beams. In this reinforcement design all of the reinforcement decks and beams in 1994 must be replaced. As shown in figure 3(c), new bridge deck is 14mm thickness. The new cross beam is located at the top of the old, still using I-section. According to the size of the old cross beam, the web of new cross beam is 12mm thickness and the lower flange is 16mm thickness which will be riveted with the upper flange of the old cross beam. The new longitudinal beam is also located at the top of the old longitudinal beam. The web of new longitudinal beam is 12mm thickness and the lower flange is 30mm thickness. There are three new I-section cross beams between each two main cross beams. The web thickness is 10mm and the lower flange thickness is 16mm. All of the open stiffening ribs will be replaced to the close U-shaped stiffening ribs whose mechanical properties are more excellent[7]. According to the construction requirements[8], the close stiffeners size is: the height is 250mm, the thickness is 8mm and the distance between two ribs is 267mm.

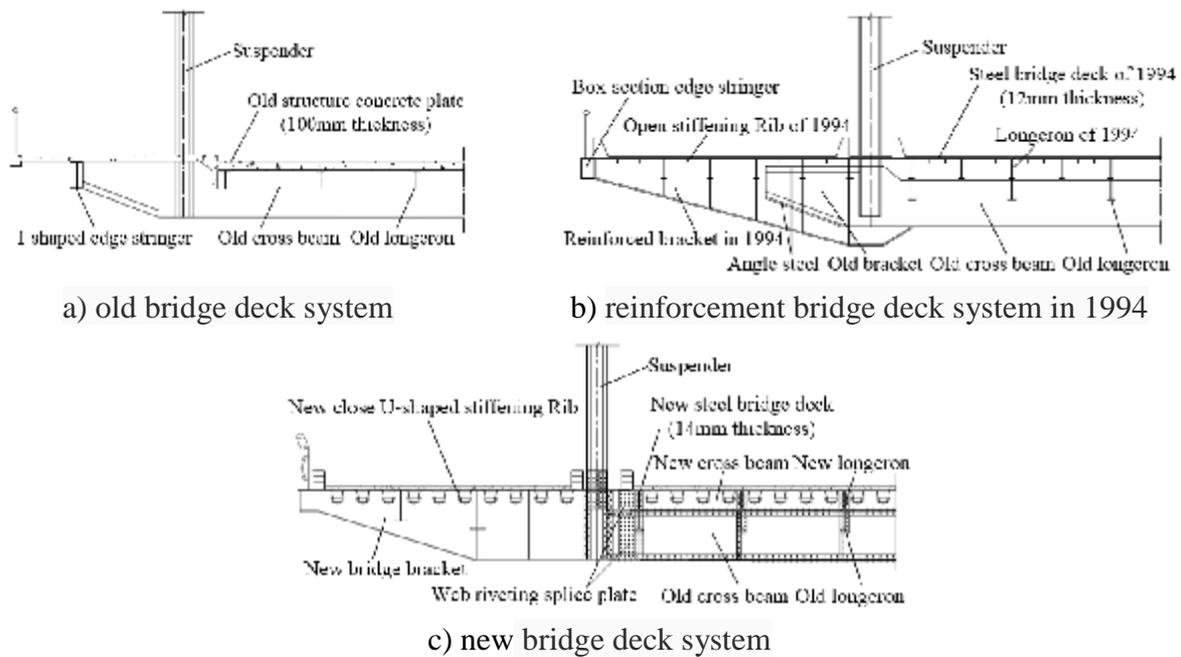
**Reinforcement of bridge deck system.** As shown in figure 3(a) and 3(b), the bridge deck

system which originally consisted of steel vertical and horizontal beams and concrete decks, was changed to orthotropic steel bridge deck system in the overhaul in 1994. At the same time in order to widen the bridge deck, the bridge bracket was reformed with a new component around the old bracket. But the clearance under the bridge was limited and the river navigation level and water level were promoted, leading to multiple ship collision accidents.

Fig.3 The schematic diagram of bridge deck system reinforcement

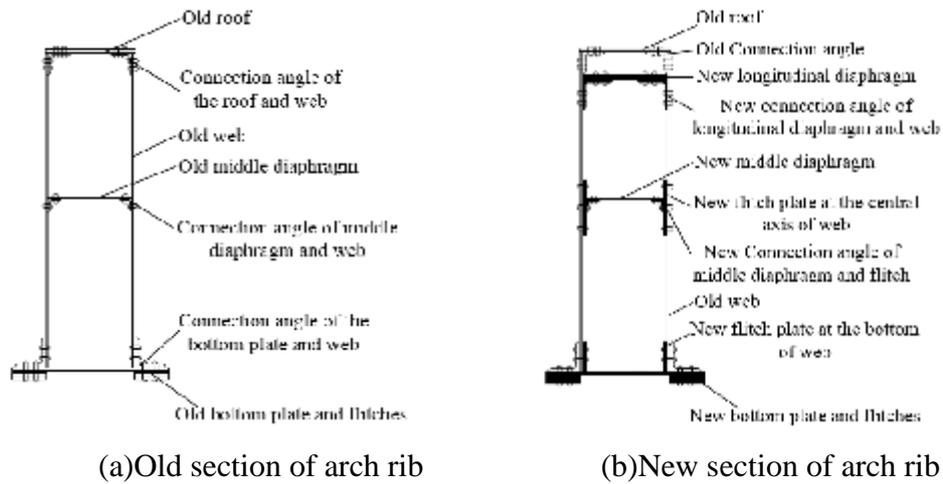
**Reinforcement of bridge arch rib.** In the reinforcement design of deck system, changing the open stiffeners to close U-shaped stiffeners, thickening the middle bridge decks, adding new cross beams and so on have increased the overall weight of bridge deck system by nearly 60%. Therefore, the arch ribs must be reinforced otherwise the bearing capacity will not be able to meet the relevant calculation requirements in the current design criteria[9] and the bridge will damage.

Fig.4 The schematic diagram of arch rib reinforcement
