Detection of Seepage Path of dam foundation Based on Groundvue Radar

Keywords: Dam foundation, Groundvue Radar, Seepage path, Detection

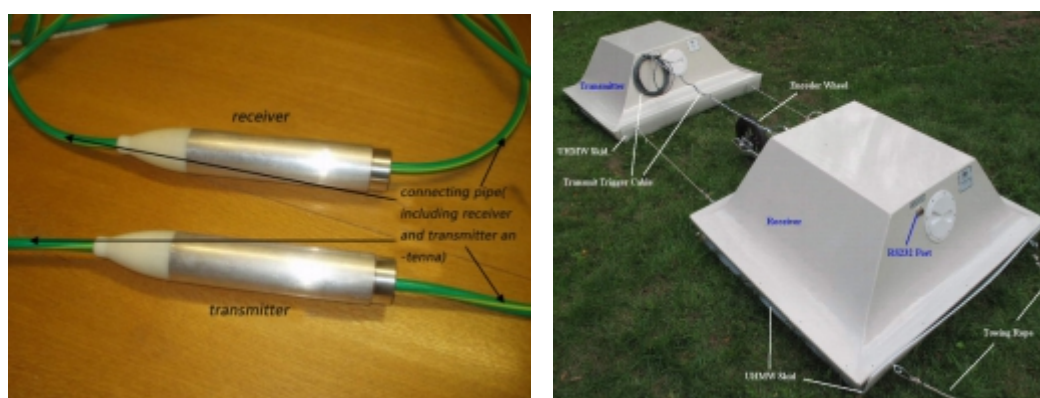
Figure 1 GV series of ground penetrating radar antenna

Geological radar antenna according to the classification in different ways can be classified into different types of antennas. From the nature of the work, it can be classified into transmit and receive antennas; from the shield or not shield, it can be classified into shielded and unshielded antenna. as shown in Figure 1.

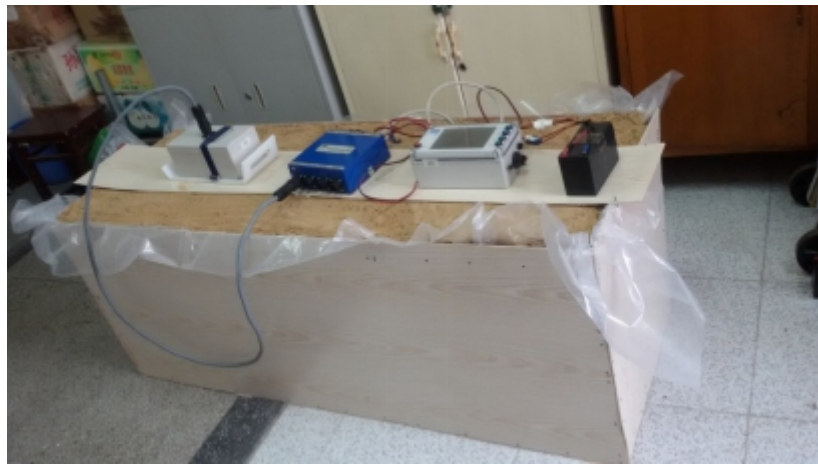
Figure 2 GV ground penetrating radar indoor test platform

For a reasonable analysis of Nanmenxia reservoir's images measured by GV ground penetrating radar, Hohai University established a simulation platform based on 1GHz of GV3 ground penetrating radar antenna in the laboratory, to understand the characteristics of the target model image measured by GV ground penetrating radar. As shown in Figure 2.

As the indoor test platform of GV3-1G antenna is able to effectively simulate and test the radar image characteristics of underground target objects, its results help to improve the detection interpretation efficiency of Groundvue geological radar.

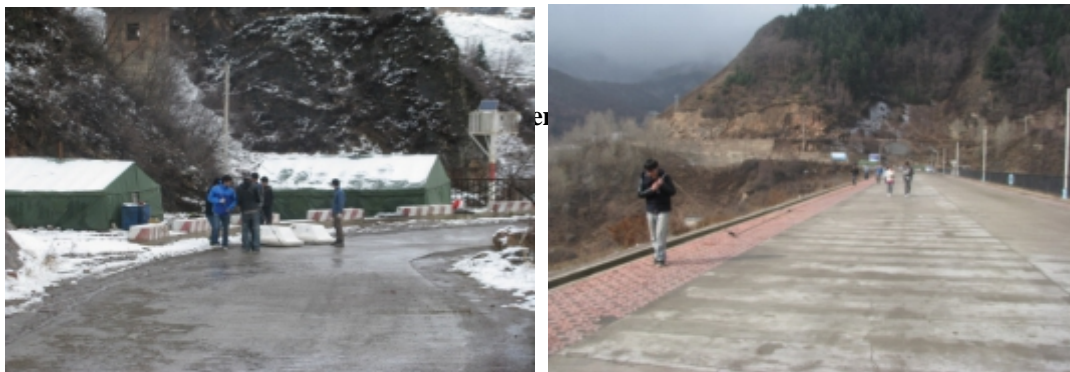
Figure 3 GV6, GV2 measured at the crest of the dam

The main survey line is arranged in the top and fore slope of the dam. The main detecting route include: three equidistant longitudinal survey lines along the highway direction on the dam crest, two longitudinal survey lines on the dam fore slope grouting platform, they were GV2 and GV6 detection; Dam fore slope survey lines were detected from grouting platform to the top of slope. It's direction perpendicular to the dam's trend. Because there are many stone on dam slope, it was not conducive to larger size and weight GV2's probe (smaller effect on the light GV6), so the measuring space was arranged to 3.5 m. The total of survey lines is 26. Test method is shown in Figure 3.

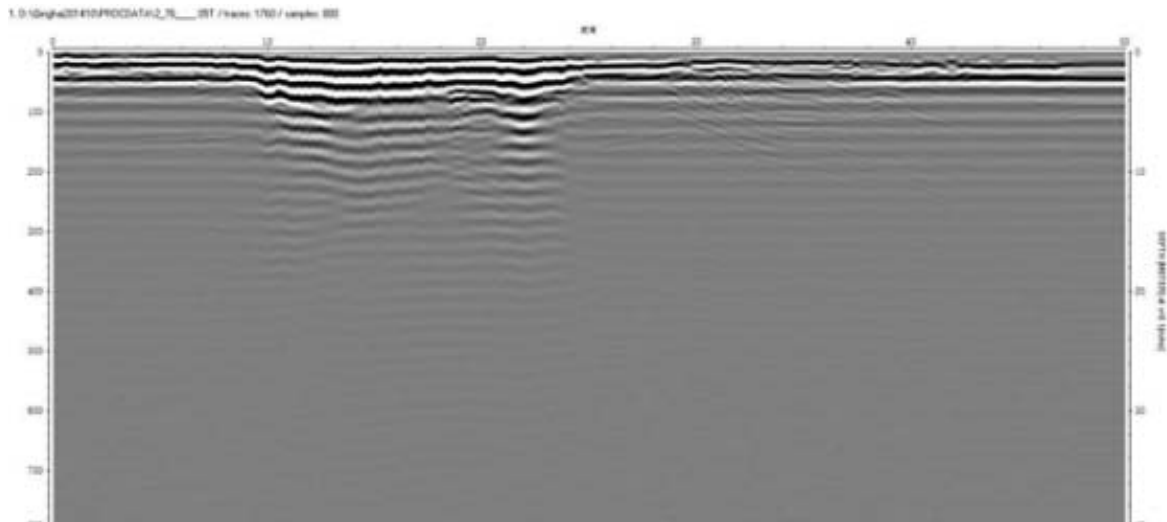
Figure 4 GV2 GPR gray scale of grouting adit on the right bank

Through GV2 GPR test and analysis in the right bank of the dam grouting tunnel, the test results showed that the 0 + 450 to 0 + 470 m section of right bank of the grouting tunnel exists obvious fractured zones, as shown in Figure 4. it need to be paid full attention in reinforcing.

Through test and analysis by GV2 radar, there has obvious fissure zone in local of the right grouting tunnel to be found, which should be paid full attention in reinforcement.

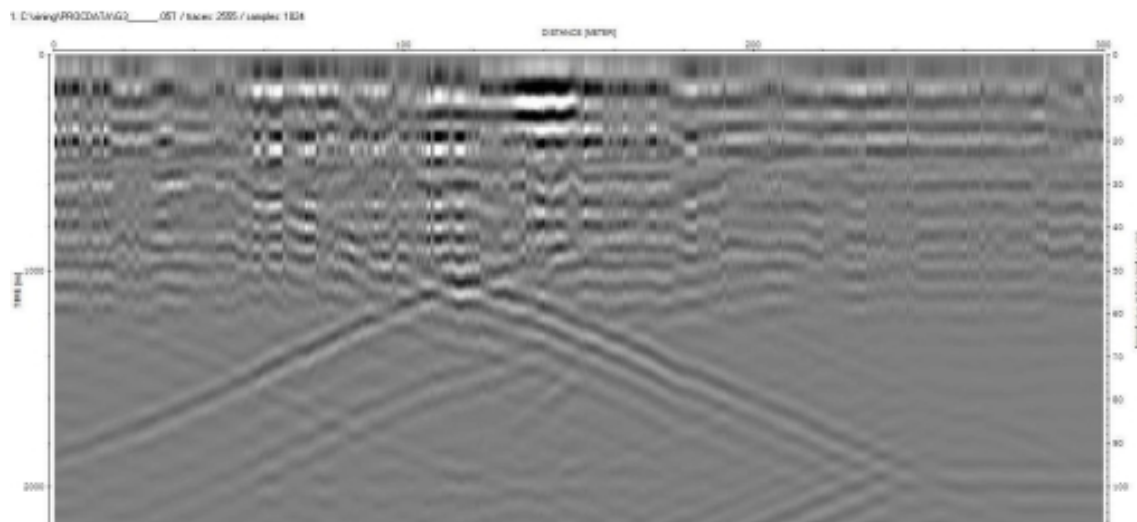
Figure5 GV6 GPR gray scale at bottom slope of dam parallel to the dam axis

Through GV6 GPR test at bottom slope of dam that was parallel to the dam axis, found the bedrock under overburden exist significant strong penetration band in the range of 0 + 155 to 0 + 205, as shown in Figure 5.

Found and determined that obvious strong permeability zone existed in the dam foundation rock by GV6 test and analysis, fracture zone could be seen in drilling verification holes at 0+160, 0+180 and 0+200. Local part has no-fill fissure zone, which was the main leakage passage of deep dam foundation.

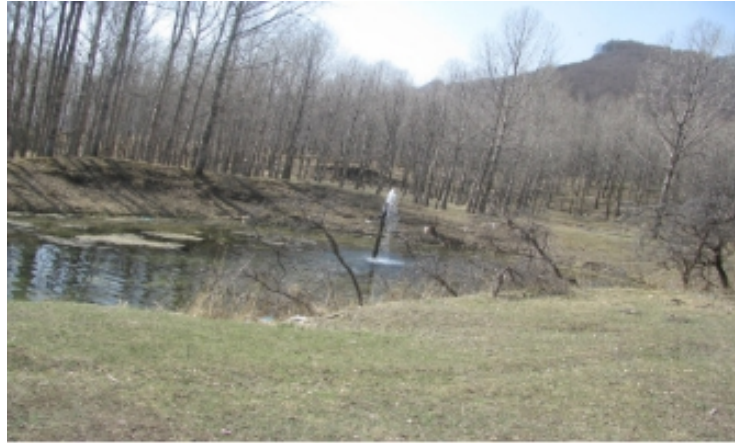
Figure 6 Self-water drilling at the platform behind dam

Drilling holes at 0 + 160, 0 + 180 and 0 + 200, fault fracture zone and partial unfilled fissure zone were seen. Self-water drilling emerged at the platform behind dam also proved that the monolith has strong permeability and a certain pressure resistance, as shown in Figure 6.
