New trends of landslide disasters after impoundment of the Three Gorges Reservoir, China, and reflections related to landslide prevention

Keywords: Three Gorges Reservoir; Landslide disaster; Recommendations; Factors causing landslides; New trends

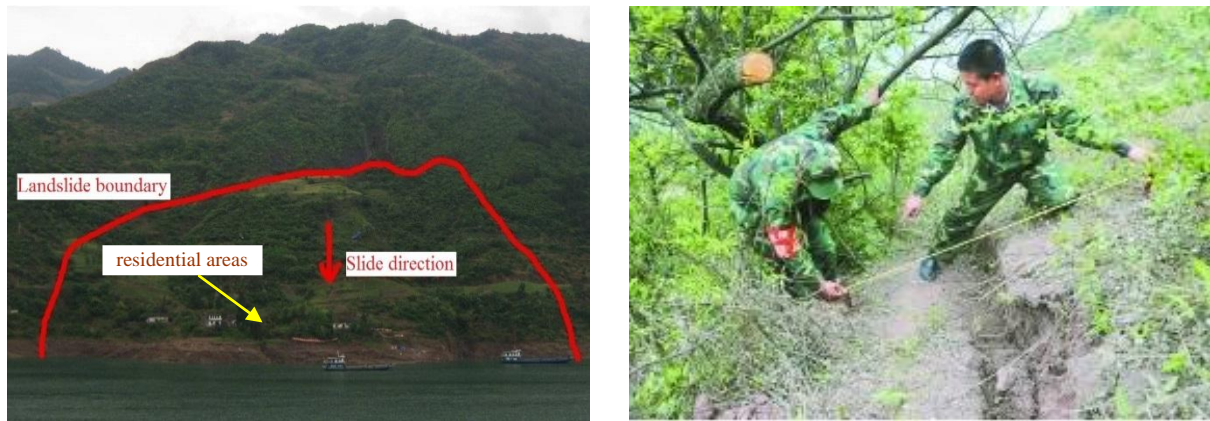
deformed exposing an apparent trend of a whole-body slide. The panorama of the Liangshuijing Landslide and the deformation in the trailing edge of the landslide is shown in Fig.1.

Fig. 1. Panorama of the Liangshuijing Landslide and the deformation in the trailing edge of the landslide.
(Sources: Xihuanet 2009)

Liangshuijing Landslide. Since March 10, 2009, flood control efforts caused the water level in the reservoir to decline. The Liangshuijing Landslide deformation was aggravated; cracks on the trailing and side edges of the landslide coalesced, and the cracks on both sides extended to the river. On April 1, 2009, the situation became dangerous at the site of the Liangshuijing Landslide; the cracks in the surrounding landslide material coalesced, and houses on the landslide were severely

The site investigation showed that the Liangshuijing landslide body was between 250–370 m long and 200–370 m wide with a mean thickness of 20 m; the total volume encompassed about 3.6 million m³. If such a massive landslide body suddenly slides into the reservoir, this will create a serious threat to passing ships, block part of the Yangtze River waterway, and the consequences would be disastrous.

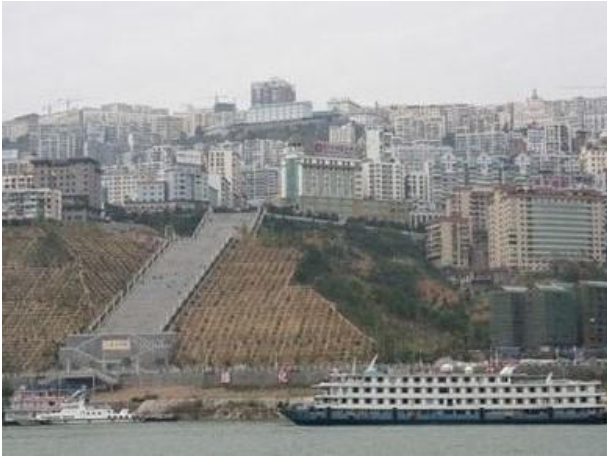
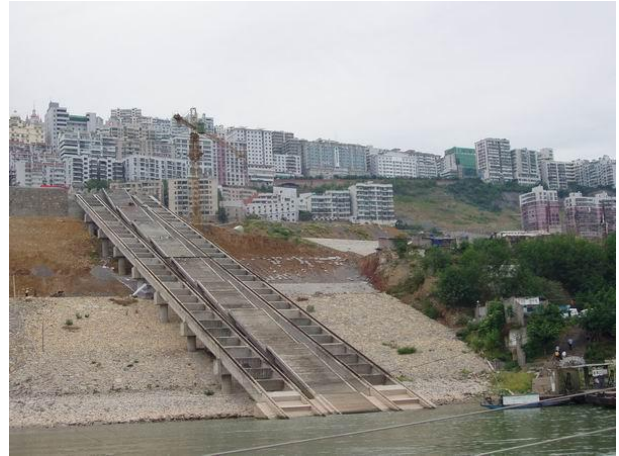
Fig.2. New Wushan County constructed in the Three Gorges Reservoir Region following the relocation after the Hongyanzi Landslide. (Sources: Baidu)

Stability of bedding planes and cut slopes in the reservoir region. The formation of steep slopes was very common during the relocation of the local population; the new reservoir bank area was originally in a semi-stable state, but with the creation of the reservoir became unstable and subject to slumping. For example, bedding planes and cut slopes have become a landslide-related safety major issue related to the construction of the new settlements for Padang and Wushan counties; the stability of bedding planes and cut slopes in the reservoir region will continue to be a concern in the future. New Wushan County constructed in the Three Gorges Reservoir Region following the relocation after the Hongyanzi Landslide is shown in Fig.2.

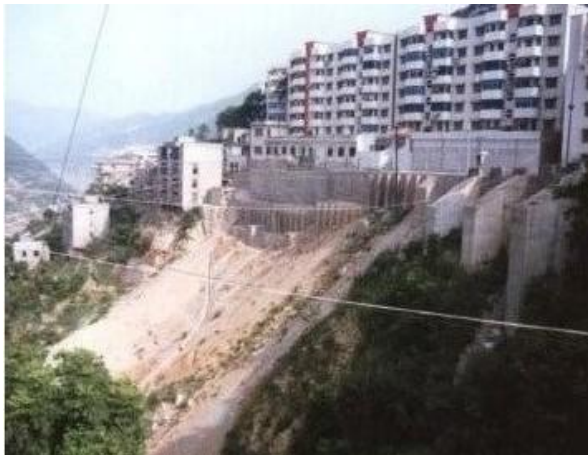
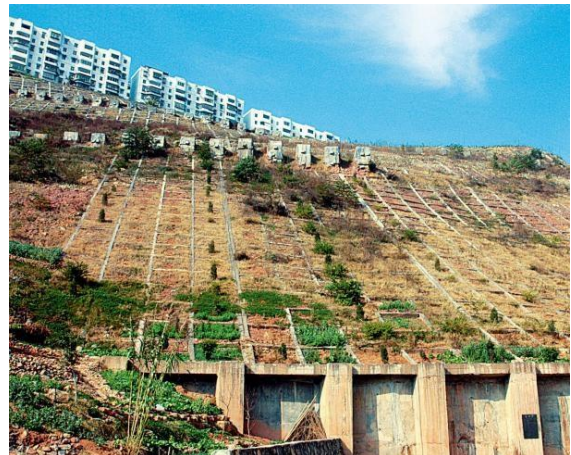
Fig.3. Residential buildings constructed on cut slopes in the Three Gorges Reservoir area. (Sources: Baidu)

Unstability of reservoir bank induced by high density buildings. In the cities and towns around the reservoir, a large number of high density buildings were constructed to relocate local residents; these buildings increased the load on the land surrounding the reservoir. In some towns, the body of some steep slopes (slope angle greater than 20°) has been deformed because of the densely packed high-rise buildings. After impoundment, the water softened the lower part of rock and soil along the river, increasing the likelihood that the upper slope would become compressed and the lower part was saturated with water. Residential buildings constructed on cut slopes in the Three Gorges Reservoir area is shown in Fig.3. As a result, the reservoir bank became unstable in some areas, which has created a major potential threat to the safety of residents in the Three Gorges Reservoir Region.

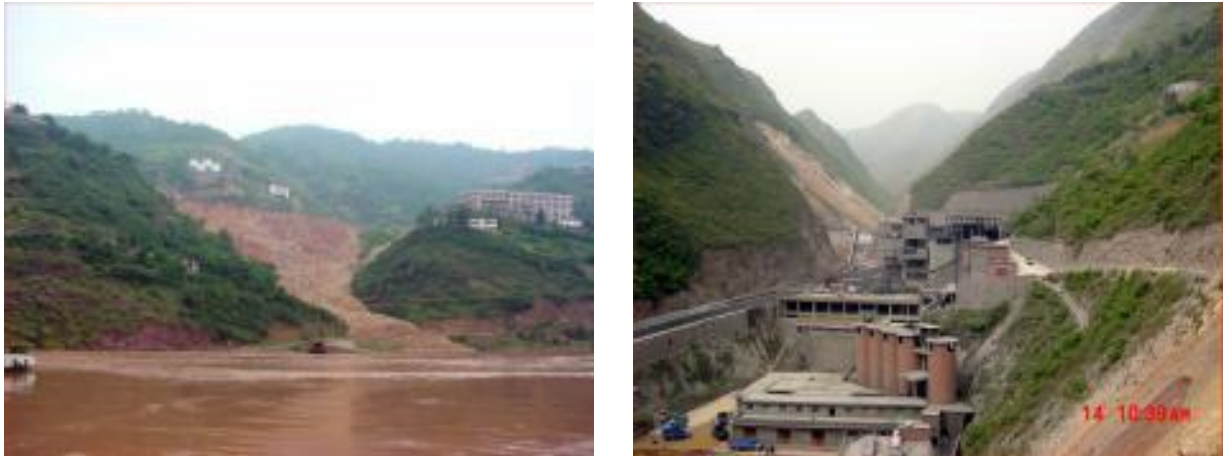
Fig. 4 Threats from spoil left from engineering operations to the Yangtze River Waterway and new residential sites constructed to house displaced persons. (Sources: Baidu)

Spoil problems during the relocation process in the reservoir region. A large amount of spoil created during the relocation process has not been processed properly in many cities and towns; drainage was not adequately considered during the side slope design, resulting in poor surface drainage, soil erosion, and even the formation of new landslides and debris flows. Currently, Fengjie, Wushan, Badong, Zigui, and Xingshan counties have encountered spoil problems, as is shown in the Fig.4, which can lead to human-caused landslides and mudslides, pose a threat to and pollute the Yangtze River waterway, and destroy the bridges across the ditches. During the urban relocation process, the engineering spoil needed to be treated promptly to prevent the threats created by engineering spoil to the Yangtze River Waterway and the poorly planned new sites recently created for displaced persons

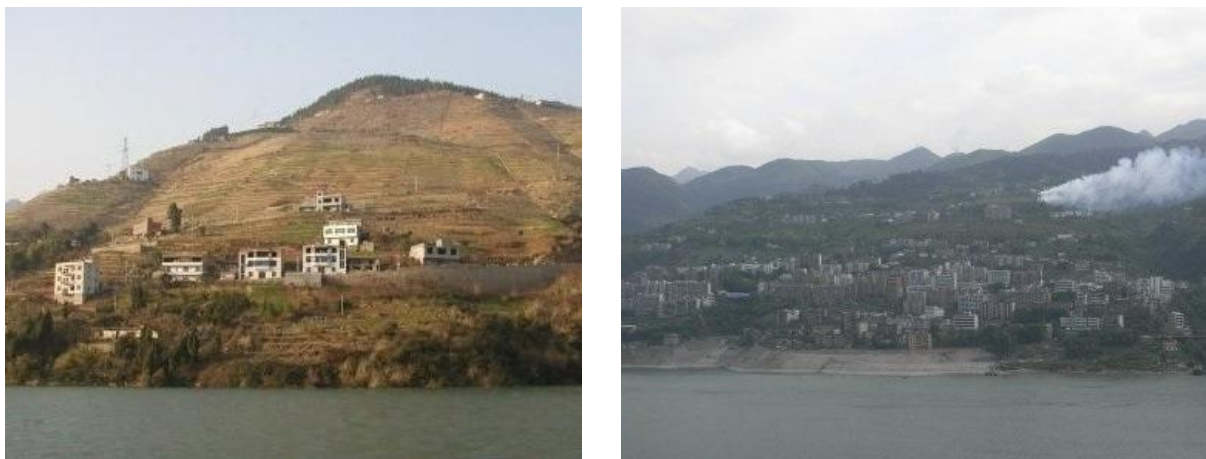
Fig. 5 Zaozishu and Huangtupo landslides in Badong County, Hubei Province, China. (Sources: Baidu)

Lack of overall planning for the relocation of many towns in the reservoir region. The planning for the relocation and construction of many towns in the reservoir region has not been strictly based on the currently topographical and geological conditions, and some new town sites have even been located in the slump, landslide, and debris flow-prone areas; these areas are typically caused by large-scale fill and excavation sites. This seriously affects the stability of the reservoir bank, and leaves some potential risks of geological disasters. For example, the new Badong County was developed under complex geological conditions, with surface fragmentation and steep slopes. Because of the large-scale of cut slopes created along the river, the stability of the bank slope is undermined, and a large number of landslides have occurred, such as the Zaozishu and Huangtupo landslides resulting in significant economic losses, as shown in Fig.5.

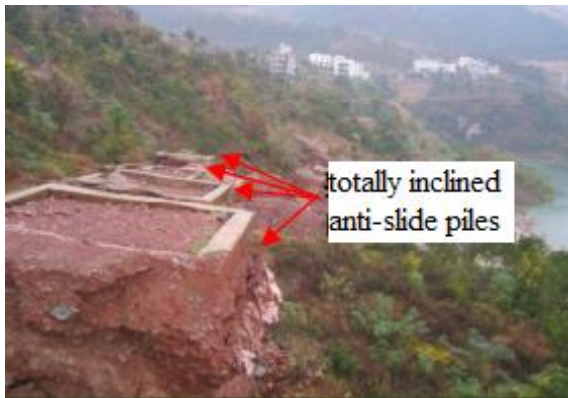
Fig. 6 Large deformation of slide piles on the Shijiapo Landslide in Badong County

The implementation of the quality of landslide treatment projects. The quality of landslide treatment projects played a significant role after impoundment of the Three Gorges Reservoir. Currently, many problems remain related to reservoir bank protection and landslide treatment in the Three Gorges Reservoir Region. For example, as is shown in Fig.6 and Fig.7, during the reservoir impoundment and trial operation in 2007, 33 concrete slide piles on the slope of the Shijiapo Landslide in Badong County showed different degrees of deformation[5]. Since the reservoir impoundment in 2006 with the water level reaching 156 m, a slow deformation has been documented in the Majiagou Landslide in Zigui County. A relatively large deformation with a maximum deformation of about 30 cm occurred in November 2008 after normal reservoir operation, and slide

piles on the top of the slope showed inclinations toward the outside of the slope with a maximum inclination angle of about 2° [5].

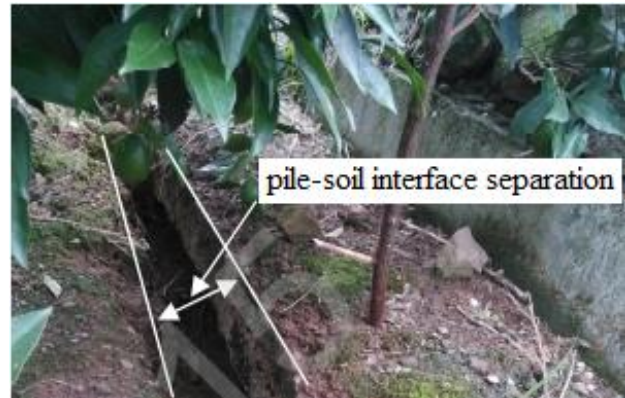
Fig. 7 Large deformation of slide piles on the Majiagou Landslide in Zigui County
