## Landslide monitoring of Mentougou Jietai Temple

**Abstract.** Jietai Temple landslide is located in the north wing slope of Ma'an mountain, Mentougou district to Beijing, and is China's key cultural relics protection units and famous Buddhist temples. According to Jietai Temple landslide formation conditions, predisposing factors, deformation and failure characteristics, stability conditions and trends, etc., using rainfall, soil moisture, surface cracks, deep displacement, groundwater level, groundwater seepage pressure, GPS deformation, geotechnical a variety of monitoring tools stress, long-term professional for Jietai Temple landslide deformation monitoring. Monitoring and analysis showed that construction monitoring network can provide an effective basis for the development of Jietai Temple to master deformed landslide.

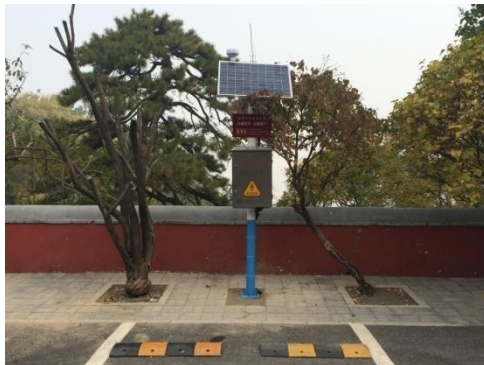
Fig.2 The field of rockstress

Rock stress monitoring, groundwater level monitoring, groundwater seepage pressure monitoring, deep displacement monitoring device emplaced shown in Figure 2 and Figure 3.

(8) Rock stress monitoring<sup>[5]-[7]</sup> .When the landslide occurrence, it will produce a stress ,by the stress test may also reflect the size of the landslide sliding state. Soil stress monitoring of Jietai Temple using deformation resistance with constant stress monitor cable.

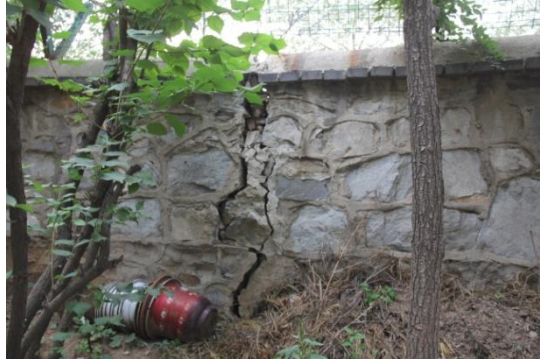
Fig.4 The ground fissure of painteryard

Since the 2004 rainy season, the temple courtyard and surrounding multiple fractures occur, and the emergence of an increasing trend. The selected surface crack monitoring data analysis accordingly. Figure 4 shows the internal courtyard of the monastery north of the painter land subsidence, causing cracking walls, and produces the maximum width of 100mm crack in the ground. For this purpose, where layout of a surface crack fracture displacement meter monitor changes.

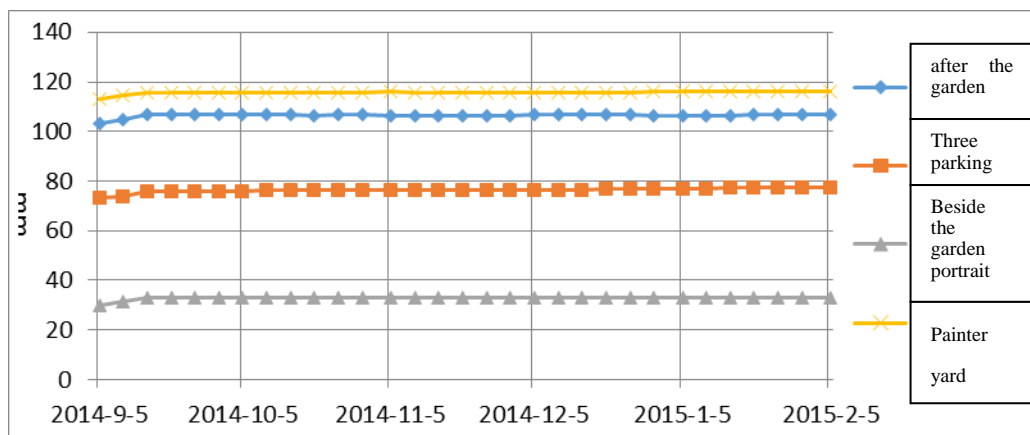
Fig.5 Monitoring of surfacecrack

Since September 5, 2014 , crack displacement meter laid begin monitoring, average hourly monitoring. Calculated by the software to filter out the outliers, four crack displacement meters emplaced , monitoring data in Fig.5 since September 5, 2014 to February 5, 2015 .It can be seen form the chart 7 that data are small rise in early installation, is due to instability caused by equipment commissioning phase. Painter yard crack monitoring value increased from 116mm to 118mm, cracks increases 2mm. It is the early stages that monitor surface cracks of Jietai Temple,and cracks ground level less obvious. through long-term monitoring and multiple spring melt phase, analysis and monitoring data will be more meaningful
