Strengthen Method of the Shear Keys in Adjacent Concrete Box-beam Bridges Using High Performance Grouting Material

Keywords: Box-beam bridge, Shear key, High performance grouting material, Maintenance.

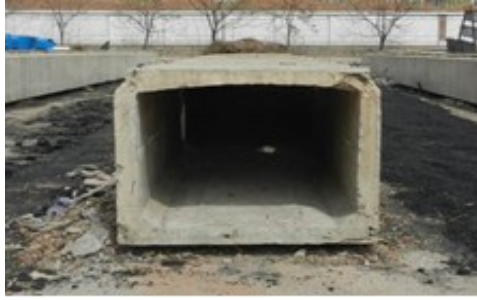
Fig. 2 The test void-box beam

The test box-beam was dismantled from a service bridge in highway road which has been in service for 10 years, as is shown in Fig. 2. The concrete's design strength is C50, and the measured strength is 54MPa. In both ends of the beam, a few of diagonal cracks have been found, and the width is no less than 0.05mm. Before the test, all the visible cracks were repaired with epoxy pouring sealant.

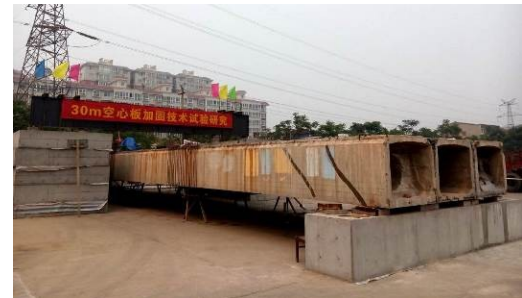
(a) schematic plot

(b) photographical side view

Fig. 3. Load applying system: (a) schematic plot; (b) photographical side view.

The loading system employed for the test box-beam is shown in Fig.3, consisted of a loading sensors, a hydraulic jack, a steel I-beam, an anti-force frame, some buttress and concrete weights etc.. The loading force was applied to the cross-sectional center of the adjacent bridge through the hydraulic jack hydraulic equipped with an out-of-plane frame as well as a force transducer to record the actual vertical force.

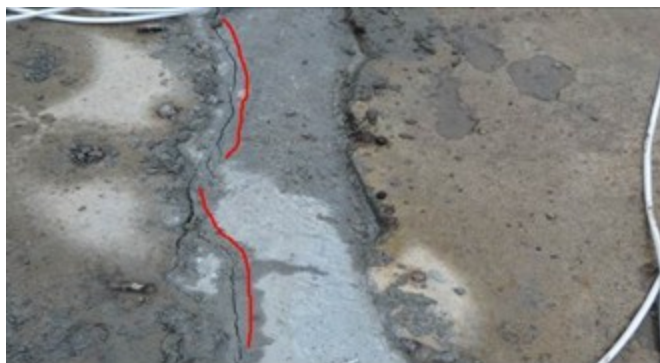
Fig. 5 The crack of shear key in the topping when load reaches 80.6t

There are no abnormal in hinge joints and plate-girder in the early stage of loading, there is abnormal sound in the hinge joint when the loading reaches 80.6t, there appears cracks from 3/4 to cross of hinge joints, with the maximum crack width is 1mm and partial dislocation, as shown in Fig. 5.

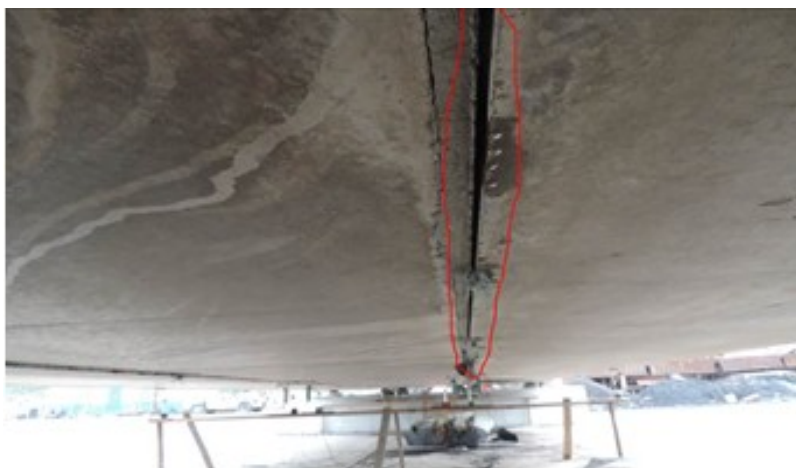
Fig. 6 Failure of the hinge joint

The cracks continue to increase with loading to 82.9t, and the hinge joints break completely along the interface. The failure process of the joints is very short, and the crack almost occurred at the Surface of junction, hinge joint concrete and concrete blocks completely separated along with surface, as shown in Fig.6, Failure surface is smooth, there is no breaking phenomenon of concrete aggregate.

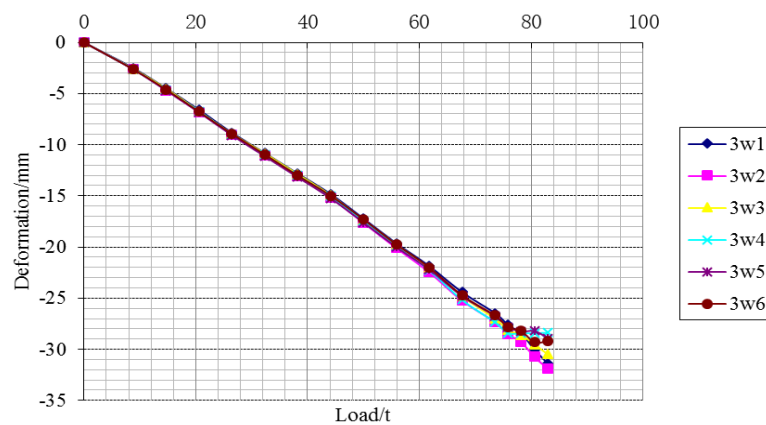
Fig. 8 Load-deflection curve of middle section

The test load-deflection curves of every section of the box-beam are shown in Fig.7, 8, 9. It can be established that the deformation of the box-beam is coincident well, and the overall performance is in good condition at the initial stage of loading, when loading reaches 70t, the displacement of the left side plate of the cross section and the 3/4 section is not coordinated; When the loading increases to 80.6t, the deflection of 3 box-beams are 30.3mm, 29.2mm and 28.7mm respectively; the deformation is 31.5mm, 29.5mm and 29.1mm when the loading increases to 82.9t, the failure of No. 2 hinge joints appears with the load increasing slightly, the readout of Jack quickly fell to 66.5t, deflection of No. 3 slab recovery to 0.96mm, deflection of No. 1 slab increases to 35.1mm, the deflection of No. 2 increases to 31.1mm. From the general change trend of the load deflection curve, the structure is in the elastic state during the whole loading process, and the elastic and plastic stage is short. Whose failure process in brittle.

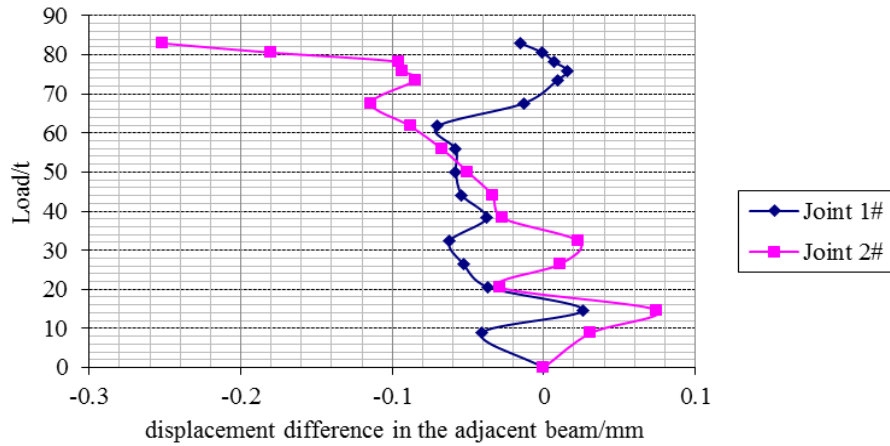
Fig. 10 The relative displacement curves of the adjacent beam in 1/4 section

The relative displacement curves of the box-beams on both sides of the hinge joints during the experiment are as shown in Fig10, 11, 12. From the development trend, the relative displacement of hinge joint on both sides of the box-beam are larger as the loading increases, but deformation values of No. 2 hinge joints on both sides of the box-beam are significantly greater than that of No.1 hinge joints, which presents the state of dispersing, the 2# hinge joints occurs damage first after reaching the limit state.

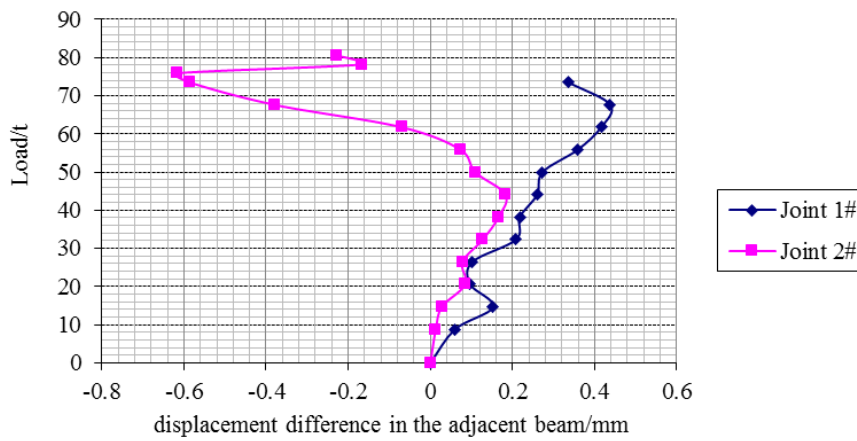
Fig. 11 The relative displacement curves of the adjacent beam in 1/2 section

Fig. 11 shows that the relative displacement of 2# hinge joints increase rapidly when the loading reaches 44t, and relative displacement load curve take on nonlinear characters. It can be conclude that the 2# hinge joints can be identified to be damaged. After that, the relative deformation continues to increase, but the slope of curve changes little, which indicates that the internal damage of the hinge joint is in the stage of stable

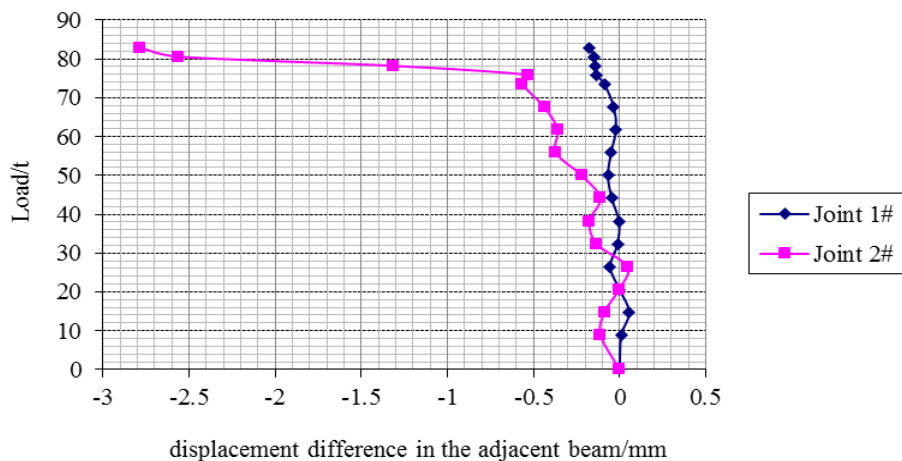
Fig. 12 The relative displacement curves of the adjacent beam in 3/4 section

development. Fig. 12 shows the relative deformation of 3/4 cross section of the hinge joints on both sides of the box-beam, it can be indicated that the shear stiffness of hinge joints and rapid degrades, eventually destroys when the loading reaches 75.8t.
