Recent advances in excavation, design and support methods: A case study of Mangdechhu project, Bhutan

AK Mishra, RK Chaudhary and P Punetha
Mangdechhu Hydro Power Authority
Trongsa, Bhutan
ppunetha@yahoo.com

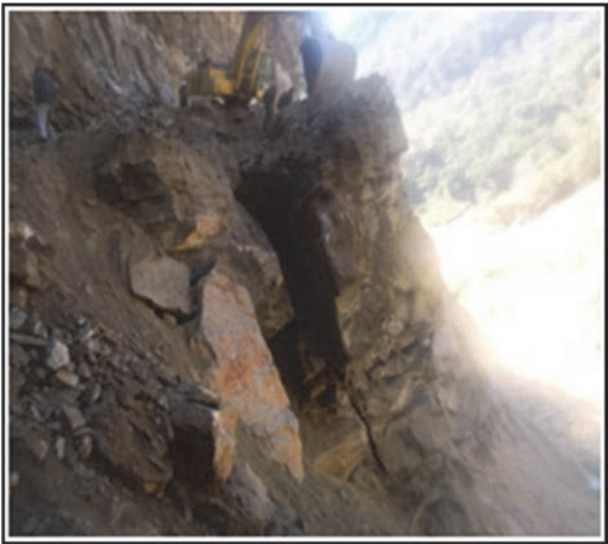
Fig.3. Dam excavation in progress depicting slump joints

These joints displayed openings upto 50cm and were found to exist well within the confines of the abutment thus necessitating removal to depth. To study the collective effect of all these negative features and ensure stability of the abutments, NIRM was requested to carry out numerical modelling studies on a periodical basis. During this period the cut slopes were monitored rigorously by the aid of an instrumentation program, while the slopes were treated by the aid of 12m deep consolidation grouting, 25m deep tendons, rock bolts and shotcrete. The FOS of the rock slope sections were evaluated prior to treatment and subsequently Never the less some minor slope failures did take place both in the rock and overburden slopes in close vicinity to the concrete dam, due to incessant rainfall during monsoons.

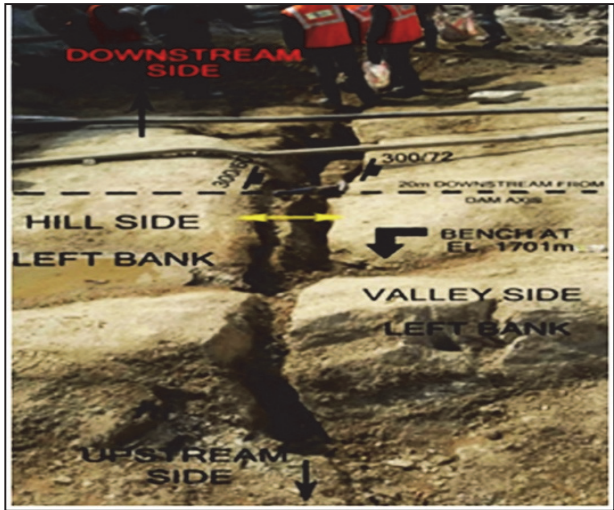
Fig.4. Plan view of open joints

(sometimes of the order of 30m) which exercised control on the stability of the abutments.

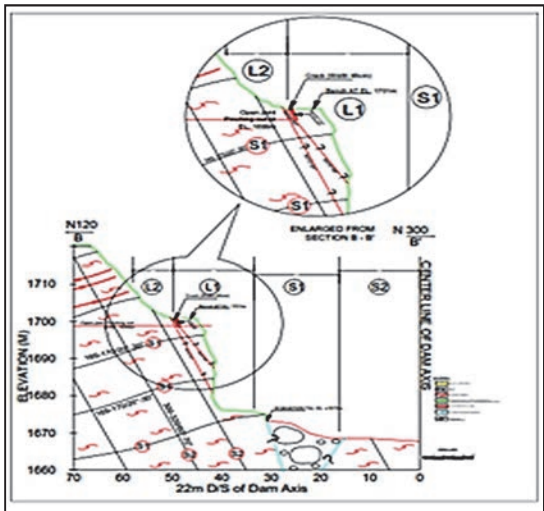
Fig.2. Cross section at Dam Axis showing Dam Blocks and depicting slump joints

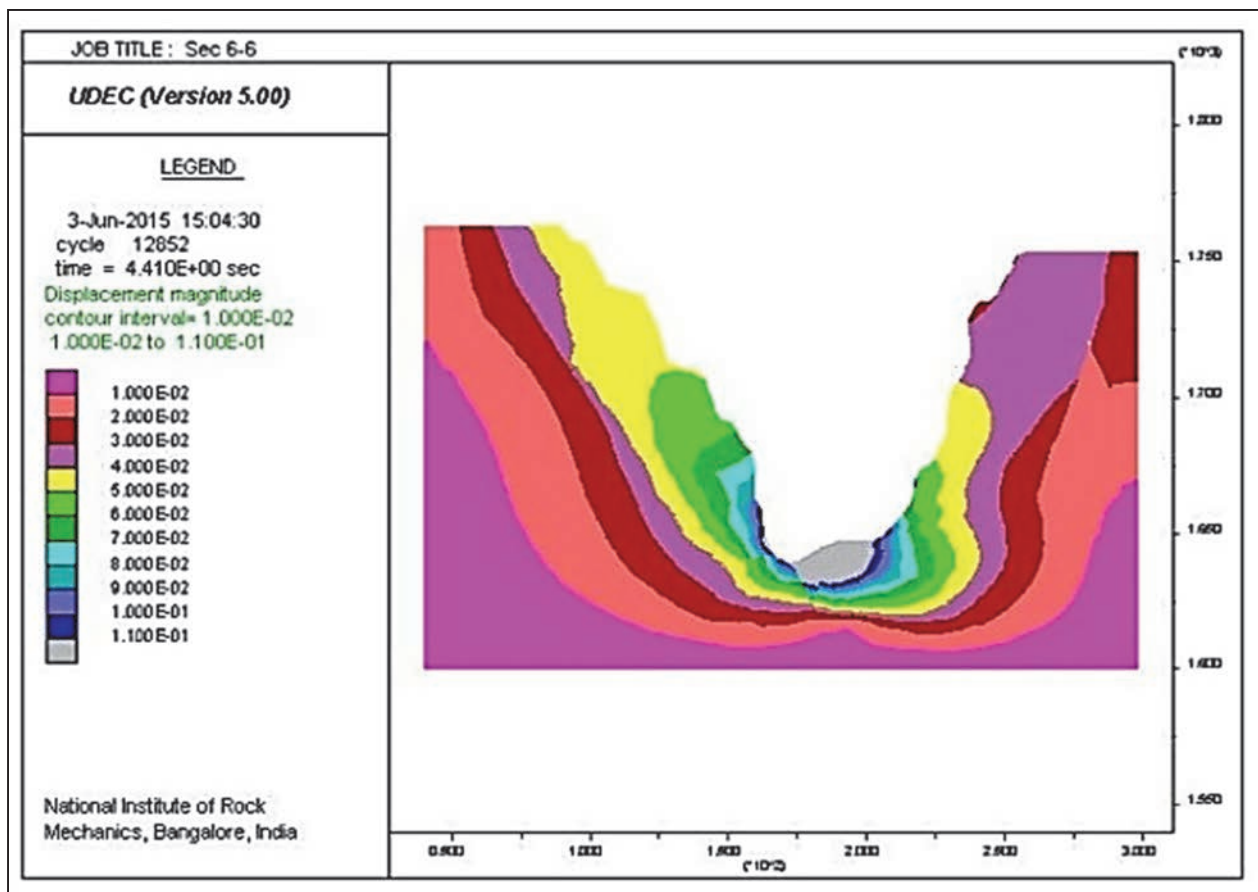
Fig.5. Typical displacement contours obtained from UDEC [1]

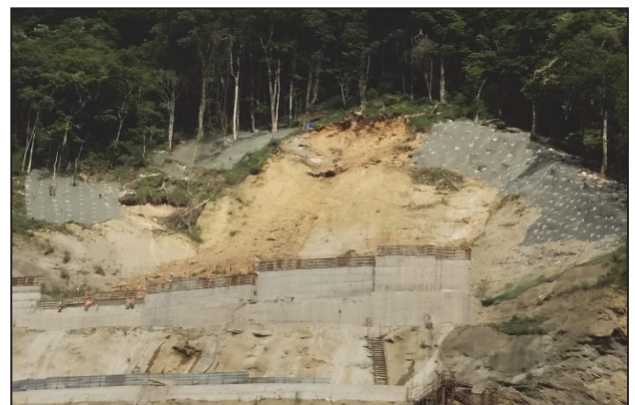
Fig.6. Non frame support work in progress left bank

The overburden failures were treated by the aid of with installed support system and found to be well within the desired limits. Non frame stabilization method by the aid of 5m long soil nails installed in a grid supplemented by wire

mesh and jute matting. The non-frame method is an active support technique for stabilizing slide zones in both homogenous and heterogeneous medium and is contrastingly different from the passive support techniques such as concrete retaining walls and gabions presently being resorted to for dealing with potentially active slides. Non frame reinforces slopes by transporting resisting force from bedrock to topsoil being structured by a number of imbedded steel bars (soil nails) connected to each other by a triangular wire net.

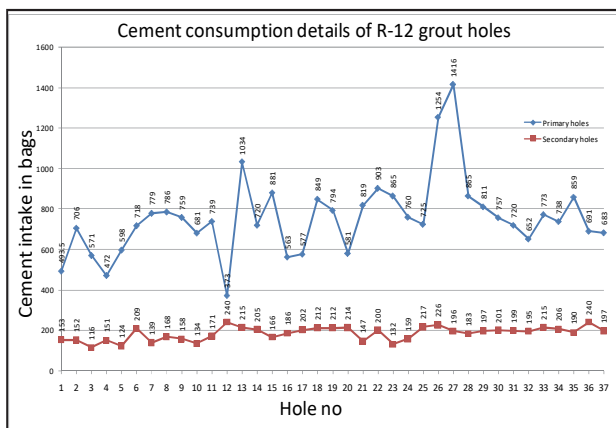
Fig.10. Grout takes for R-12 Peripheral Grouting (Bags)

Shaft, Valve Chamber and the Penstock Erection Galleries, for which special excavation and support methodology had to be devised comprising pre and post excavation grouting, 9 to 12m deep rock anchors, shotcrete and ISMB 250 steel ribs at 0.5m spacing. In view of the greater schist component in the rock mass constituting the surge shaft, pre grouting around the periphery with OPC having a water cement ratio of 1:1 at significantly high pressures was required to achieve consolidation of the weathered medium followed by 9 to 12m long rock anchors and shotcrete of 100mm thickness. The excavated profile was supported by ISMB 250 steel rib sections at 0.5m interval anchored to the rock mass by the aid of 36mm dia., dowels of 3m length. Simultaneously with the excavation peripheral grouting was taken up radially in the form of two concentric rings around a zone, 4m and 7m away from the periphery of the shaft to a depth of 100m.

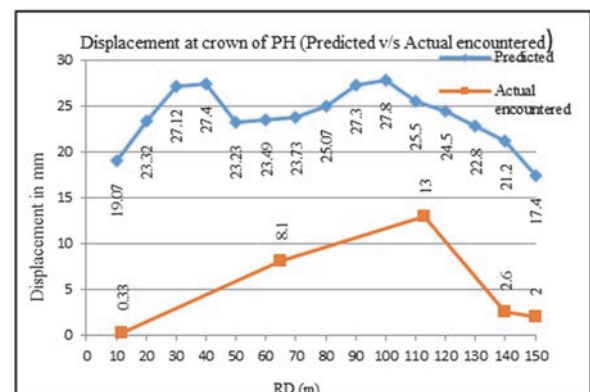
Fig. 17. Graphical presentation of actual v/s predicted deformation at Crown of PH Cavern.

The actual deformation observed and recorded at site during excavation was closely monitored and compared with predicted/anticipated displacements in the 3DEC numerical modeling studies. The maximum deformation as anticipated at Crown of Machine Hall was 27.8mm whereas maximum deformation observed at site was only 13mm (as on 30.06.15). Similarly the anticipated deformation at U/s and D/s wall of Machine Hall was assessed as 78.69mm and 61.49 mm whereas maximum deformation observed was 13.6 mm and 39.7mm respectively (as on 30.06.15). The graphical presentation of instrumentation for monitoring the rate of deformation vis-à-vis excavation sequences comparing anticipated deformation and actual deformation observed at site during course of excavation of both the Caverns has been detailed in the figures provided below.

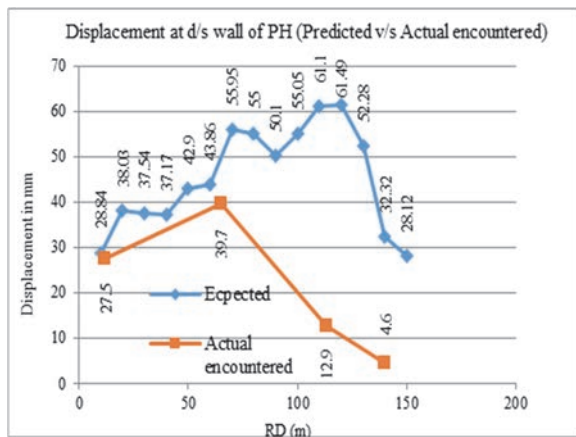
Fig.18. Graphical presentation of actual v/s predicted deformation at d/s wall of PH Cavern.

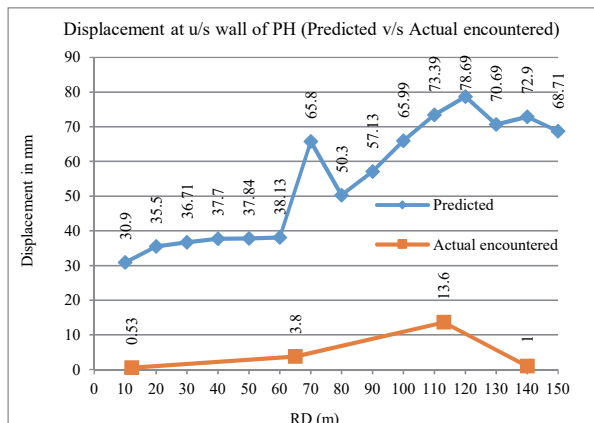
Fig.19. Graphical presentation of actual v/s predicted deformation at u/s wall of PH Cavern..

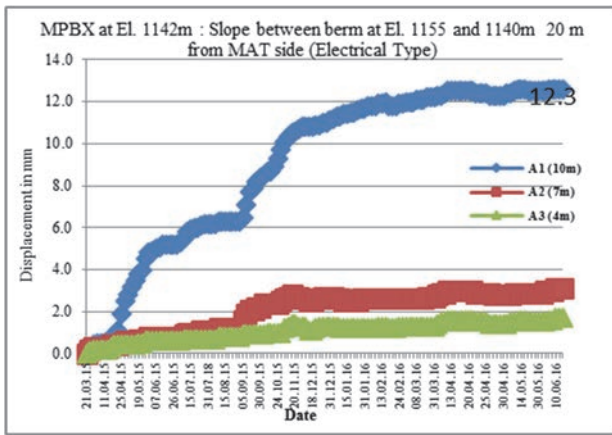
Fig.21.Graphical presentation of deformation at El.1142m

The bench slopes between El. 1103 and 1205 experienced displacement in the range of 50-60mm. Typical graphical representations of displacements and load measured at various Chainages and levels by aid of MPBX and load cells are given below. Meanwhile, during Oct 2015 some hair line cracks were observed in the shotcrete covering the berms and interconnecting slope faces between El 1108 to 1158m, mainly concentrated towards downstream of RD 110m where weaker rockmass prevailed and natural slope gradients were gentler.

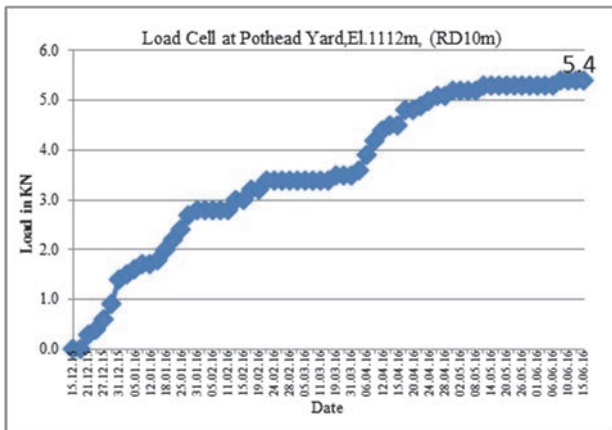
Fig.22.Graphical presentation of Load at El.1112m

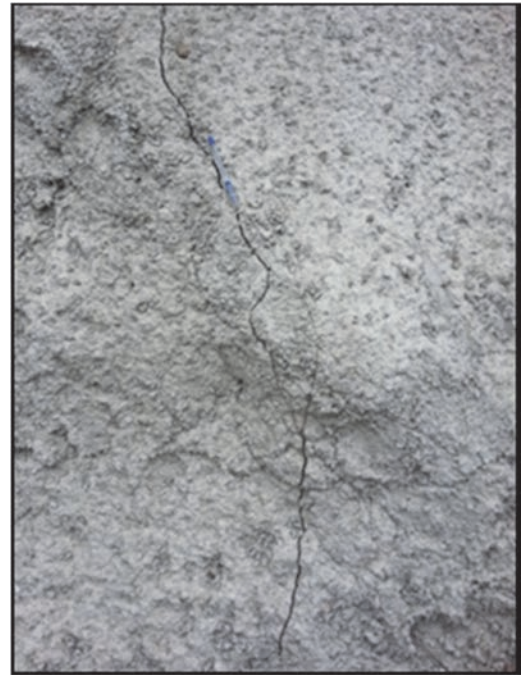
Fig.23. Showing Cracks in Shotcrete of Pothead yard

The appearance of these cracks raised apprehension of settlements in the weaker rock sections towards downstream and which called for immediate revalidation of support measures. Meanwhile upon the excavation reaching below 1090m, an approximately 50cm to 1m wide shear plane was encountered with dip towards downstream, as this feature could have repercussions on the stability issue, it was considered prudent to introduce 25m long cable anchors as an additional measure to provide support to the toe of the excavation between El 1093m and 1140m. In addition secondary and tertiary grout holes along the berms were also introduced for better consolidation of the rock mass.

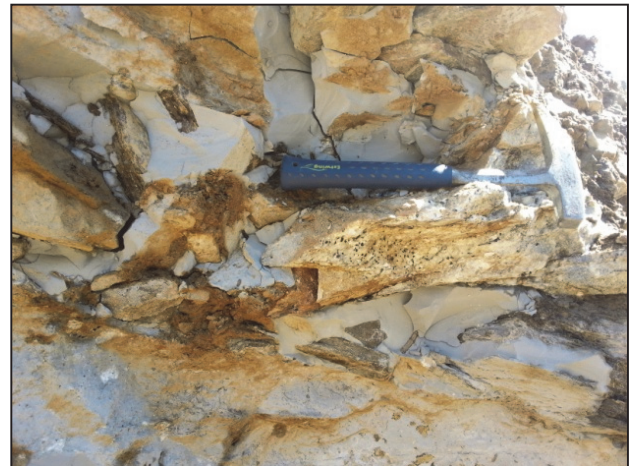
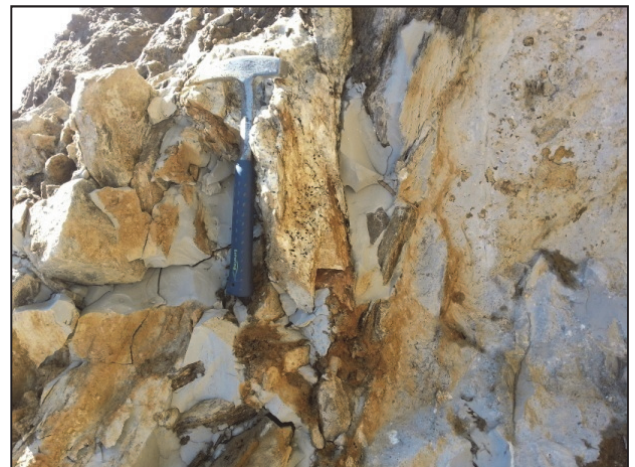
Fig.24. Grout imprints in excavated sections of pothead yard

Fig.25. Grout imprints in excavated sections of pothead yard

The efficacy of the grouting is displayed in the photos below. Pre and post grouting water pressure tests carried out in 3m stages, during secondary stage grouting of cable anchor drill holes, confirmed the elimination of voids and consolidation of rock mass as is evident by the values displayed in the Table III.
