# *Microseismics for cavern stability evaluation of a powerhouse structure after excavation*

**Abstract**—The powerhouse of Tapovan Vishnugad Hydropower project (TVHPP) of NTPC is located in the tail of the Great Himalaya range in the Chamoli district, Uttarakhand and is located at +300m depth having adverse geological conditions. The project area is situated near the northern side of MCT around 2.0 Km and lies in the seismic zone V of India. This site encounters a number of rockburst during and after excavation at various places which may be due to the stress redistribution. This paper discusses the designing and primary application of microseismic monitoring technique after post excavation in rocks. A microseismic network has been installed at the powerhouse site of a hydropower project to study the strata conditions and redistribution of stresses after excavation. This paper discusses the microseismic network design based on the existing geological reports, rockburst history, feasibility of drilling and many other parameters. The monitoring system consists of a three dimensional array of sensors, data acquisition unit, cable layout, and an underground laboratory equipped with c

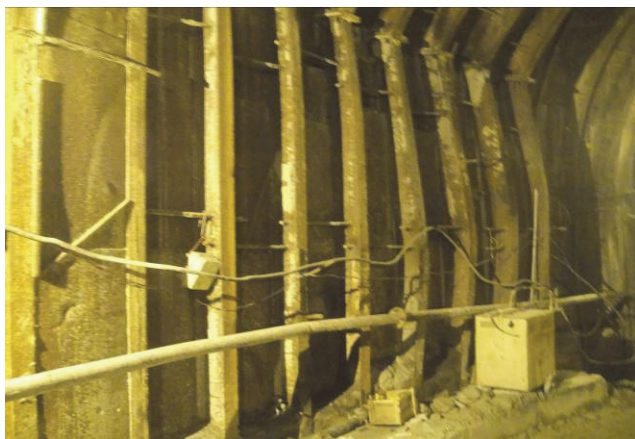
Fig. 2a. Bending of steel ribs in UPS-1

On 13 Sept 2010, a blast was taken for benching activity in the APS that results in rock bursting phenomena on that day intermittently, and but main effect occurred in Unit penstock (UPS) 1 & 2. Due to this, steel ribs provided in the UPS-1 and UPS-2 buckled / bent little in the crown portion "Fig 2".

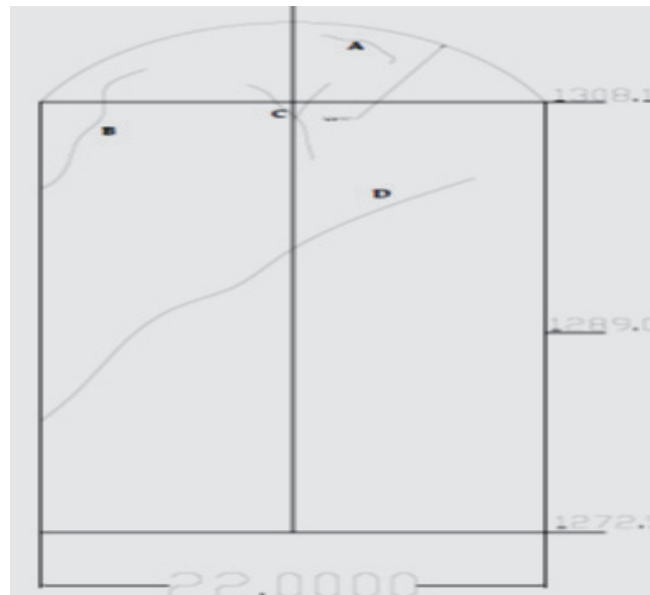
Fig.4. Detail of cracks in end wall of the powerhouse chamber

The end wall of the powerhouse cavern has four cracks marked as A, B, C and D as shown in "Fig.4", with the respective length of the crack varies between 4.00 to 16.00 m and thickness of the crack varies between 15.00 mm to 100.00 mm.

Crack No	Crack Thickness (in mm)	Crack Length (in m)
A	15-22	4-6
B	20-25	6-10
C	10-20	8-14
D	50-100	10-16

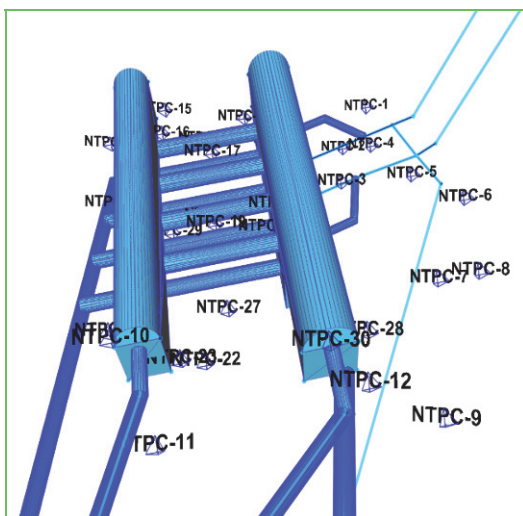
Fig. 7. 3D Visualisation of Geophone at TVHPP powerhouse site

Thirty sensors (fifteen uniaxial and fifteen Triaxial) has been installed at the powerhouse site of TVHPP to monitor the different area of the powerhouse site. Two sensors were installed in the UPS 1 and 2 to monitor both the UPS having one uniaxial and other Triaxial. Similarly, two sensors were installed in the UPS 3 and 4 to monitor both the UPS. These areas encountered rockburst that results in the buckling of two numbers of steel ribs in the UPS-2 and three numbers of ribs in the HPS1 in the crown portion, near to fault, popping sound heard earlier.

Five sensors were installed in the APS, having three triaxial and two uniaxial. These sensors not only monitor the APS but also the activity in the upstream wall of the powerhouse chamber. Only one uniaxial sensor (sensor no 28) has been installed due to the site constraints in the upstream wall of powerhouse chamber. Two sensors has been installed in the Adit to Transformer hall (TH) to monitor the adit to TH and cable shaft as moments has been appeared in the steel ribs in the cable shaft after post construction and adit to transformer has a number of cracks and new cracks are also expected in this zone.

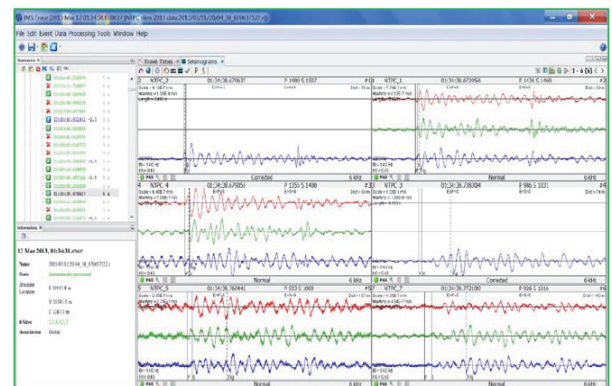
Fig. 8. Typical Microseismic waveform

Due to site constraints initially only eight geophones have been installed in the APS and four penstocks which registered about 2000 microseismic events for about six months of data acquisition. The microseismic events are processed using Trace software, one such event has been shown in "Fig.8" along with its source parameters in "Fig. 9". and then plotted on the cavern 3D plan using JDi software shows in "Fig.8".

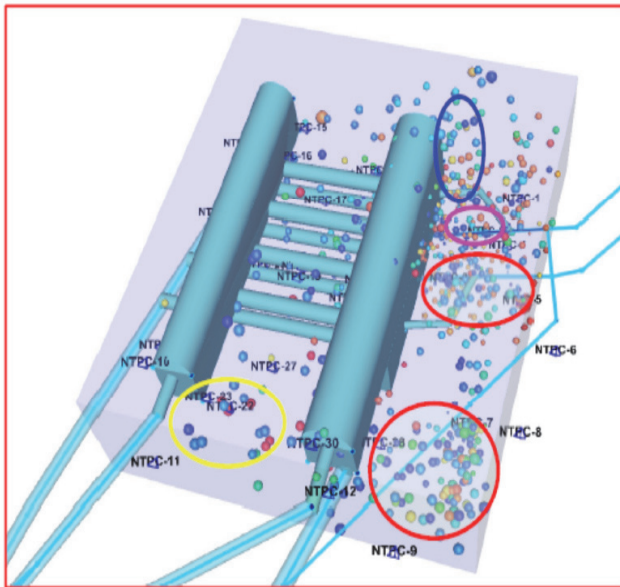
Fig. 10. Microseismic Events

Five events concentration pockets marked in circle in "Fig.10", gives the potential rock fracture zones in the

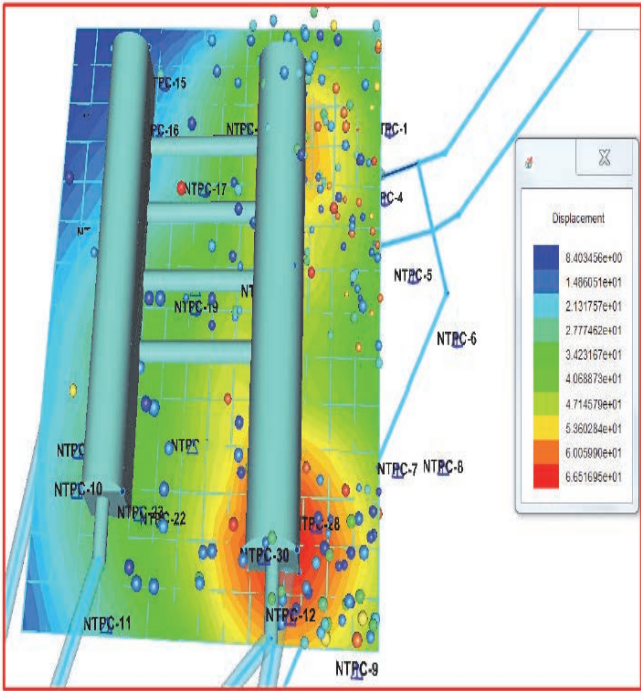
Fig. 11. Displacement contour diagram

cavern. "Fig.12", plots the number of events versus magnitude which gives the hazard magnitude 1.47. The processed microseismic data has been analysed for the temporal variations of the seismic source parameters to find the stress concentration areas and seismic energy released areas including resultant estimated displacements of different parts of the cavern has been shown in displacement contoured diagram in "Fig. 11".

The maximum estimated seismic displacement in the cavern is about 66mm at the entrance of the APS and close to the penstock-1 to 2 Junction towards pressure shaft side.
