## A case study of interior booming noise control in an HEV

**Abstract.** An interior booming noise issue occurred during a development stage of an HEV program. Based on the noise generation mechanism, the root cause analyses were carried out. It is found that the interior booming noise was mainly induced by the excessive second order noise from the exhaust tail pipe. The effort was focused on the noise source reduction. Using acoustic simulation and parameter optimization, a Helmholtz resonator was designed and proposed. The measured results based on the proposed design showed that the interior sound pressure peak level responsible for the booming noise sensation was reduced significantly. The effectiveness of the proposed design was validated by vehicle testing and subjective evaluations.

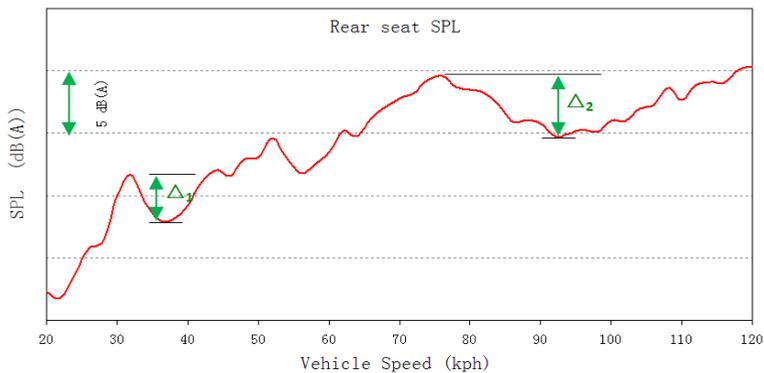
A noise measurement test was carried out on a chassis roll dynamometer in a semi-anechoic room to identify the root cause. The measured points were set up at the left ear of the right rear seat passenger. Using the LAN-XI 50 channel noise acquisition equipment made by B&K, the measured sound pressure level result is displayed in Fig. 1. From the figure, it is seen that there are two pronounced peaks, one around vehicle speed of 33 kph and the other around 74 kph. The noise peak level  $\Delta_2$  around 74 kph is greater than that ( $\Delta_1$ ) around 33 kph, which indicates that the higher the vehicle speed, the worse the booming noise level. This outcome is consistent with the subjective observations under on-road driving conditions. Since the speed 74 kph falls into a normal on-road driving range, it is an urgent priority to resolve this issue.

**Figure 1.** The measured rear seat noise level in the baseline vehicle during acceleration.

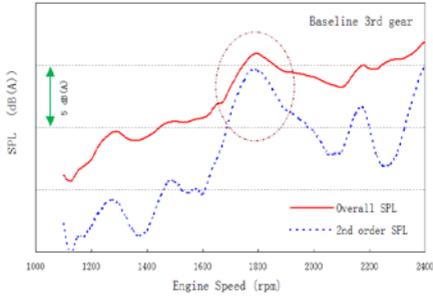
overall noise level while the dotted blue curves denote the 2<sup>nd</sup> order noise levels. Both figures demonstrate that the 2<sup>nd</sup> order noise is significant in the vicinity of the engine speed 1750 rpm, and in fact it contributes by far the most to the overall noise level.

**Figure 2.** Rear seat noise level in 3<sup>rd</sup> gear acceleration.

The booming noise issue occurs around 33 kph and 74 kph. After analyzing the TCU shift control strategy for vehicle accelerating operation, it reveals that the speed 33 kph uses Gear 3 while the speed 74 kph is in Gear 6. By further examining the gear ratio, the engine speed is found to be in the vicinity of 1750 rpm for both 33 kph and 74 kph vehicle speeds, around which the booming noise issue surfaces. The frequency of the issue is about 58 Hz, which corresponds to the second order engine excitation at 1750 rpm, and they are related by the mathematical expression  $1750/60 \times 2 = 58.3\text{Hz}$ . The guesstimate was that the booming noise is induced by the engine excitation, intake noise or exhaust noise.

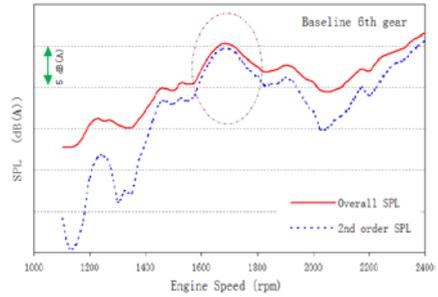
**Figure 3.** Rear seat noise level in 6<sup>th</sup> gear acceleration.

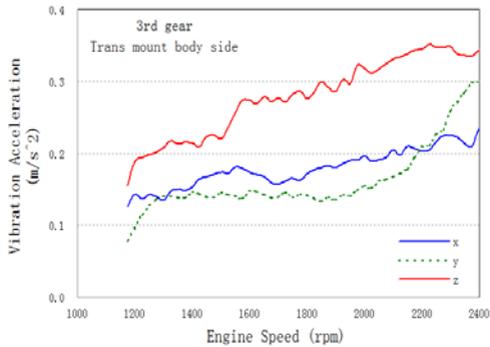
A transmission mount isolation test was carried out, and the results are shown in Figures 4 and 5. From the figures, it is apparent that the vibration amplitude is relatively small at the connection point between the transmission mount and the body. Moreover, there is no pronounced peak around the engine speed 1750 rpm. Therefore, it is concluded that the transmission mount is not a major contributor to the booming noise issue.

**Figure 4.** Transmission mount vibration in 3<sup>rd</sup> gear acceleration.

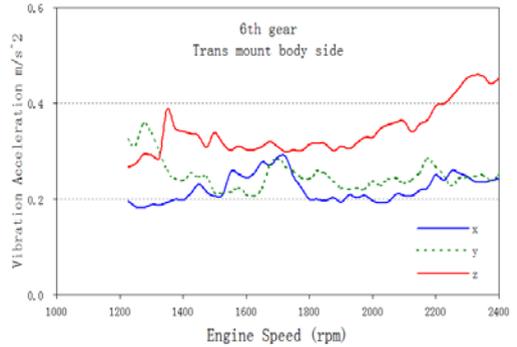
**Figure 5.** Transmission mount vibration in 6<sup>th</sup> gear acceleration.

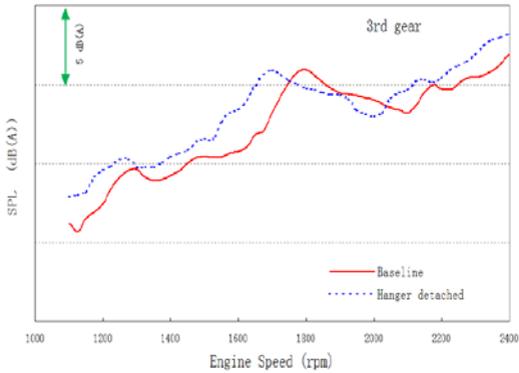
All exhaust hangers were disconnected while keeping all other components intact, and the measurement tests were performed on the chassis roll dynamometer. The comparison results are shown in Figures 6 and 7. From the figures, it is obvious that the noise levels with the hangers detached are not much different from those of the baseline case. Subjective evaluations on the chassis roll dynamometer confirm that the improvement is not discernible. This concludes that the hangers are not the cause of the issue.

**Figure 6.** Noise level comparison with and without the exhaust hangers in 3<sup>rd</sup> gear acceleration.

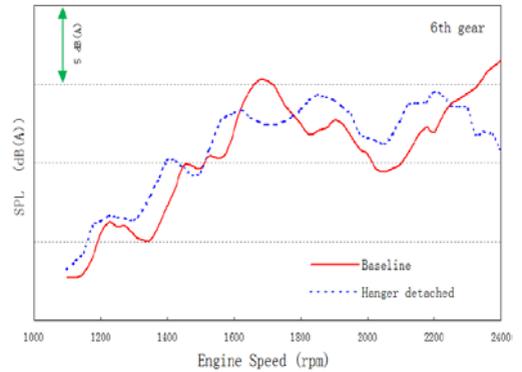
**Figure 7.** Noise level comparison with and without the exhaust hangers in 6<sup>th</sup> gear acceleration.

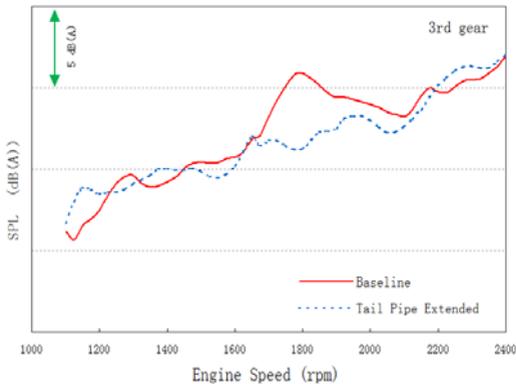
To look into the influence of the tail pipe noise, a 2.5 meter long pipe was connected to the tail pipe in order to simulate the absence of the tail pipe noise. The measured results are represented by the dotted blue curves in Figures 8 and 9, where the red curves represent the baseline results for reference.

**Figure 8.** Noise level with extended tail pipe compared to baseline in 3<sup>rd</sup> gear acceleration.

With the extended tail pipe, the interior noise level around the engine speed 1750 rpm is reduced significantly. From Figure 8, it is seen that the maximum interior noise reduction is 5 dB(A) in Gear 3, while in Gear 6, the maximum reduction reaches 8 dB(A) as shown in Fig. 9.

Furthermore, the linearity of the powertrain sound, a metric of powertrain NVH refinement, is improved. The booming noise sensation in this case is minimized. It is therefore concluded that the tail pipe noise is the root cause of the booming noise issue. The outcome in Figures 8 and 9 also renders the study of muffler noise unnecessary.

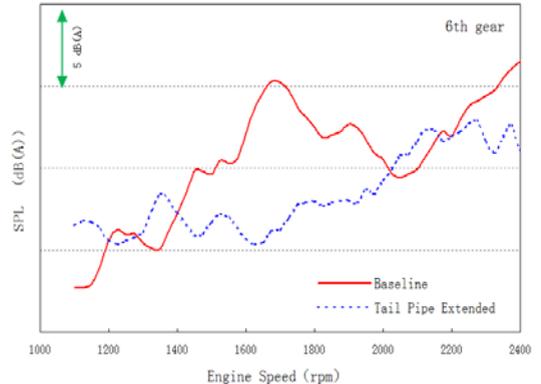
**Figure 9.** Noise level with extended tail pipe compared to baseline in 6<sup>th</sup> gear acceleration.

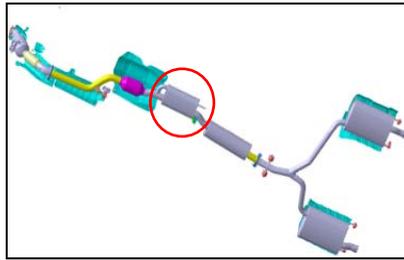
Fig. 10 shows the exhaust system for the vehicle in this study. It incorporates a two stage noise reduction layout involving a front muffler and a rear muffler.

**Figure 10.** The baseline exhaust system.

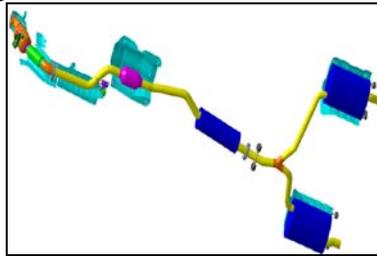
**Figure 11.** The proposed exhaust system with an added resonator.

In consideration of program timing, cost, package limitations and the effectiveness of the measure, it was decided that the original system should be kept intact. Therefore, a design of a Helmholtz resonator in front of the front muffler was proposed as shown in Fig. 11, with the intended center frequency of 58.3Hz.

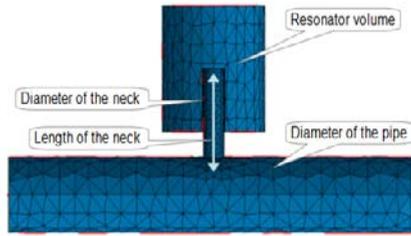
Therefore, before the resonator design, the temperature and flow velocity at the intended resonator installation location need to be obtained, and the quantities measured from testing were used as the boundary conditions when establishing the Helmholtz resonator model. As indicated in Fig. 12, the optimal geometric parameters were obtained by DOE analyses in which important parameters were variables and maximizing transmission loss around desired frequency content was the objective.

**Figure 12.** Helmholtz resonator CAE model.

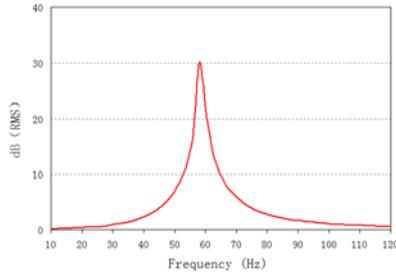
**Figure 13.** Transmission loss

After optimization, the parameters were obtained as listed in Table 2. The transmission loss, calculated based upon these parameters, is displayed in Fig. 13, which shows a center frequency of 58.3 Hz, effective bandwidth of about 12Hz and the peak transmission loss of 30.1 dB.

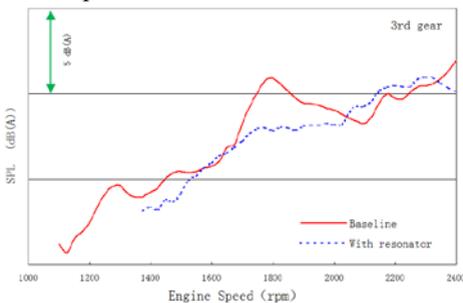
The proposed resonator was fabricated and implemented on a prototype vehicle. The measurement was carried out again in the semi-anechoic room. The obtained results are represented by the blue dotted curves in Figs. 14 and 15, where the baseline result is represented by the red curves for comparison.

**Figure 14.** SPL with resonator compared to baseline in 3<sup>rd</sup> gear acceleration.

The pronounced peak basically disappeared for the proposed design around engine speed 1750 rpm in Gear 3 acceleration, and the booming noise issue is resolved in this case. In Gear 6 acceleration, Fig. 15 indicates that the sound pressure level decreases by 3 dB(A) around 1750 rpm with the proposed design. Although the noise peak still exists, its level is greatly reduced. Subjective evaluations indicated that the booming noise sensation is reduced noticeably.

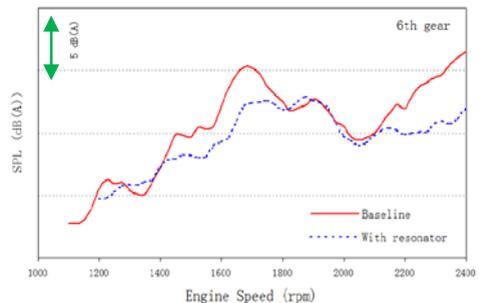
**Figure 15.** SPL with resonator compared to baseline in 6<sup>th</sup> gear acceleration.
