Development of Microbiological Vegetation on Facades of Thermally Insulated Houses Repairing a One Column Paper with MS-word for Windows

Abstract—In connection with the increasing number of facades additionally equipped with contact thermally insulated system the number of cases in which facades are depreciated with microbiological vegetation has raised. The vegetation of microscopic algae, fungi and blue-green algae on the outer surface of perimeter walls depreciates aesthetical function of facades and can also have a negative impact on the health of population of affected houses.

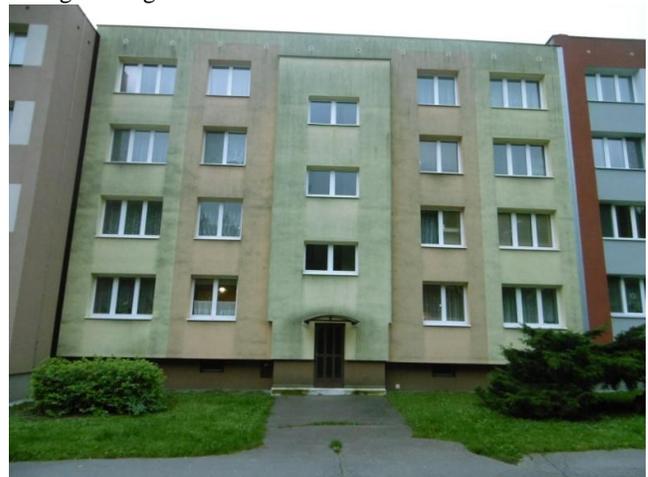
Figure 1. Facade of a building with vegetation of microscopic fungi, algae and blue-green algae

From visual observing of the vegetation it can also be found out whether the infestation of facade is caused by bad performance of the ETICS system or not. If the occurrence of coloration of facade surface is extensive (Fig.1), we can exclude the fault in the thermal insulated system performance. The local occurrence of stains is mostly the consequence of a fault in thermal insulation performance.

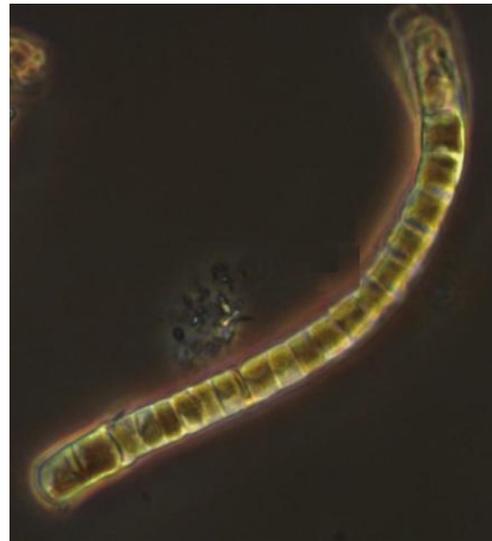
Figure 3. Microphotography of a sample infusion 400x

placed in Eppendorf's bowl and refilled with deionized water. The samples were left to infuse for 24 hours and 72 hours under laboratory conditions. Photic radiographic microscope with connected CCD camcorder which enabled to make a set of colorful microphotos at enlargement 400 x (Fig.2 and Fig.3). Thanks to the photos it was found out that there were green algae, blue-green algae, fungal spores and fungal hyphas in the samples. As far as blue-green algae are concerned, the kind *Chroococcidiopsis* was determined. Regarding green algae, it is not possible to find out the kind with regards to the character of samples. However, it is possible to say without any problems that they are green terrestrial algae (*Chlorophyceae*).

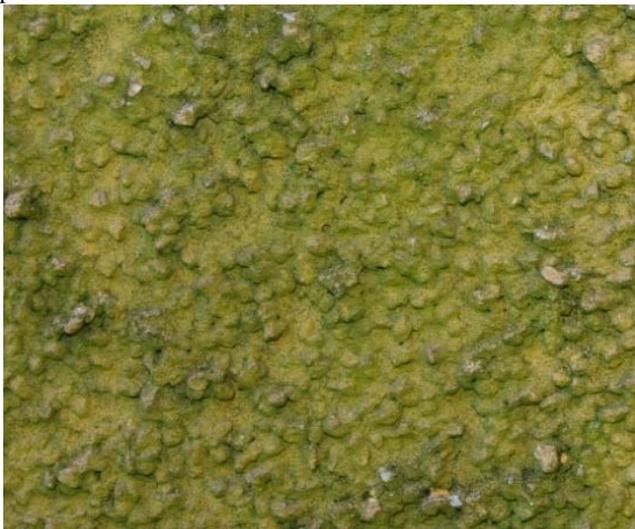
The basic living condition for algae, fungi and blue-green algae is a sufficient supply of humidity. Vegetation of microorganisms occurred especially on northern sides where there is a long-term influence of humidity because they are dried by sun radiation at least. Other factors contribute to the long-term humidity influence at the observed facades. They are e.g. shadowing of the facades by the surrounding construction, structure of the façade, closeness of vegetation, closeness of water areas. On gable walls and facades without window opening the vegetation occurred on the whole surface evenly. These facades are a big catcher of rainfalls, spores and dust particles. On facades with located window openings the vegetation occurs especially in interfenestral parts. On the surface above and below windows they occur less or not at all. These places are protected by window ledge against water flowing down and thanks to the horizontal division of facade by windows, the length of the possible water influence is shortened (water is amounted less and dried faster). Another factor which increases the danger of infestation by green microorganisms is facade structure. Plastering with a very coarse-grained structure and sharp-edged grains (Fig.4), which is another strongly contributing factor for a successful growth of microorganisms on facade. The rougher surface, the more suitable one with respect to draining of vegetation and dust particles.

Figure 4. Strongly damaged by plaster with coarse grains

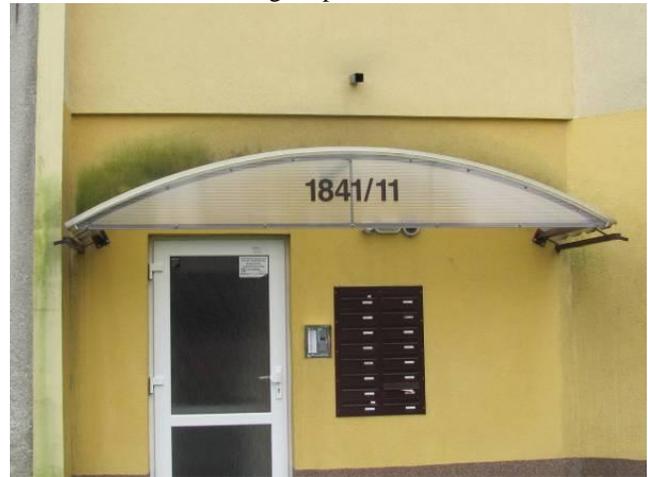
Most often it concerns unsuitable detail solving – connection of tinsmithing elements to ETICS, or their total absence. Water is accumulated excessively in these places. This way the places become suitable for the growth of algae, fungi and blue-green algae. In that case it is the maker's fault. An example of a strong local occurrence of green covering of microorganisms is also apparent in Fig.5. The cause here is the missing skirting in the place of connection of small roof to facade. During rainfalls, the water splashes on facade and rises to higher places.

Figure 5. False solutions detail on the facade

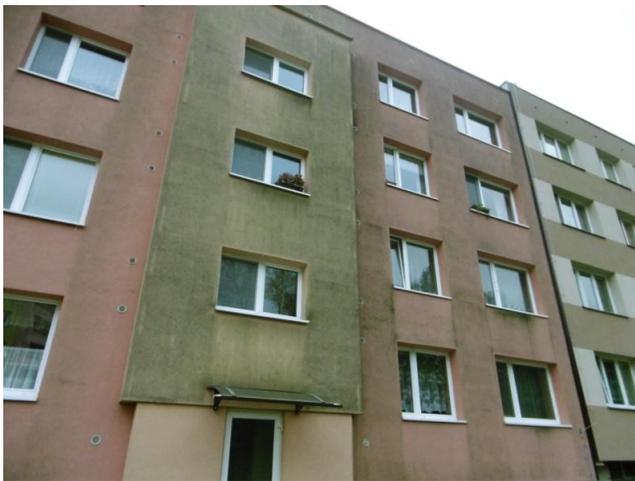
The density of vegetation on the observed facades got bigger during years. In Fig.6 there is pictured the condition of facade in the year 2013, in Fig.7 the condition of facade in the year 2016. Biotic infestation is currently more intensive and more extensive. Aesthetical function of the facade is totally devaluated and the health of all inhabitants of the building is at risk. During airing the spores of algae, fungi and blue-green algae can get easily into the interiors of buildings where they can cause e.g. allergies and breathing problems to sensitive people.

Figure 7. Facade of of a residential building in Ostrava in 2016
