Analysis and Preventive Measures on Bird Pest of Transmission Line

Fushun Power Supply Company, Liaoning Electric Power Company Limited, State Grid, China

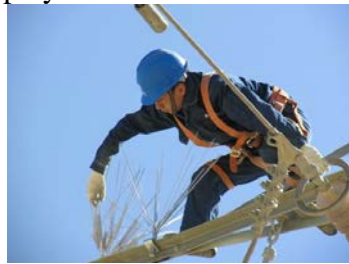
Tripping caused by bird droppings flashover, less points but wide surface makes it not fixed. Bird droppings flashover accident occurs mostly at 4~5 o' clock in the morning, most big birds stand on the opposite ends of the cross arm, bird droppings falls along the edge of the insulator that leads to the cross arm discharge. In the upper insulator string, adding up to a large hat insulator should be able to have the effect to prevent guano whereabouts. However, we consider that adding insulator need to increase a lot of work, so the synthesis of silicone rubber paste way at the top of insulator can also help to prevent guano whereabouts, anti-icing shim, anti-fog pine flashover.

So it's safe for maintenance personnel to use "synthetic insulation big umbrella" in the past. The diameter of the big umbrella is 100mm larger than the edge of the anti-pollution insulator; which is 150mm larger than the edge of the composite insulator. It should be said that the use of this kind of big umbrella has played a considerable role.

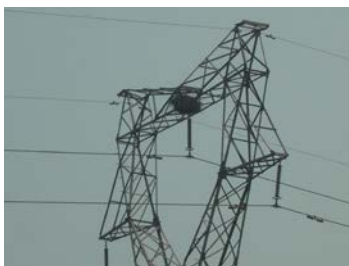
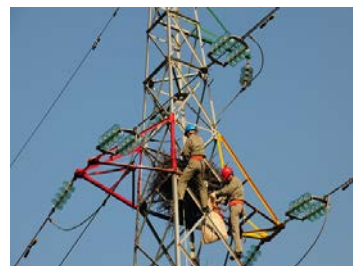
Installing repelling thorn above cross arm of the tower suspension insulator string, the repelling thorn is made up of steel strand GJ-70, whose length is :110kV line 350~450mm, 500kV line 500mm~550mm. The steel strand board should be installed at the end of the U-shaped card, one side scatters radiated that there is a thimble screw under the U-shaped card, card installed on the cross arm angle, with a thimble screw tight.

66kV of the sound of the fault phase occurs in the edge, 220kV of the sound of the fault is in phase, which is because the structure of the phase cross arm in 220kV tower is applicable to the bird nest. One repelling thorn is installed in each phase of 66kV line, 220kV line due to cross arm wide, two are installed in each phase, and repelling thorn can effectively block insulator string. Repelling thorn can effectively prevent guano stay on the tower, which is a good method that simple, easy to install. However, it has influence to the maintenance staff to do assignment on the pole, due to personnel movement, even inadvertently be stabbed by repelling thorn, so maintenance staff should be careful when they finish assignment on the pole.
