Analysis And Improvement Of Leaked Failure For Automotive Water Pump

Keywords: automotive water pump; thermostat cover; failure analysis; improvement

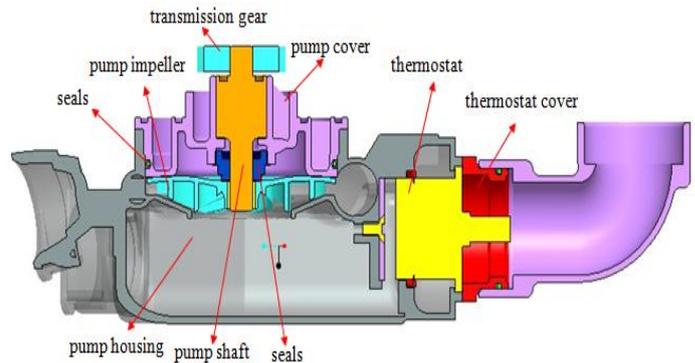
Figure 1: Schematic diagram of automotive water pump

The automotive water pump to be studied is a centrifugal pump, which widely used in automotive engines^[2, 3]. The engine drives the pump shaft and the pump impeller through the transmission gear. The coolant in the pump is driven by the impeller. In the role of centrifugal force is thrown to the edge of the pump shell, while generating a certain pressure. This pressure causes the coolant to flow out of the waterway or water pipe. The pump and thermostats are integrated. The pump is mainly composed of pump housing, pump shaft, seals, pump impeller, transmission gear, pump cover, thermostat, and thermostat cover. The specific structure is shown in Figure 1.

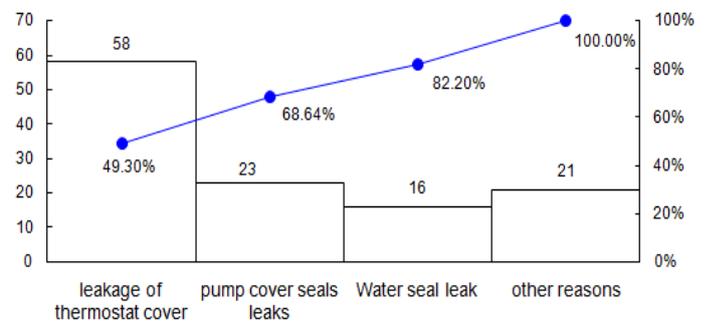
Figure 2: Distribution of Leakage faults in automotive water pump

Pump leakage fault element is collected while collecting member is disassembled. The total number of pump leaks is 118 pieces. The cause of the leak was analyzed statistically, as shown in figure 2. As can be seen from the statistical results, The main reason for the automotive water pump leak is. The main reason for the automotive water pump leak is leakage of thermostat cover, pump cover seals leaks, water seal leak and other reasons. The leakage of thermostat cover accounts for 49.3%. Its proportion is relatively high. Therefore, it is necessary to further analyze the causes of leakage of thermostat cover^[4].

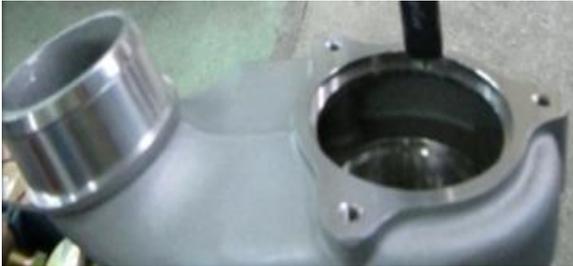
Figure 3: Recess of pump housing

The causes of leakages of thermostat cover are analyzed from the view of processing size, sealing material and design structure. The depth of recess of pump housing and the roughness are measured, as shown in figure 3. The results show the depth range of 5.42-5.48 mm. The size of the qualified range is 5.35-5.65mm, which is in line with the requirements. The roughness measurement is $Ra = 2.43\mu m$, which is in line with the requirements.

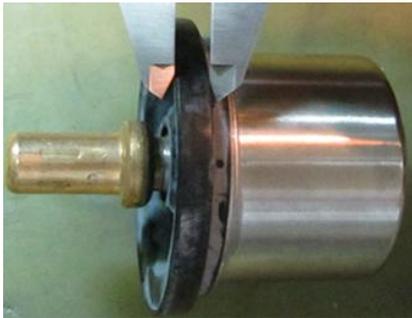
Figure 4: thermostat seal

The size of the thermostat seal is measured, as shown in figure 4. The results show the thickness range of 6.65-6.76 mm. The size of the qualified range is 6.6-6.9mm, which is in line with the requirements.

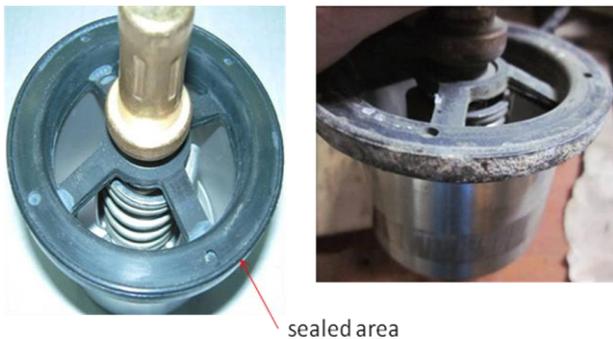
Figure 5: Sealed area and fault pieces

From the design point of view, the end of the thermostat seal with rubber seal^[5], this is dependent on the compression of rubber to seal. This means that the seal is entirely dependent on the rubber anti-aging ability, As shown in Figure 5. Once the rubber is aged, it will make the sealing effect worse or even fail. The disassembled components are observed, as shown in Figure 5. The sealing bosses have been polished and the rubber has lost the elasticity of the seal. Therefore, this is the main reason for the formation of leakage, which requires the improvement of this part of the design.

Third, increasing seal gasket design to the thermostat cover. This program is low cost, and easy to operate control, the program is feasible.

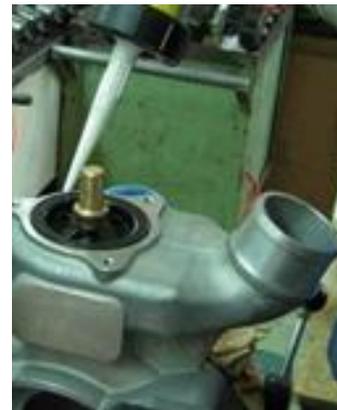
Figure 6: Increase the pneumatic coating

Second, in the thermostat cover contact surface to increase the pneumatic coating, as shown in figure 6. The use of pneumatic coating machine, in the thermostat cover contact surface coating, which can reduce the leakage, but it is easy to create new problems. Such as operating trouble, the amount of glue is not easy to control; the appearance is not good, affecting painting. The program is still not feasible.

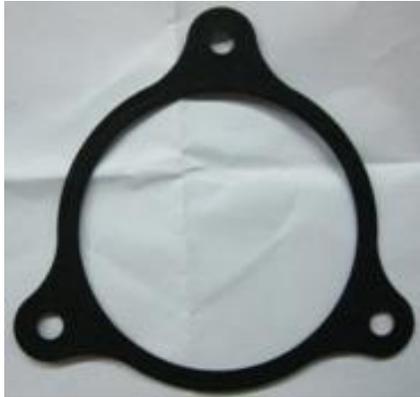
Figure 7: Foam rubber metal composite plate gasket structures

Second, we can consider adding foam rubber metal composite plate gasket. The characteristic of foam rubber metal composite panel gasket is the surface rubber NBR. This

material in the pump working load (34.5MPa). Compression rate of $35 \pm 10\%$, recovery rate $\geq 65\%$, Application: Coolant temperature $-40\text{ }^{\circ}\text{C} - +150\text{ }^{\circ}\text{C}$. And pump operating conditions under the material requirements are consistent. The program is feasible. The structure is shown in Figure 7.

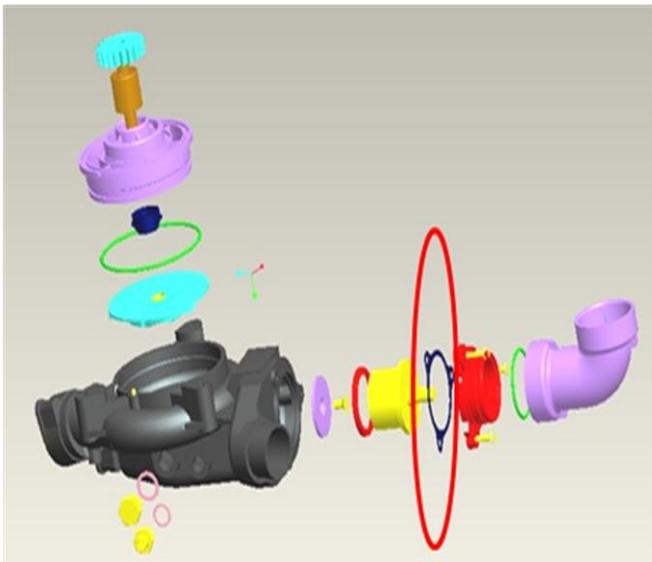
Figure 8: The installation position of the gasket in the pump

Seal diameter size selection thermostat diameter: $74 (-0.3 \text{ to } +0.1)$ mm, the outer diameter of the gasket is selected as the size of the volute: $74.5 (0 \sim +0.2)$ mm, thickness of 0.8 ± 0.08 mm. In order to prevent axial movement of the thermostat, the groove depth of the volute in contact with the thermostat rubber is changed from 5.5 ± 0.15 mm to $5.5 (+0.15 / 0)$ mm. The gasket is installed in the pump, as shown in figure 8.

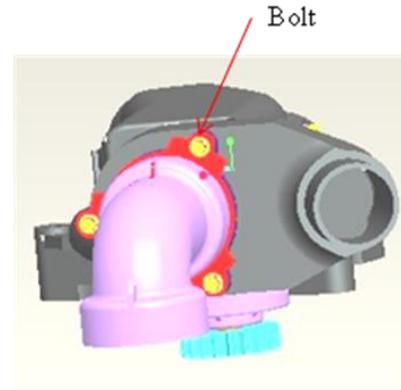
Figure 9: Bolt mounting position

The bolt mounting position is shown in Figure 9. Bolts use M6 bolts, the material is 35, the yield strength is 640Mpa, and the torque is 10N.m.

The single face surface area of the gasket is 2172 mm^2 , and the gasket is subjected to the pressure.

$$3 * 8333.3\text{N} / 2172\text{mm}^2 = 11.51\text{MPa} \quad (4)$$

The pressure of the gasket provided by the manufacturer is up to 34.5Mpa. The current design meets the requirements.
