## Crack Analysis in Tension Roll of Leveler for Continuous Casting Equipment

### Broken Roller Introduction

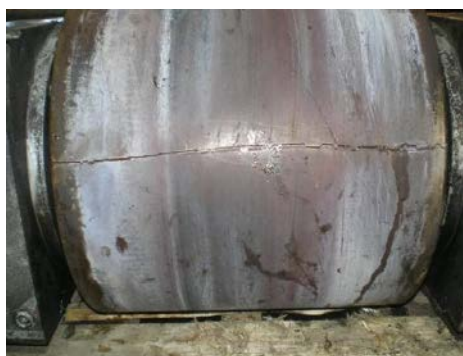
Fig.1. Longitudinal cracks on rollers

The roll rupture originates from a single axial (length direction) crack, the crack extends to the length of the whole roll (457mm), terminate on both sides of the bearing installation position. The bearings have been removed from the bore, in spite of this, probably due to crack expansion and deformation, the other side of the bearings can not be taken out. The crack on the roll is shown in Figure 1, the case where the crack extends into the roll is shown in Figure 2.

(4) The crack on the roller extends from the longitudinal crack to the whole roll body until the end of the roll neck, this crack indicates a quenching crack or is caused by a severe inconsistency between heating and cooling.

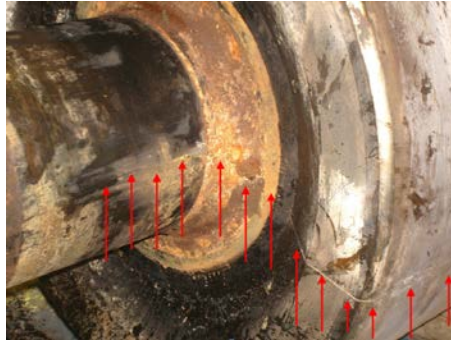
Fig.3. Crack in fitting zone / bearing mounting area

Take the bearings out of the roll, the extent of the crack extension can be observed on Figure 3, the red arrow indicates where the crack is.

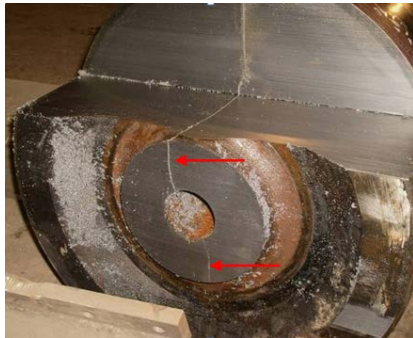
Fig.4. The crack passes through the roller section

As shown in figure 4, the installation of the bearing at the outer end of the shaft and neck is cut by sawing, as shown in the red arrow, the crack extends to the cross section of the roll to the center hole, shaft neck mounted through both sides of bearing.

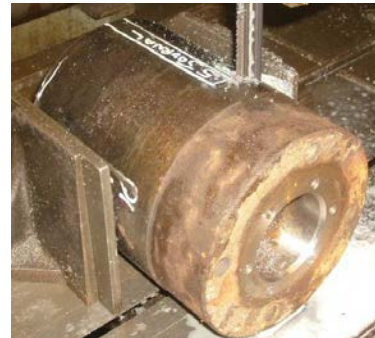
Fig.5. Interception of test pieces

As shown in figure 5, cut off the part of the roller with a saw to avoid stress concentration, take two 25mm thick 140mm long test pieces, cut from a direction of 90 degrees from the direction of the crack, as shown in Figure 6; The two cuboid specimens and performance markings are shown in Figure 7, all tests are carried out at the radial 1/3 depth (29.6mm) from the mounting surface of the bearing.

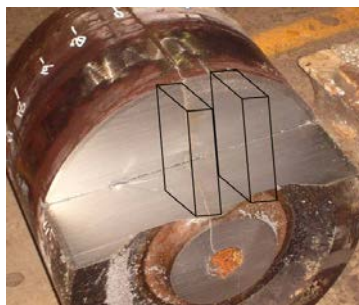
Fig.8. Cuboid specimen

As shown in Figure 8: Cutting roller, take two cuboid specimens, 150mm long x 200mm deep x 25mm thick, cut off, do crack analysis and do macroscopic (test piece) corrosion test, each specimen consists of a relatively cracked surface.

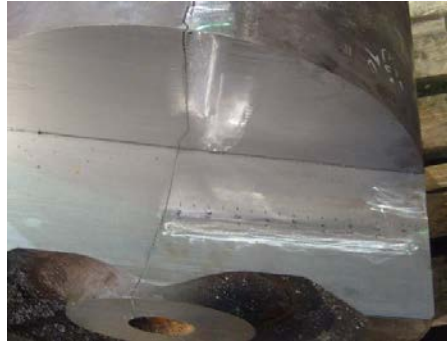
Fig.9. Lateral hardness position

**Roller Transverse Stiffness.** All hardness is read by Proceq Equotip-2 hardness tester. Read transverse hardness at two positions: The first position is about 3 inches (76mm) from the edge of the roller, the angle from the crack to the radial depth of 9 inches (228mm) is about 80 degrees; The second position is about 5-3/4 inches (146mm) from the edge of the roller, the crack is close to the roller's radial depth of about 1 inches (25.4mm), as shown in Figure 9, the yellow arrow indicates, the results are shown in Table 1 and Table 2. The hardness is converted to HV30 (Vivtorinox hardness) by ASTM E140 from HRC, it is found that the hardness is the same throughout the roll body depth, press HV30 (Vivtorinox hardness), the hardness at position 1 is 391 HV, the value at position 2 is 387 HV.

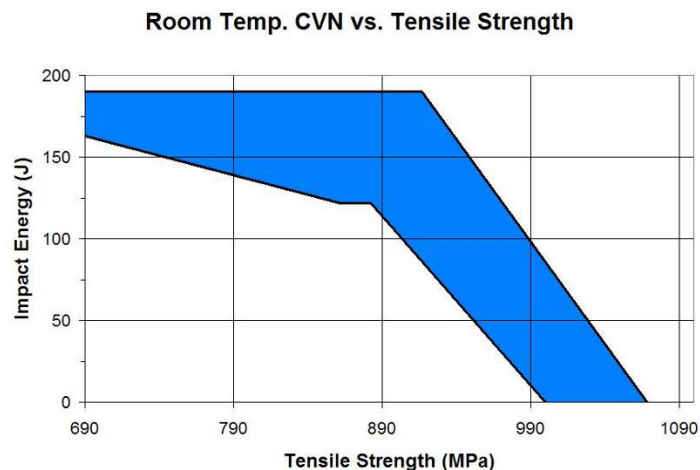
Fig.10. Relationship between impact energy and elastic strength

Based on historical data, 21CrMoV5- 11 relationship between impact energy and elastic strength is shown in figure 10, the color section is the relation between the impact energy and the elastic strength of the material, the impact of material test Charpy V-> 880 MPa, showing a high impact strength range. It is shown in the diagram that the impact energy of 21CrMoV5-11 material is very low at 1236.9 Mpa tensile strength.

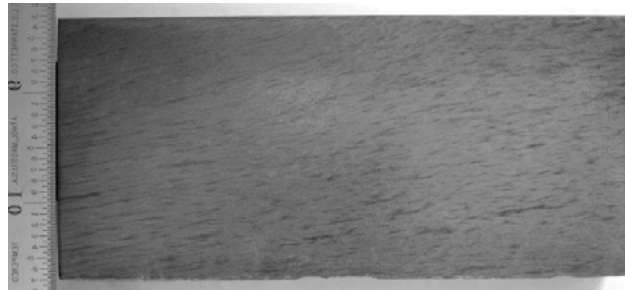
Fig.11. Shaft neck longitudinal macro corrosion test specimen

**Macroscopic Corrosion Test of Roll Neck (test piece).** The cuboid specimen is placed in the HCl hot solution of 50:50 for 10 minutes, etched specimens are shown in Figure 11, the macro etching shows the grain streamlines of the forging roller material, there is no macroscopic discontinuity.

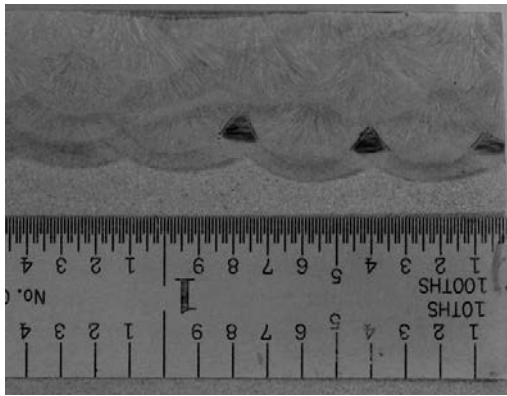
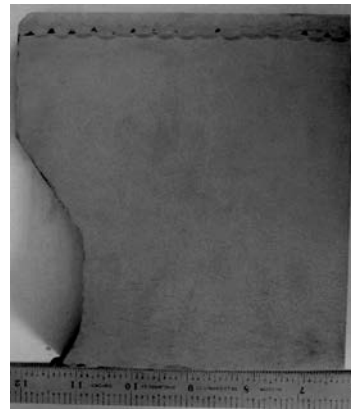
**Macro Etching.** The cuboid specimen is placed in the HCl hot solution of 50:50 for 10 minutes, etched gaskets and typical weld metal are shown in figures 12 and 13, test results proved that there were no discontinuities, close observation shows that the roller has been welded three layers, and the roller surface is in the middle welding layer of third layers, the black corrosion zone in the middle of the first surfacing layer is the parent of the forgings, this case is narrow for solder drop forming, don't think it's harmful.

Fig.12. Macro corrosion test piece

Fig.13. Macroscopic corrosion pattern
