Study on Earthquake Disasters and Seismic Reinforcement Measures about Buildings of Different Structure Types

Damage characteristics and earthquake damage analysis of different types of buildings

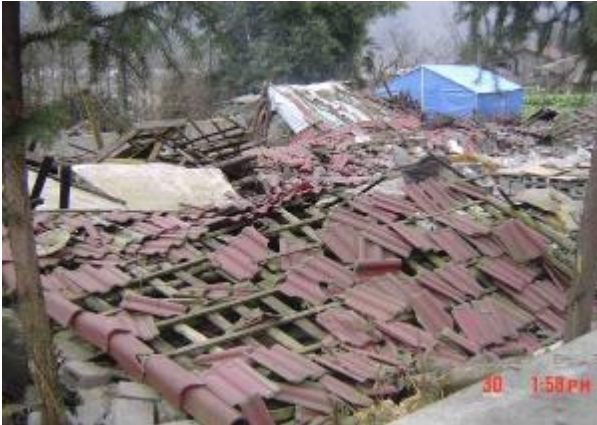
The brick-wood buildings in strong earthquake are severely damaged overall, and their earthquake characteristics are as follows: the roof tiles falling; wood truss damage, partial collapse or collapse, beam fracture and even collapse; the wall between windows appear a large number of "X" shear crack; the load wall crack, damage, and even collapse, and even houses collapse. Most of the buildings almost are structural damaged, even completely collapsed in the earthquake disaster area (X, XI intensity area) in this paper (Fig.1) .

Fig.1 Complete collapse of brick-wood structure

(1) Strengthen the mutual connection among the components of the building to make buildings have good integrity[10]; Pay attention to setting corner bar and reinforced concrete circle beam in order to enhance the overall seismic performance of housing and effectively curb local damage of the wall by uneven seismic action.

(2) Strengthen the quality of walls masonry and guarantee sufficient thickness of the walls to improve the shear strength of the walls.

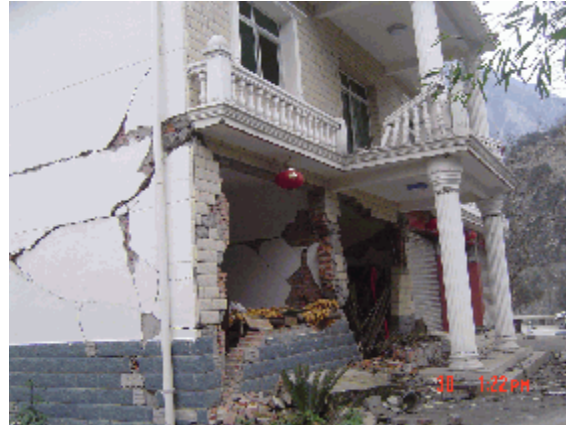
Fig 2 Earthquake disaster characteristics of brick-concrete structure

The overall destruction of brick concrete structure is light, the damage is mainly as follows: the load-bearing wall appear "X" cracks, even partial collapse; structural column damage or even individual column bending fracture; beam bending, even damage; cast or prefabricated stairs damage, even the overall collapse; precast floor collapse; the connection between individual wall and column is broke; filler wall body crack, etc. (Fig 2); roof parapet, wall, corridor railings and other affiliated structure are structural damaged(Figure 3). The body of this kind structure can keep erect, and have certain seismic performance.

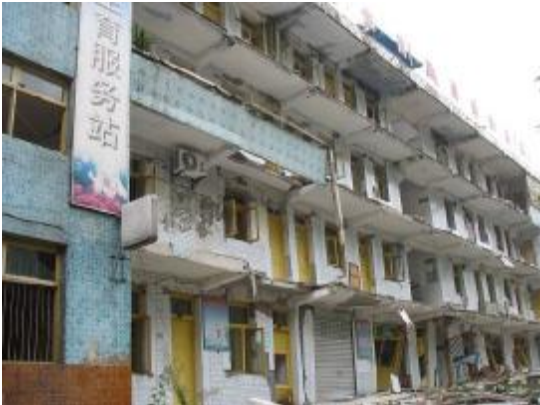
Fig 3 Brick fence in outside corridor of office building collapsed

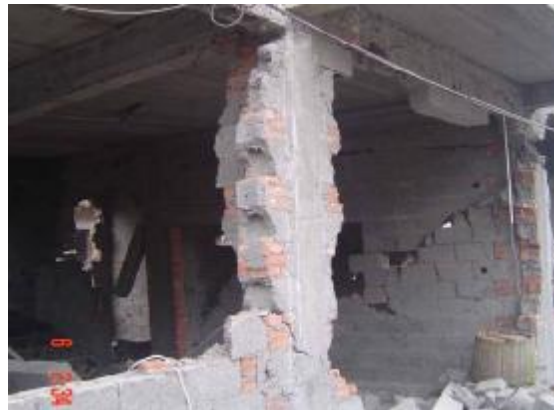
Most of the buildings have certain anti-seismic structural design, which are assembled with cast-in-place reinforced concrete column and beam, but due to insufficient reinforcement, or no enough cross section of component, components of this structure can be lead to stress failure and fracture, and cannot to effectively resist earthquake damage(Fig 4, fig 5).

Fig 4 Loading failure of constructional column

(1) For the brick-concrete structure, according to the seismic code for seismic design of buildings, the corresponding measures of seismic resistance can be given: structure column, ring beam and floorslab of cast-in-place reinforced concrete, designing component cross sections and reinforcement parameters according to the specification requirements.

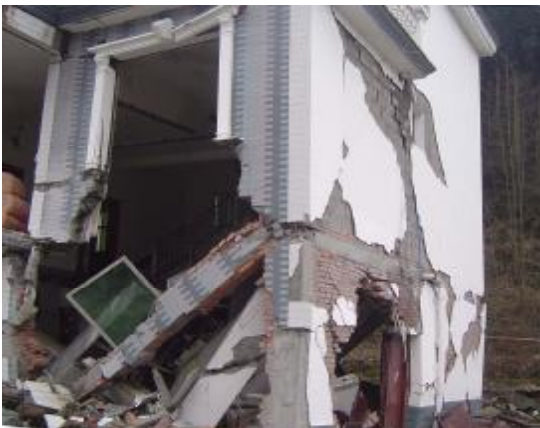
Fig 5 Loading failure of ring beam

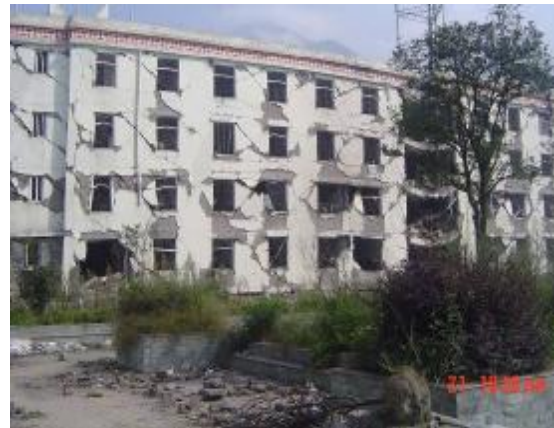
A large number of buildings seem to be erect and intact, in fact, the load-bearing walls have more serious shear damage, with a large number of "X" shaped cracks (Fig 6), and even collapse, the overall structure of the building is severely damaged. Because shear strength of the brick and masonry wall is poor, and there is no tiebars between the walls, the walls and the floors, connectivity between the walls and the other components is failure during the action of seismic shear force and vertical loads. When the tensile stress of walls is larger than its strength, load-bearing wall will have diagonal cracks or "X" shaped cracks.

Fig 6 Dormitory of Yingxiu middle school suffered "X" shear cracks

(2) Strengthen the quality of wall masonry to improve the shear strength of walls; and ensure the connection between wall and other components.

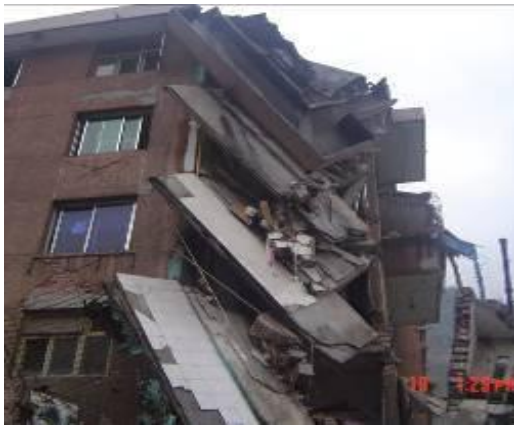
For most of the brick concrete structure, the top floor slab is made of cast-in-place reinforced concrete slab, but considering the economic reasons, non-top floor slab still mostly adopt precast floor. Because of the connection between precast floor slabs and beams, and walls is very fragile, this connection is easy to cause instability, resulting in progressive collapse of overlapping of multiple floors (Fig 7).

Fig 7 Domino effect triggered by prefabricated slabs

(3) Brick-concrete structure is strictly forbidden to use prefabricated floor slab in earthquake high intensity area.

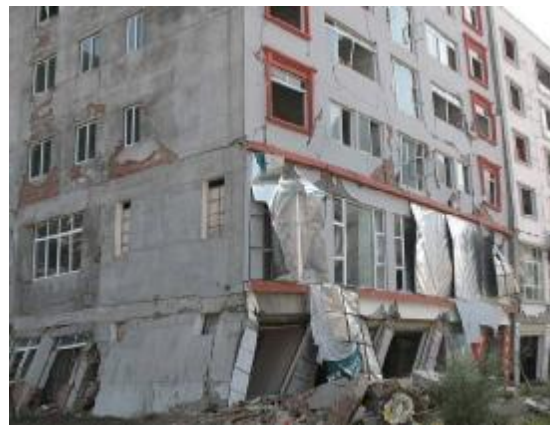
Brick-concrete structure of bottom frame is overall heavily damaged, in addition to damage characteristics similar to brick-concrete structure, the most serious damage phenomenon is: destruction or collapse of the whole building structure caused by collapse and tilt of bottom frame. It is basically embodied in: serious damage of columns of bottom frame, filling wall collapse(Fig. 8), even the whole structure collapse (Fig 9), so the seismic performance of the buildings structure of is very poor.

Fig 8 Brick-concrete structure of bottom frame with serious damage

As for brick-concrete structure of bottom frame, because bottom framework materials of the structure are different from the upper materials of brick-concrete, the structure is composed of two kinds of load-bearing and anti-lateral force system. Because that bottom frame and upper wall stiffness influence on structure under earthquake force and deformation are more prominent, resulting in discontinuous structural strength and stiffness. This discontinuity will cause excessive

stress concentration at local weak parts, and make the structure serious damage or even collapse (Fig 8, fig 9). Therefore, seismic performance of the structure is very poor, and this structure system should be avoided in earthquake high intensity area as much as possible.

(1) Try not to adopt the stiffness discontinuous structure system like brick-concrete structure of bottom frame.

(2) If this structure must be adopted due to constraints of planning and funding, the buildings need to be designed and constructed strictly in accordance with relevant regulations. The key measure is not to adopt pure frame structure, as for bottom frame part of this kind of structure. Seismic walls in two directions must be set to form frame-seismic wall structure, and the seismic walls are arranged to symmetrical.

(3) The measures of strengthening the angle steel of the bottom frame column and the constructional column and strengthening the haunch of the bottom frame beam can be taken.

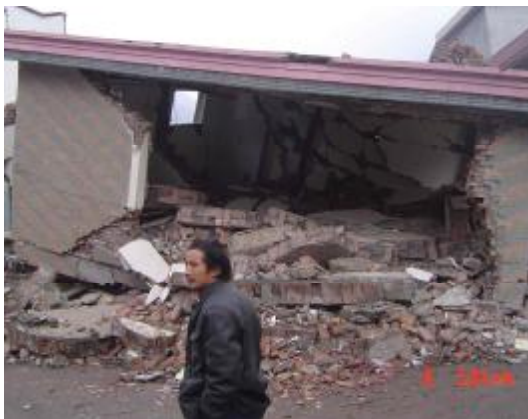
Fig 9 Integral collapse of brick-concrete structure of bottom frame

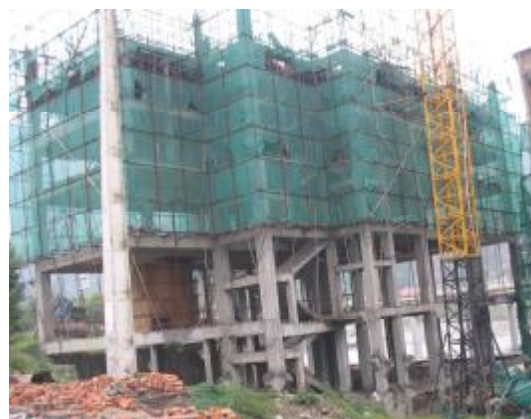
Fig 10 Earthquake disaster characteristics of reinforced concrete frame structure

In the observation spot, the destruction of the column is mostly manifested as: cracks and damage of concrete of column end, reinforcement exposure, column collapse, stirrup failure; the destruction of the beam is mostly manifested as: the surface layer of concrete beam crack, reinforcement exposure, etc. Fig 10 shows a frame structure of constructed in Beichuan County, and beam-column joints of the overall framework are cracked and the reinforcement is exposed. On the whole, the damage of the column is more serious than that of the beam. The main reason is that stiffness ratio of beam to beam is out of proportion, not to achieve the "strong column and weak beam" design purpose, it may even lead to more serious damage, namely collapse of whole layer or the whole building collapse. The main reason for the destruction of the concrete column is: the longitudinal reinforcement of the column is not enough to bend yielding and can form a plastic hinge, when earthquake occurs; insufficient strength of concrete; confined longitudinal reinforcement failure because of too small diameter of column stirrup.

(3) For the frame structure, the seismic design and construction should guarantee the ductility of frame of “strong column and weak beam” in order that the beam is the first line of defense, and the column is the second line of defense, so as to avoid the destruction of columns before the beams, and realize original design of “strong column and weak beam”.

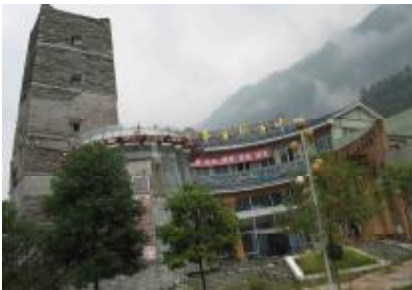
Fig 11 Top tilt and wall cracks of Beichuan social service center

As for the frame structures we observed, the most prominent damage feature is the destruction of filler wall. Its appearance looks like intact structure; actually its non-bearing wall has produced serious shear damage with large number of diagonal cracks or "X" cracks (Fig 11), it will cause

more serious person safety and property loss. The reason is that shear strength of the brick and masonry wall is poor, and in the earthquake shear force and vertical load, the connection between the walls and other various components will be failure due to lack of tie bar between the walls of the masonry structure, and the walls and the frame beams and columns. If the tensile stress exceeds its strength, the walls will produce oblique or skew cracks. But the destruction of the infilled wall can also absorb a large number of seismic energy in the earthquake, and serve as the first seismic line of whole framework, delaying destruction of main frame.

(1) Strengthen the quality of wall masonry to improve the shear strength of walls, and ensure the connection between the walls and other components.

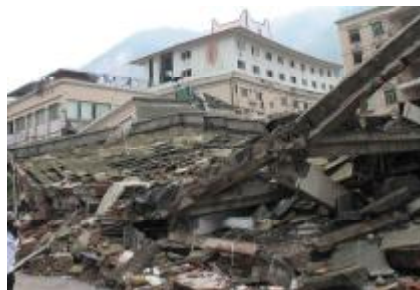
In meizoseismal area of Yingxiu Town and Beichuan County, due to the earthquake intensity's reaching 11 degrees, a lot of reinforced concrete frame structures were severely damaged. Damage degree of reinforced concrete frame structure was small in others earthquake affected area. The damage was mostly embodied in: non-load bearing wall shear crack (Fig 11), even partial collapse or overall collapse; the stigma and the base damage (Fig 9): crack of concrete frame columns, and reinforced concrete columns exposure; column concrete crush, longitudinal reinforcement bending; collapse of underlying structure collapse, the whole floor or overall collapse (Fig 12, fig 13).

Fig 12 Partial collapse of Beichuan Hotel

The whole layer collapse often occurs in change layer of lateral stiffness of structure, such as building top or bottom layer, or variable cross-section layer. It is mainly due to stress concentration of local layer caused by lateral stiffness change of the structure. The main reason of overall collapse is due to bearing structure failure caused by load bearing column failure , mostly belonging to the "strong beam weak column" type.

(2) Determine the stiffness ratio of the frame structure reasonably, and avoid the collapse of the partial structure caused by the local layer stress concentration caused by the change of the lateral stiffness of the structure.

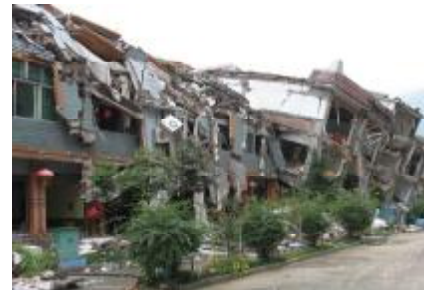
Fig 13 The collapse of a three-story frame structure in Beichuan County
