Preparatory stage for instrumental monitoring and structural inspection of buildings and structures

Keywords— monitoring of structural state, settlement marks, tilt, deformations

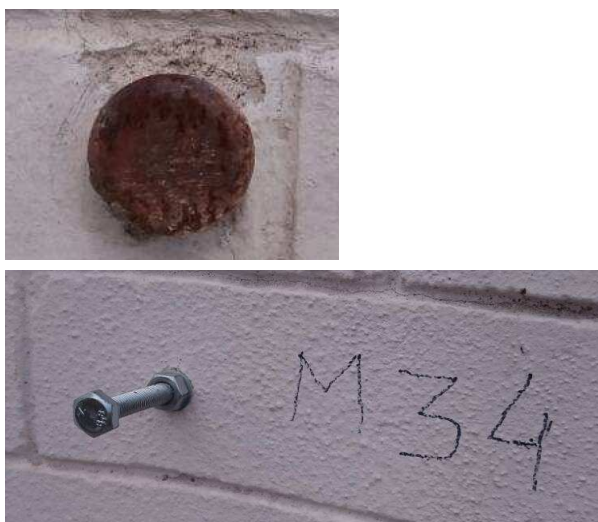
As a rule, settlement marks, spaced at 15 m, are installed along the perimeter of buildings and structures at the points of internal walls abutment and in areas of unfavorable engineering and geological conditions. It is allowed to use steel bolts which are fixed in the walls in pre-made holes, e.g. with epoxy adhesive or dowels which are firmly embedded in the masonry (Fig. 3).

Fig. 3 Settlement marks

Geodetic marks are installed in the base course of buildings and structures to monitor extra settlements.

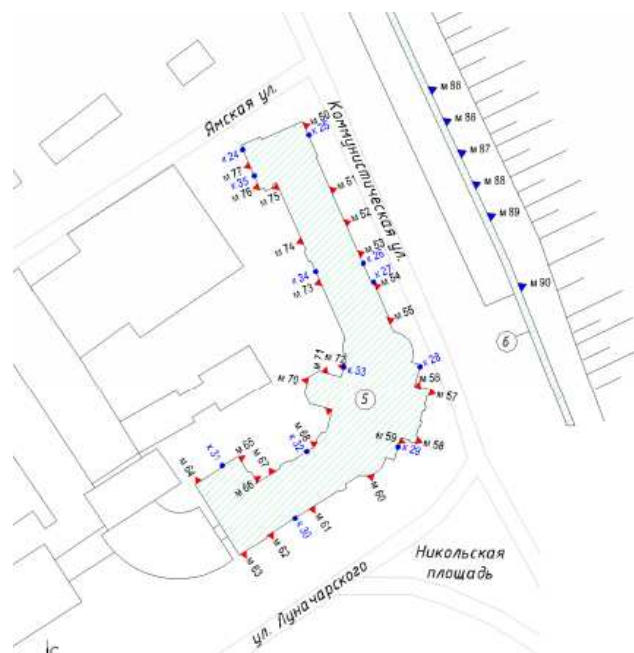
Fig.5. Schematic illustration of geodesic settlement marks at the Commercial School

Fig. 5 shows the following objects of monitoring: 5 – the building of Commercial School; 6 - bank protection structures of the embankment.

Ninety geodetic settlement marks and seventy reflective marks were installed at the listed buildings and sections of bank protection structures of the embankment. Schematic illustrations of geodesic settlement marks and reflective marks are given in Figures 4 and 5.

increase of foundation settlement exceeding the maximum allowable settlement for buildings of the 3rd category according to the structural state; this was observed on marks No. 46, №47, №80 and №81.

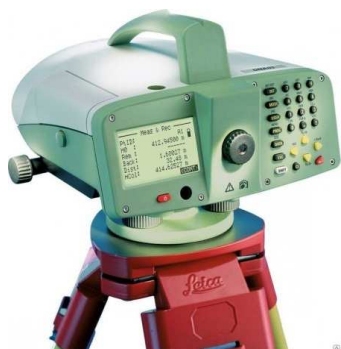
Observations were made by direct leveling using precision digital batter levels when the marks moved in relation to the initial observation. The difference between the elevation points of zero and subsequent measurement cycles makes it possible to analyze the absolute values of deformations and rate of their variations. The measurements with LeicaDNA03 batter level incorporating two invar three-meter rails were made at the Trinity Monastery and the building of former Commercial School (Fig. 6).

Fig. 6 Leica DNA03 batter level

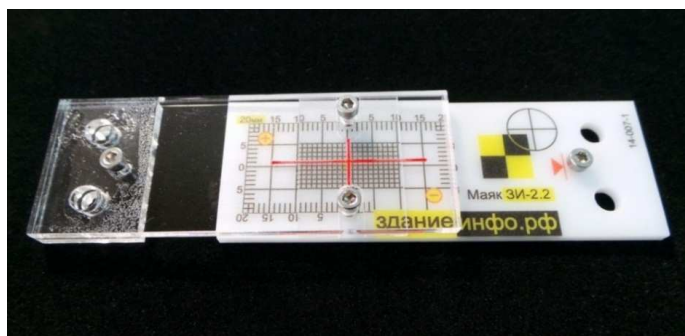
Width of crack growth on the vertical and horizontal axes were observed using Mayak-ZI-2.2 crack meter (Fig. 7).

Fig. 7 Mayak-ZI-2.2

The crack meters were installed at places specified after the inspection of buildings. The scale division of Mayak-ZI-2.2 working surface is 1mm; the range of observations along the X-axis is 15 + 20 mm, along the Y-axis - 10 + 10 mm. A total of 27 crack meters were installed.

When measuring crack width with crack meters for the period from 25.12.2016 to 25.01.2017, gain over 1 mm in the growth of crack width was revealed during the entire period of observation at crack meters No. 16 and 21.

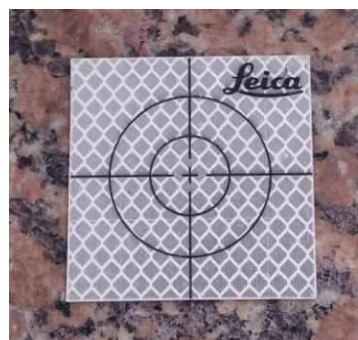
To control extra tilts in the buildings under monitoring, reflective marks were installed on the walls (Fig. 8).

Fig. 8 Reflective mark

Observations were made with a tachymeter when the marks moved in relation to the initial observation.

When carrying out geodetic measurements of tilts with reflective marks for the period from 25.12.2016 to 25.01.2017, areas with extra tilts exceeding the ultimate limit values were revealed.

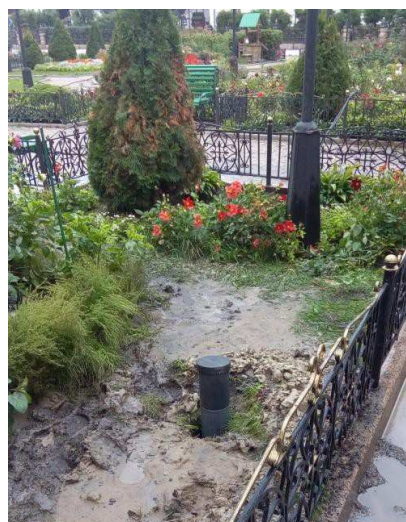
To monitor hydrogeological conditions, some piezometers were installed: three – at the area of the Trinity Monastery and two – at the area of the building of former Commercial School (Fig. 9, 10).

Fig. 9 Piezometric well

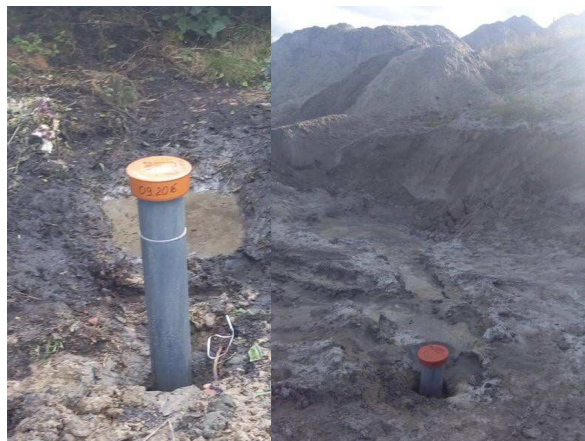
Fig. 10 Piezometric wells

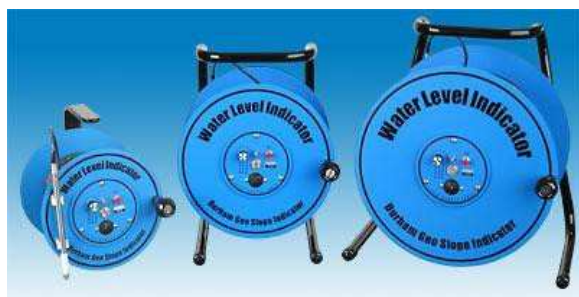
Variations in the groundwater level in the wells are determined with special water level indicators (Fig.11).

Fig. 11 Water level indicators
