Failure Mechanism Analysis of Elevator Brake

4. The case of plunger damping failure

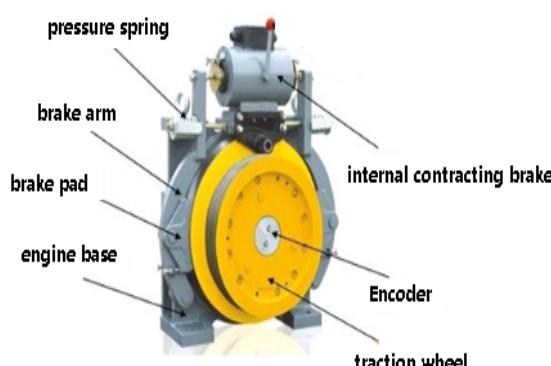
Figure 1. Brake mechanical structure

The brakes used on the elevator equipment are friction-type electromechanical "normally closed" brakes. The brake mechanical structure mainly consists of four parts: directed pressure spring that produces power; electromagnet device that produces release force; Brake pad applied to braking on the brake wheel; brake arm, drive and adjustment mechanism.

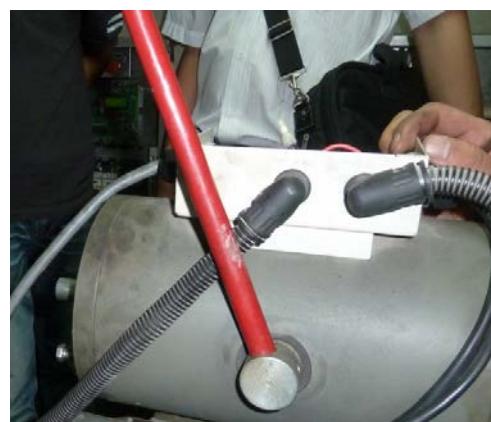
Figure 2. Invalid elevator brake

One day, the elevator hoisting accident occurred in a residential area. Before the accident, the elevator car opened at the first floor, and suddenly ran up until it hit the top of the well. One passengers were injured in this accident. Via checking, the plunger damping failure of the elevator brake is the direct cause of the accident.

Based on the above analysis results, it can be concluded that the failure of plunger damping card is related to the abnormal adhesion of plunger and magnetic ring. This adhesive wear occurs mainly due to the abnormal rotation of the slack brake lever and the formation of the embedded plunger and magnetic ring clearance.

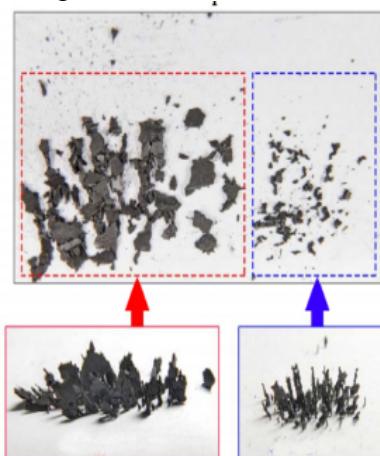
Figure 3. Morphology under magnetic field

After the brake is disassembled, cut the frame and guide ring (sleeve) lengthwise along the center, visible plunger and guide ring (set) have obvious longitudinal wear and tear striation. In the gap region, there is a small powder and a sheet of adhesive. These particles and adhesion are formed along the magnetic field lines in the magnetic field. All of them are ferromagnetic materials.

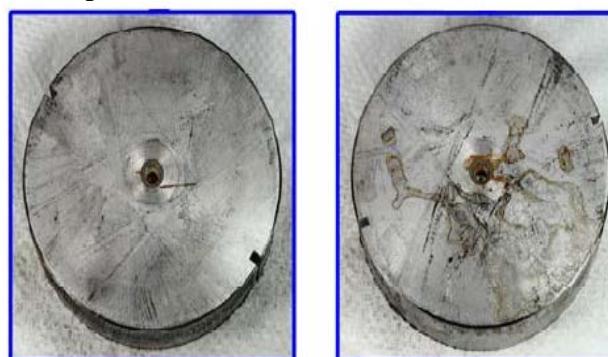
Figure 4. Plunger damage morphology

Two iron core shape and damage morphology are basically the same.In the two iron core and the magnetic cover (ring) to match the segment has obvious wear phenomenon,its matching segment traces width of 22.2mm ~ 23.2mm.

In the bottom surface of the two plunger body, there are a number of impact indentation with the loose bars, the depth of the marks is different, and the fan distribution shows that the plunger has a certain rotational motion in the operation.

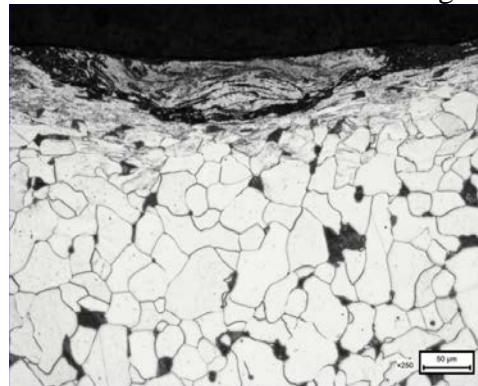
Metallographic analysis was performed on the cross section of the wear zone.In the cross-section, we can see that the surface of the worn surface is in the form of a depression, the flow rate is as deep as 0.024mm and the matrix structure is iron element +a small amount of pearlite,And can be seen folded rheological cracking morphology, rheological depth of 0.08mm.Distribution of cracks in the gray oxide, indicating that the late surface oxidation due to rheological rheology.

Figure 5. Worn surface structure is subject to extrusion rheology

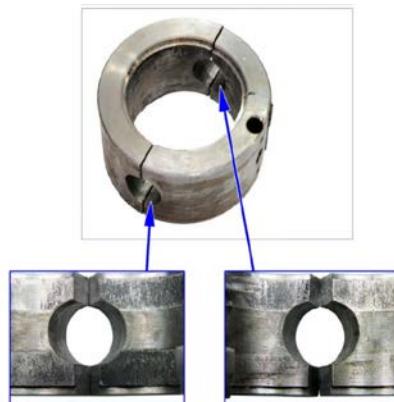
Figure 6. Magnetic ring wear morphology

As shown in figure 6, the outer diameter of the guide ring is about phi 42mm. The width is about

67mm; The outer diameter of the guide sleeve is approximately phi 102mm and the width is about 5mm.

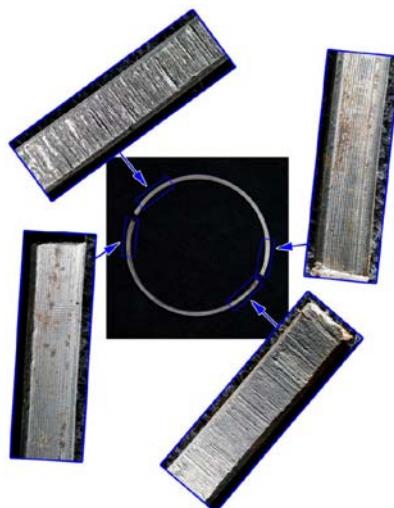
Figure 7. Magnetic sleeve and wear morphology

The inner surface of the two magnetic guide sleeve is blocked by the uneven wear. The wear area basically corresponds to the inner surface of the permeable ring, the shape of the furrow is worn, and the shades are different in depth. However, there is no obvious wear in some areas, and ring marks can still be seen.

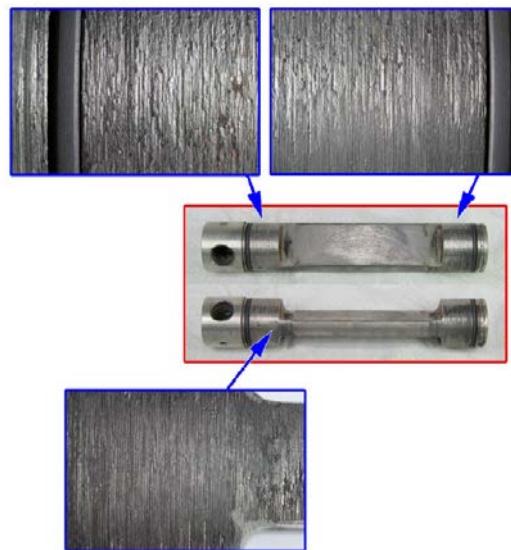
Figure 8. Slack brake lever wear morphology

The outer circle of the slack brake lever is about 33.5mm, and the length is about 191mm. The material is cold drawn 45 steel, and the outer surface is galvanized Daniel.

The fitting section of the slack brake lever and the magnetic guide ring is badly worn, and it is visible to the furrow of the furrow. The diameter of the section is approximately phi 33.07mm ~ phi 33.10 mm, and the outer diameter of the unworn segment is approximately phi 33.24 mm, indicating the wear of about 0.07mm (unilateral), as shown in figure 8.
