Research on the Protection and Reconstruction of the Landscape Heritage Based on Digital Reduction Technology

—Taking AD1837 as an Example of the Huangci Bridge in Qing Dynasty in Nanning, Guangxi

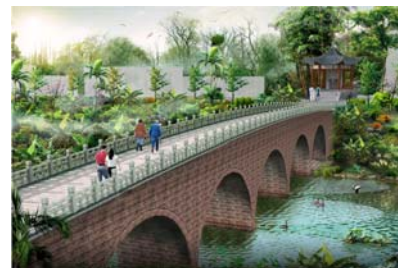
FIGURE III. THE REAPPEAR DESIGN OF THE BUILDING LANDSCAPE AND ENVIRONMENT

Given the fast progress of urbanization, we should tend to historical and cultural landscapes and value their protection and restoration, as they are not only the necessary part of the development of a city, but also a prerequisite for the continuity of the unique texture of a city(Figure3、 4). Hopefully, the methods summarized in this article may offer some theoretical assistance to research on regional historical and cultural landscapes. Meanwhile, it can provide some restoration methods for other historical and cultural landscapes of the same type.

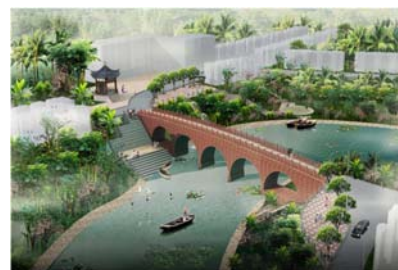
FIGURE IV. THE REAPPEAR DESIGN OF THE BUILDING LANDSCAPE AND ENVIRONMENT No.2
