## Analysis of the cause of crack in a brick structure

Shang Xiang<sup>1, a</sup>, Guobo Luo<sup>1, b</sup>, Xuerui Yang<sup>1, c</sup>

<sup>1</sup>Guizhou Construction Science Research & Design Institute Co. Ltd, Guiyang 550000, China

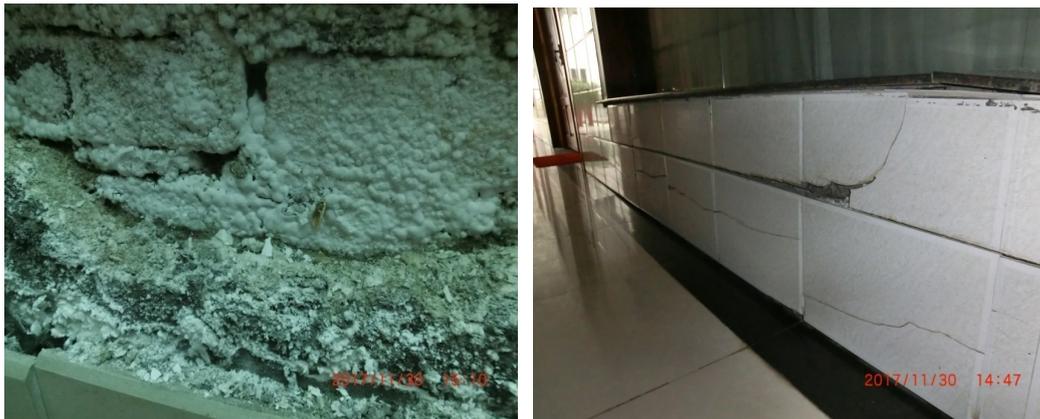
**Wall crack and defect detection.** The maximum crack width of the building was 3.0mm, and the cracked wall was mainly wet and severe, and the wall was precipitated with white, As shown in figure 1.

**Fig.1 The wall is cracked and white matter precipitates out.**

**Expansion and shrinkage cracks.**through on-site inspection, the position of the serious USES horizontal cracks Gao Jiangnai water gypsum brick or gypsum mixed with baked brick masonry, cracks are part of the foundation, wall in the bathroom wall, kitchen window sill have water or wet areas, such as dry wall does not appear obvious horizontal crack, thus the water is the cause of the problem above.

Gao Jiangnai gypsum brick, water is the dihydrate gypsum ( $\text{CaSO}_4 \cdot 2 \text{H}_2\text{O}$ ), the water rigid gelled material as the main raw material, after blank preparation, forming and steam curing is main wall made of building gypsum products, exciting agent is added in production (such as: yellow phosphorus slag, fly ash, lime, etc.). In the humid environment, water enters the inside the brick, easy  $\text{CaSO}_4$  combine with water to regenerate the  $\text{CaSO}_4 \cdot 2 \text{H}_2\text{O}$ , phosphorus gypsum brick after absorbing water volume expansion, will produce larger expansion stress, lower the adhesive strength of mortar and brick, and generate along the horizontal crack of mortar joint. At the same time,  $\text{CaSO}_4$  and  $\text{MgSO}_4$  are slightly soluble in water, and as the water evaporates, the white crystals are precipitated on the surface of the brick and there is a frosting phenomenon. The physical and chemical changes of high-strength water-resistant gypsum bricks and water are long-term cycles, and physical and chemical changes will occur as long as the water is in contact with  $\text{CaSO}_4$  in gypsum tile.

Known from the analysis of the above, the building wall ceramic tile burst, horizontal cracks and the cream of the brick surface is mainly Gao Jiangnai water gypsum brick produced under the influence of water lead to the results of physical and chemical changes.
