Research on Surrounding Rock Control Technology of Roadway Excavated in Residual Coal Pillar

Abstract— In order to research surrounding rock control technology of roadway excavated in residual coal pillar, this article took excavation roadway in coal pillar that was between the two parallel empty roadways as the research background, used field investigation, theoretical analysis and calculation, similar material grouting test, numerical simulation analysis, field engineering application and other methods, Analyzed stress state in pillar when excavating in coal pillar; analyzed grouting reinforcement mechanism of cracked coal-rock mass the consolidation body strength and analyzed the diffusion radius of slurry through three-dimension broken coal-rock mass grouting changing performance system developed independently; researched stress and deformation damage of roadway surrounding rock after bolt-grouting through using numerical simulation software FLAC3D. Through field practice we can draw: that damage depth and deformation of roadway surrounding rock decreased through using bolt-grouting support way, besides, anchor and anchor cable can play a role effectively, bolt-grouting suppor

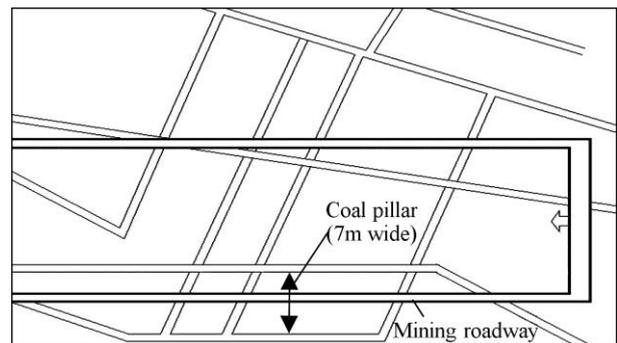
Fig.1 Repeated mining face layout

The repeated mining work face was located in 3# coal seam of Xucun coal mine, 3# coal seam was buried depth in 220m and its thickness was about 2.8m, figure 1 was repeated mining work face layout. Old mining area left two empty roadways, there was a 7m wide coal pillar during these two empty roadways, the roadway of repeated mining work face was arranged in residual coal pillar. The abutment stress in coal pillar was increased as far away from the coal wall, therefore, coal wall plastic failure had occurred within a certain range from the edge of the coal wall. Apply limit equilibrium theory and formula 1[8], can calculate the width of plastic area.

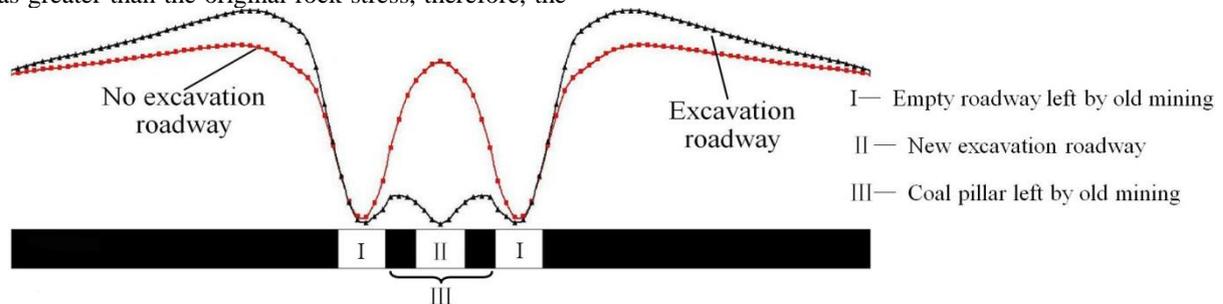
Fig.2 Coal pillar stress graph

It can be seen from figure 2 that the maximum stress concentration factor of coal pillar load reached 1.2 when no roadway had been excavated in the remaining coal pillar; when the roadway was excavated in coal pillar, the bearing stress in the remaining coal pillar became smaller. The load was transferred to the side of the solid coal. Due to stress transfer, the maximum stress concentration factor in the solid coal was greater than the maximum stress concentration factor that there was no roadway.

stress concentration phenomenon was happened in coal pillar; while two sides of coal pillar were not bound by lateral pressure, so, the compressive strength of these areas was more low and failure had occurred more easily; then, concentrated stress transferred into coal pillar inside. Because of the superposition of abutment stress in coal pillar inside, the largest vertical stress was supported by the center of coal pillar, and it was larger than rock stress, the vertical stress on the whole pillar appear “arch” distribution[9-10], as was shown in figure 2.

(1) Through the analysis of the stress distribution in the coal pillar which two sides was mined and the analysis of the stress distribution in the coal pillar when excavating roadway in this coal pillar, we can draw that excavating roadway in residual plastic pillar, the new roadway and the empty roadways constituted roadway group. The more denser of roadway was, the more larger of abutment stress was, when the residual coal pillar was destroyed due to its small size, the load on the coal pillar would be transferred to the adjacent coal pillar, if the adjacent pillar was damaged under the superimposed load, there would be a wide range of pressure arch in which overburden strata can move. In the research content of this article, the coal pillar was damaged, and the load on the coal pillar was transferred to the side of the solid coal. The maximum stress concentration factor in the solid coal was greater than the maximum stress concentration factor that there was no roadway.

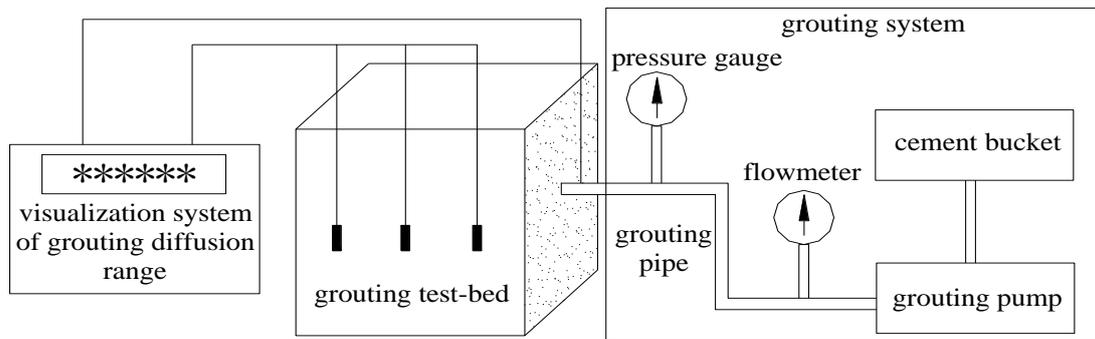
Fig.3 Three-dimension broken coal-rock mass grouting changing performance system and connection of each part

In order to study the mechanical properties of roadway surrounding rock mass which grouted, used self-developed three-dimension grouting experiment system of changing performance of broken coal-rock mass, it included grouting test-bed, grouting system and visualization system of grouting diffusion range, figure 3 was the connection of each part.

The grouting test-bed's size was 0.5m×0.5m×0.5m, it's frame was welded by angle steel and was surrounded by tempered glass, in the middle of tempered glass of one side of the test-bed had a grouting hole, the bottom of the test-bed was a piece of wood, on the wood there were five slurry overflow holes, and the test-bed was mounted on a base welded by angle steel.

The grouting system included cement bucket, grouting pump, pressure gauge, flow meter, grouting pipe, stop valve, hole packer and so on. Grouting pump was manual pressure grouting pump of MG-808 type. The pressure gauge and flow meter were installed on the grouting pipe which was installed on slurry outlet, they can measure the grouting pressure and grouting volume.

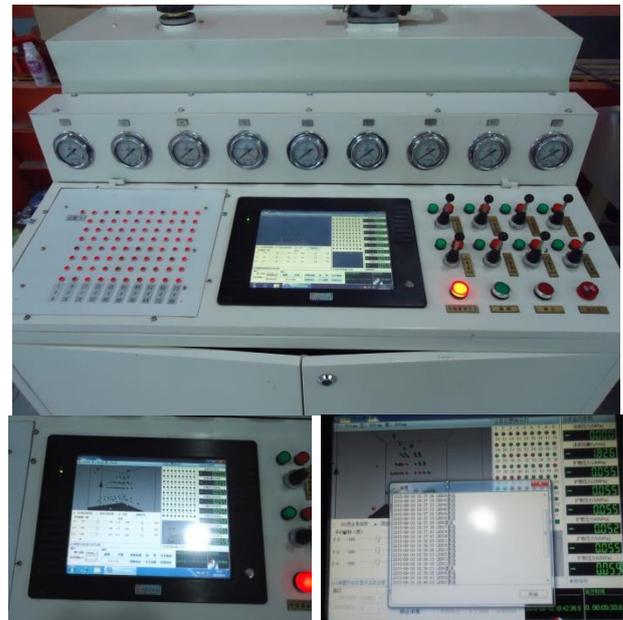
Fig.4 Visualization system of grout diffusion range

The visualization system of grouting diffusion range was a self-developed visualization system for monitoring slurry conditions in the laboratory, it can monitor the slurry diffusion range during grouting, the diffusion time of the slurry to the sensor and the diffusion pressure of the slurry at the sensor. The sensors of the visualization system were embedded in grouting test-bed during laying the broken coal-rock material. During the grouting experiment, once the slurry had spread to the sensor position, the corresponding signal light in the visualization system lighted up, and then the distance between the sensor's position and the grouting port, the time and pressure at which the slurry flowed to the sensor can be recorded. The visualization system of grouting diffusion range was shown in figure 4.

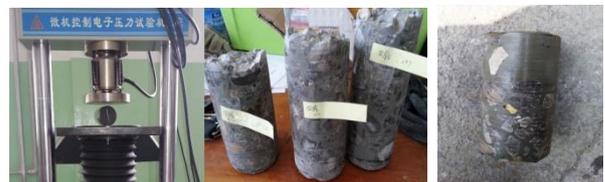
Fig.5 Test the mechanical parameters of grouted gravel core

The grouting experiment of roadway surrounding rock was carried out according to the matching ratio of similar materials simulation experiment[12]. The similar materials were gravels of different sizes, the slurry material was cement slurry, the grouting pressure was 0.25MPa, and the slurry water-cement ratio was 0.8:1. After the grouting was completely and all the slurry had solidified, a uniaxial compression test was performed on cores at different locations in the surrounding rock of the roadway. The core test was shown in figure 5, and the mechanical parameters of the surrounding rock of the roadway after grouting reinforcement were tested, the test results were shown in table 1.

It can be seen from table 1 that the strength of the mechanical parameters of the specimen was higher, and the strength of the grouting consolidation body was increased because the slurry entered into the fractured coal-rock mass and caused the properties of the coal-rock mass to change. The first reason was that the grouting slurry improved the mechanical properties of the weak face of the fractured coal-rock mass, reduced the sliding ability of the coal-rock mass between the weak faces, and improved the tensile strength, shear strength, and other strength parameters of the fractured coal-rock mass; the second reason was that the slurry entered into the fractures of the coal-rock mass and filled the cracks and voids of the fractured coal-rock mass, because of the bond effect of the slurry, the fractured coal-rock mass became a load-bearing consolidation body that can play bearing capacity, the cohesive force and internal friction angle of the coal-rock mass were improved and the consolidation body after grouting was difficult to be destroyed.

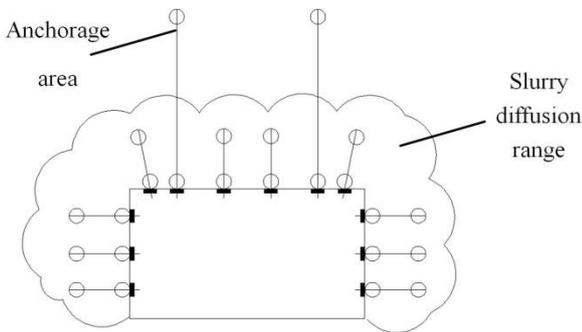
Fig.6 Bolt-grouting mechanism

The bolt-grouting support was to grouting reinforcement of the roadway surrounding rock, and then used anchors and anchor cables to support the surrounding rock of the roadway[13]. The cement slurry was injected into the fractured surrounding rock mass and the mechanical parameters of the surrounding rock were improved. The anchors were all located in the reinforced surrounding rock and had a force foundation, the surrounding rock in anchorage zone formed by anchors composed compressed-combined arch and the compressed-combined arch was suspended in a stable rock formation above the roadway through the anchor cables. The mechanism of action was shown in figure 6.

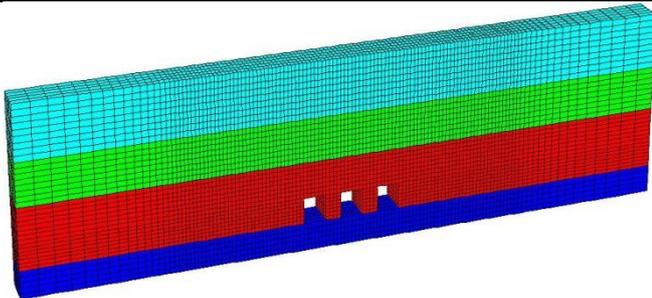
Fig.7 Numerical simulation model

After the grouting reinforcement was adopted, the physical and mechanical properties of the surrounding rock of the roadway were improved due to the effect of the slurry, and the integrity of the fractured coal-rock mass and the bearing capacity were also improved. When the grouting pressure was 0.25MPa and the water-cement ratio of the slurry was 0.8:1, the slurry diffusion radius which was measured by slurry diffusion radius monitoring system was 2.5m. In the numerical simulation calculation, the rock mechanics parameters of the surrounding rock within the range of 2.5m of the roadway was properly adjusted according to the rock mechanical parameters after grouting reinforcement in order to simulate the stress and deformation of the roadway surrounding rock after grouting. The length, width, and height of the numerical simulation model were 86m, 40m, and 26m respectively, and the buried depth was 220m. The size of the empty roadway left from the old mining was width×height =3m×2.8m, and the width of the pillar between the two empty roadways was 7m, the bottom of the model limited the displacements in the X, Y, and Z directions, at the upper boundary of the model applied the load provided by the overburden. The simulation model had 22940 blocks and included 28500 nodes. The required mechanical parameters for each rock formation were shown in table 2. The model adopted the Mohr-Coulomb failure criterion to simulate the stress and failure deformation of surrounding rock of roadway excavated in remaining coal pillar with or without bolt-grouting support. The numerical simulation model was shown in figure 7.

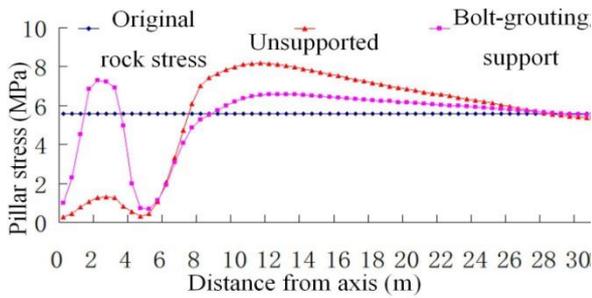
Fig.8 Pillar vertical stress of excavating roadway in pillar

Simulated and analyzed the roadway surrounding rock stress and deformation damage under the support and unsupported conditions, extracted the simulation data, drew the coal pillar stress diagrams, as was shown in figure 8.

As can be seen from figure 8, whether supported or unsupported, the change trend of the vertical stress on the coal pillar was consistent during excavating roadway in coal pillar, the stress increased from the axis of the roadway to both sides first, then decreased and then increased, finally, the stress tended to be stable. The difference was that the vertical stress value on the pillar was smaller before the pillar was supported while the vertical stress value was significantly increased after bolt-grouting support, the maximum vertical stress value on the coal pillar was increased from unsupported 1.3MPa to 7.3MPa, and the stress concentration factor was 1.33; at the same time, the stress value in the solid coal side of the old mining remaining roadway was significantly reduced, the maximum vertical stress value was reduced from unsupported 8.2MPa to 6.2MPa, and the maximum stress concentration factor was reduced from 1.5 to 1.1. By analyzing figure 8, it can be concluded that due to the support of bolt-grouting, the ability of coal pillar to carry overburden load significantly improved, the coal pillar between the roadways and the solid coal jointly beard the overburden load.

(3) By equivalently changing the mechanical parameters in the corresponding range of roadway surrounding rock and using FLAC3D numerical simulation, to study the stress and deformation damage of roadway surrounding rock under the conditions of bolt-grouting support, we can draw: the vertical stress value in coal pillar was significantly increased after bolt-grouting support, while the vertical stress value in the solid coal side of the old mining remaining roadway was significantly reduced, the plastic area of the surrounding rock of the new excavation roadway was significantly smaller, the roof new excavation roadway of was hardly damaged, the horizontal displacement of the two sides of the roadway was reduced by 70%, and the amount of roof subsidence was reduced by 64%, and the destruction depth of the solid coal side of the old mining remaining roadway was also reduced. After the surrounding rock of roadway was bolt-grouting supported, the slurry solidified the broken coal-rock mass and formed a solid body that had a bearing effect, the ability of coal pillar to carry overburden loads significantly improved, the coal pillar between the roadways, and the solid coal jointly beard the overburden load, the surrounding rock of roadway was in a stable state.

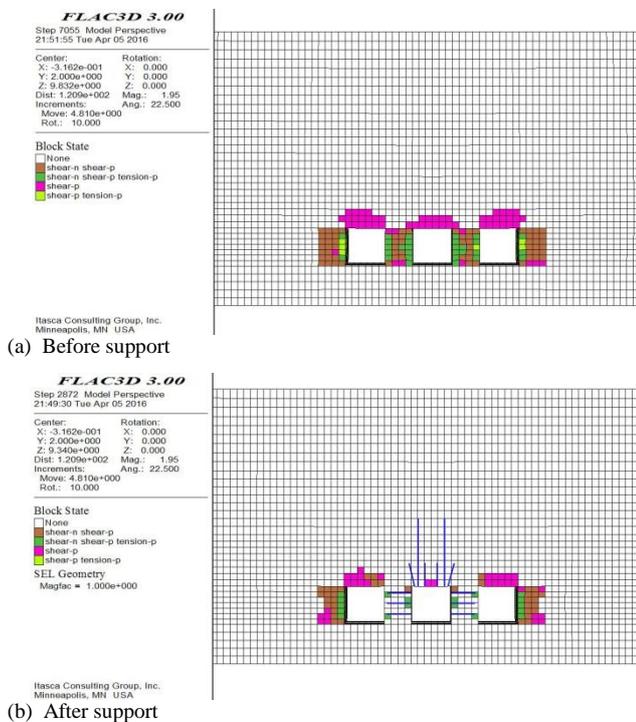
Fig.9 Surrounding rock damage of excavating roadway in coal pillar

Figure 9 reflected the depth of plastic failure before and after roadway support, and the support method was bolt-grouting support.

It can be seen from figure 9 that under the condition of no support, the two sides of new excavation roadway were

completely destroyed and the damage depth of the roof was about 2m; after the surrounding rock of roadway was bolt-grouting supported, the slurry solidified the broken coal-rock mass and formed a consolidation body that had the bearing effect, the plastic area of the surrounding rock was significantly smaller, the roof of the new roadway was hardly damaged, the damage depth of the solid coal side of the empty roadway left from the old mining was also changed from the original 3.5m to 2m. The smaller the failure depth of the solid coal side of the empty roadway, the greater the width of the pillar which supported the overlying rock load, and average load on coal pillar became smaller, this environment was more conducive to make the surrounding rock of roadway stable.

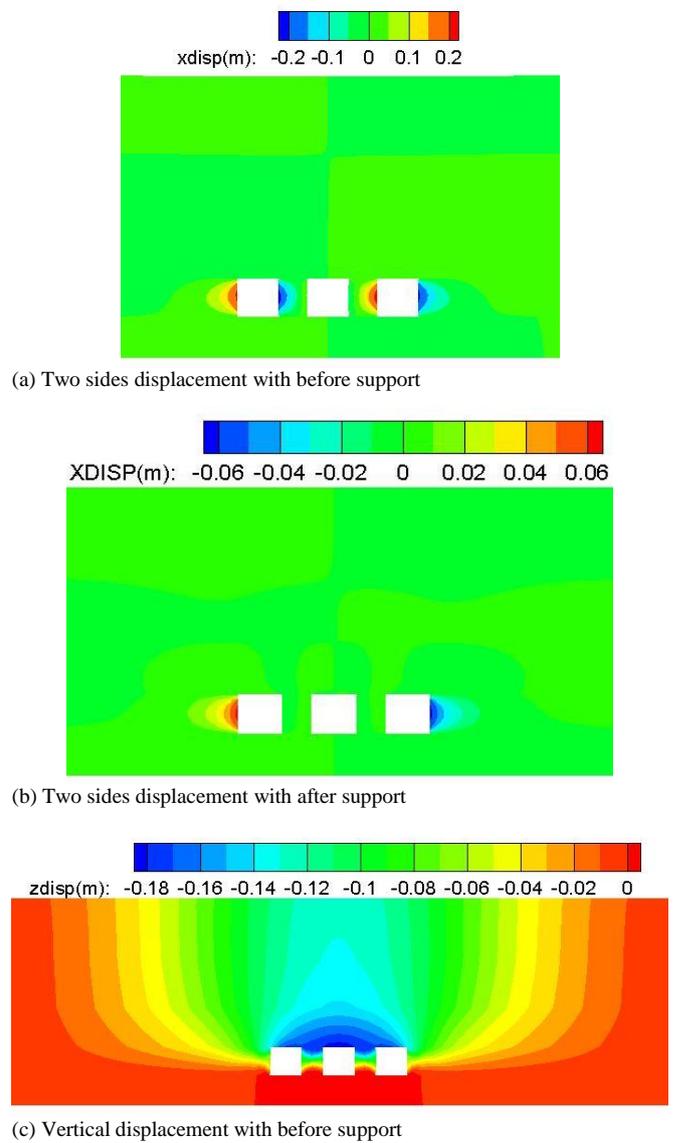
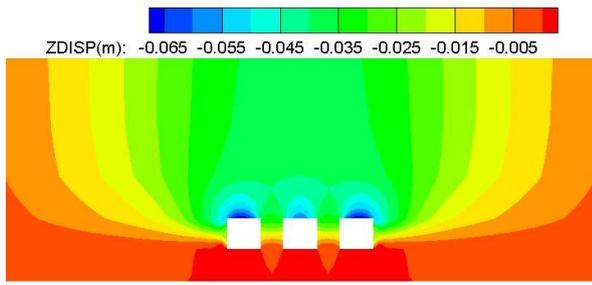
Fig.10 Surrounding rock displacement of excavating roadway in coal pillar

The simulation results were imported into Tecplot software to obtain the schematic diagram of horizontal and vertical displacement changes of roadway surrounding rock, as were shown in figure 10.

It can be seen from figure 10(a)(c) that before the roadway was supported, the horizontal displacement of the two sides of the roadway reached 400mm, and the amount of roof subsidence was about 180mm; it can be seen from figure 10(b)(d) that after bolt-grouting support, the horizontal displacement of the two sides of roadway was about 120mm which was reduced by 70%, and the amount of roof subsidence was about 65mm, which was reduced by 64%.

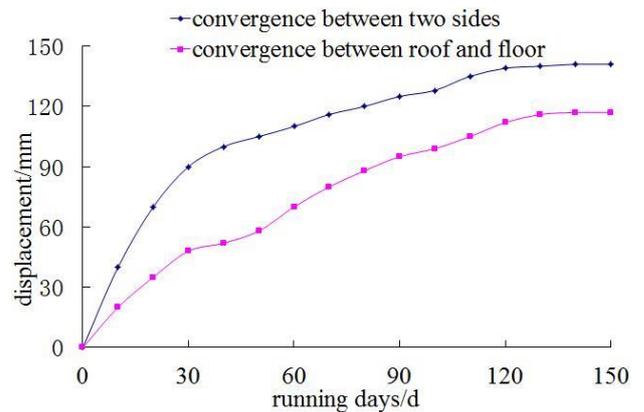
Fig.12 Surrounding rock displacement

After the roadway was dug, monitored the deformation of surrounding rock of the roadway and recorded the displacement of the two sides and the displacement between the roof and the floor within 5 months, the observation results were shown in figure 12.

It can be seen from figure 12 that roadway deformation was large within 30 days after excavation, and then the deformation trend was slowed down, and the deformation of surrounding rock tended to be stable in about 130 days. During the monitoring period, the displacement of the two sides was about 150mm, the displacement between the roof and the floor was about 120mm, and the deformation of the roadway was small, which did not affect the use of the roadway. The results showed that the bolt-grouting support method was used for the roadway excavated in the coal pillar, which can effectively maintain the stability of the roadway.

(4) It had been verified through engineering verification that the roadway adopted the bolt-grouting support, which can changed the mechanics parameters of surrounding rock of the roadway. The anchors and anchor anchors had force points, which can effectively reduce the deformation amount between the roof and floor and reduce the deformation amount between the two sides of roadway, maintained the stability of roadway surrounding rock effectively.
