The Effects of Low Ventilation on Thermal Condition in Cathedral Churches

Keywords— Sustainable Architecture, Passive Cooling, Thermal Condition, Historical Building, Church

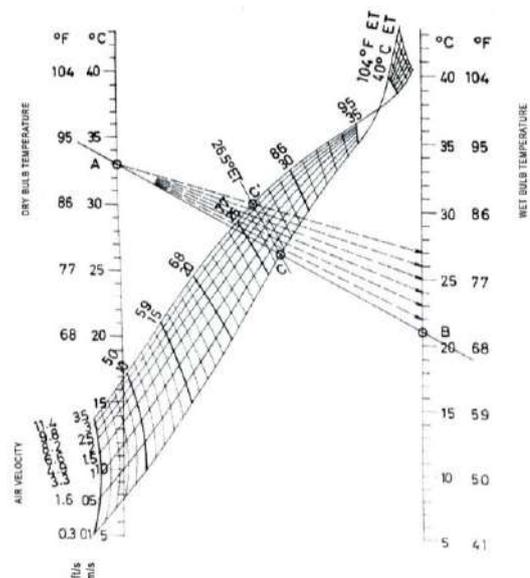
Fig. 1. Effective Temperature Diagram (Source: Lippsmeier 1994)

temperature. Furthermore to determine the thermal comfort, some factors such as: humidity, temperatures. air velocity shall be obtained under several different spots and periods before being related to the people sensations [5]. Thermal comfort is the condition where the effective temperature is between 23°C - 27°C, the air humidity is between 30% -60%, the metabolic rate is between 1-1.2, the clothing condition is between 0.5 - 0.6, the wind speed is more than 0.2 m/s, ET is around 23°C - 27°C [6].

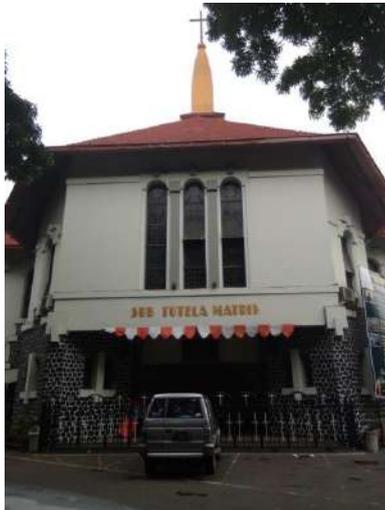
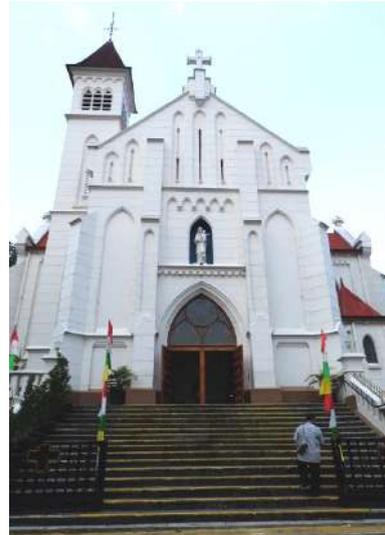
Fig. 2. Semarang Cathedral (upper) Bogor Cathedral (lower)

Indonesia has structures and infrastructures that are being developed from the European colonialism era until present. Some of the buildings stand as witness to the history of Indonesia development phases [9]. Colonized for almost 365 years, Dutch colonialism was the biggest influence of Indonesia's building development. Dutch colonial buildings had a lot of development as well. They learned from environment, culture, and also the tropical climate of Indonesia. A lot of historical buildings from Dutch colonial era are spread across Indonesia, including in Semarang and Bogor cities. Semarang and Bogor are cities that have a lot of historical buildings from Dutch colonial era. They both have a Cathedral Church from Dutch colonial era that still stands and also functions until now. Semarang and Bogor Cathedrals still can use their passive cooling system until now and they become interesting objects to study about their thermal condition. They both have special ventilations that were installed at the bottom of the wall called low ventilations.

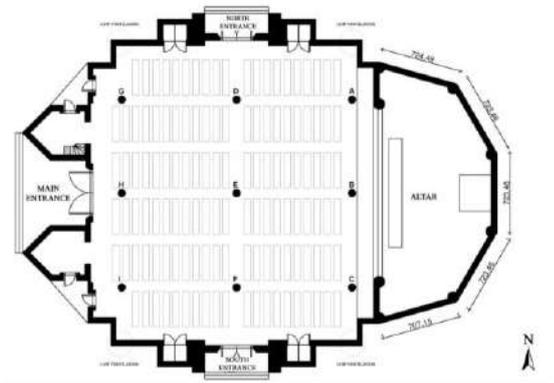
Fig. 3. Measuring Spot Plan of Semarang Cathedral

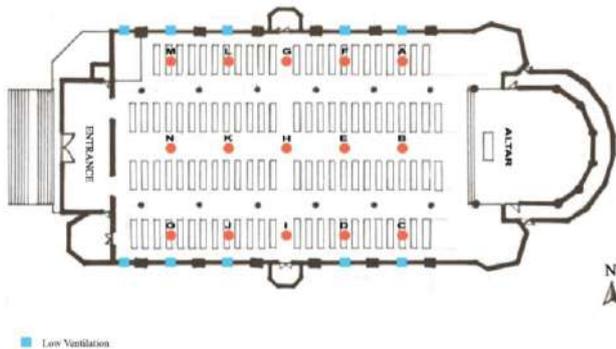
Fig. 4. Fig. 3. Measuring Spot Plan of Bogor Cathedral

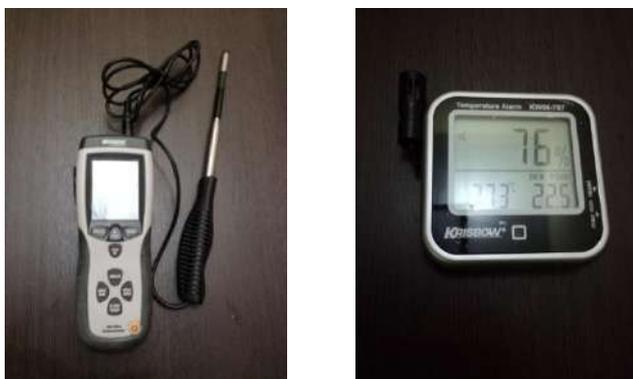
Fig. 5. Hotwire Anemometer.(left), Digital Thermo Hygrometer (right)

For this research, data collection is separated into two stages, first was site observation to obtain floor plans, and second was thermal measurements inside both cathedrals. Data for thermal measurement inside the cathedrals consisted of relative humidity (%), air velocity (m/s), and dry bulb temperature (°C). Data was taken on specific spots inside the cathedrals. Data was measured during worship activity when the air conditioners were turned off. As shown in figure x, Semarang Cathedral had 9 (nine) spots and Bogor Cathedral had 15 (fifteen) spots. Table 1 shows that thermal measurements to collect data were held on 3 (tree) different worship times. Low ventilations of two cathedrals were conditioned as open and closed as shown in figure 2 and 3 when collecting data. To help collecting data, there were several gears used as shown in figure 4 and 5; they are hotwire anemometer and digital thermo hygrometer that had already been calibrated properly.

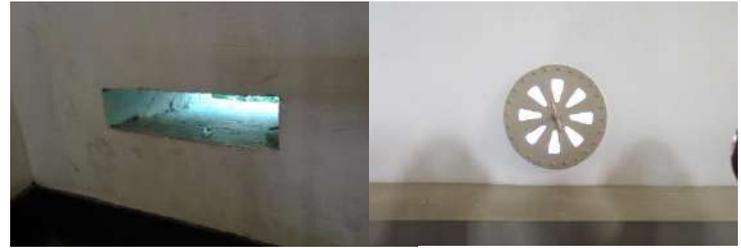
Fig. 6. Semarang Cathedral's Low Ventilation (left) and Bogor Cathedral's Low Ventilation (right)

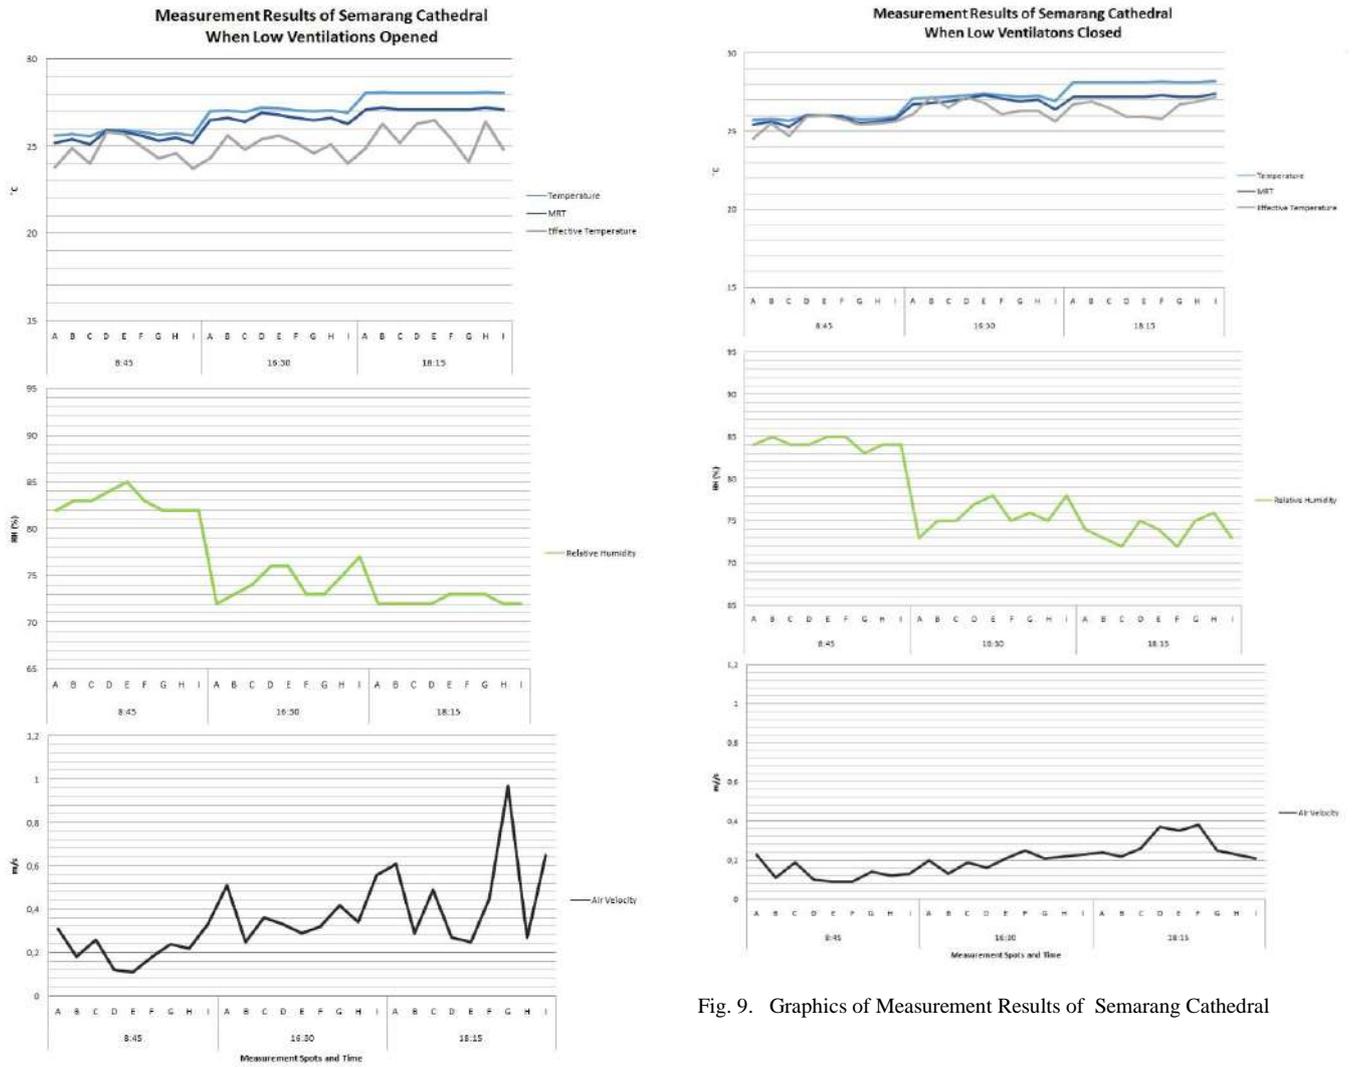
Fig. 9. Graphics of Measurement Results of Semarang Cathedral

Figure 7 and 8 are measurement results of thermal conditions inside the cathedrals. Figure 7 shows the results of Semarang Cathedral and it shows that when low ventilation was open, air velocity was 0.09 to 0.11 m/s higher than air velocity when low ventilation was closed. But when low ventilation was open, relative humidity (RH) was 1.3 to 1.4% lower than RH when low ventilation was closed. The effective temperature (ET) when low ventilation was open ranged between 0.8 to 1.5°C lower than ET when low ventilation was closed. Figure 8 shows results of Bogor Cathedral. It shows that when low ventilation was open air velocity was 0.09 to 0.11 m/s higher, in the other side RH become 1.5% to 2.5% lower than when low ventilation was closed. ET ranged between 1.1 to 1.3°C lower when low ventilation was open. The measurement results of both cathedrals show the same results that low ventilation made air velocity became higher but RH and ET became lower. Low ventilation made significant impacts on the thermal conditions inside both cathedrals.

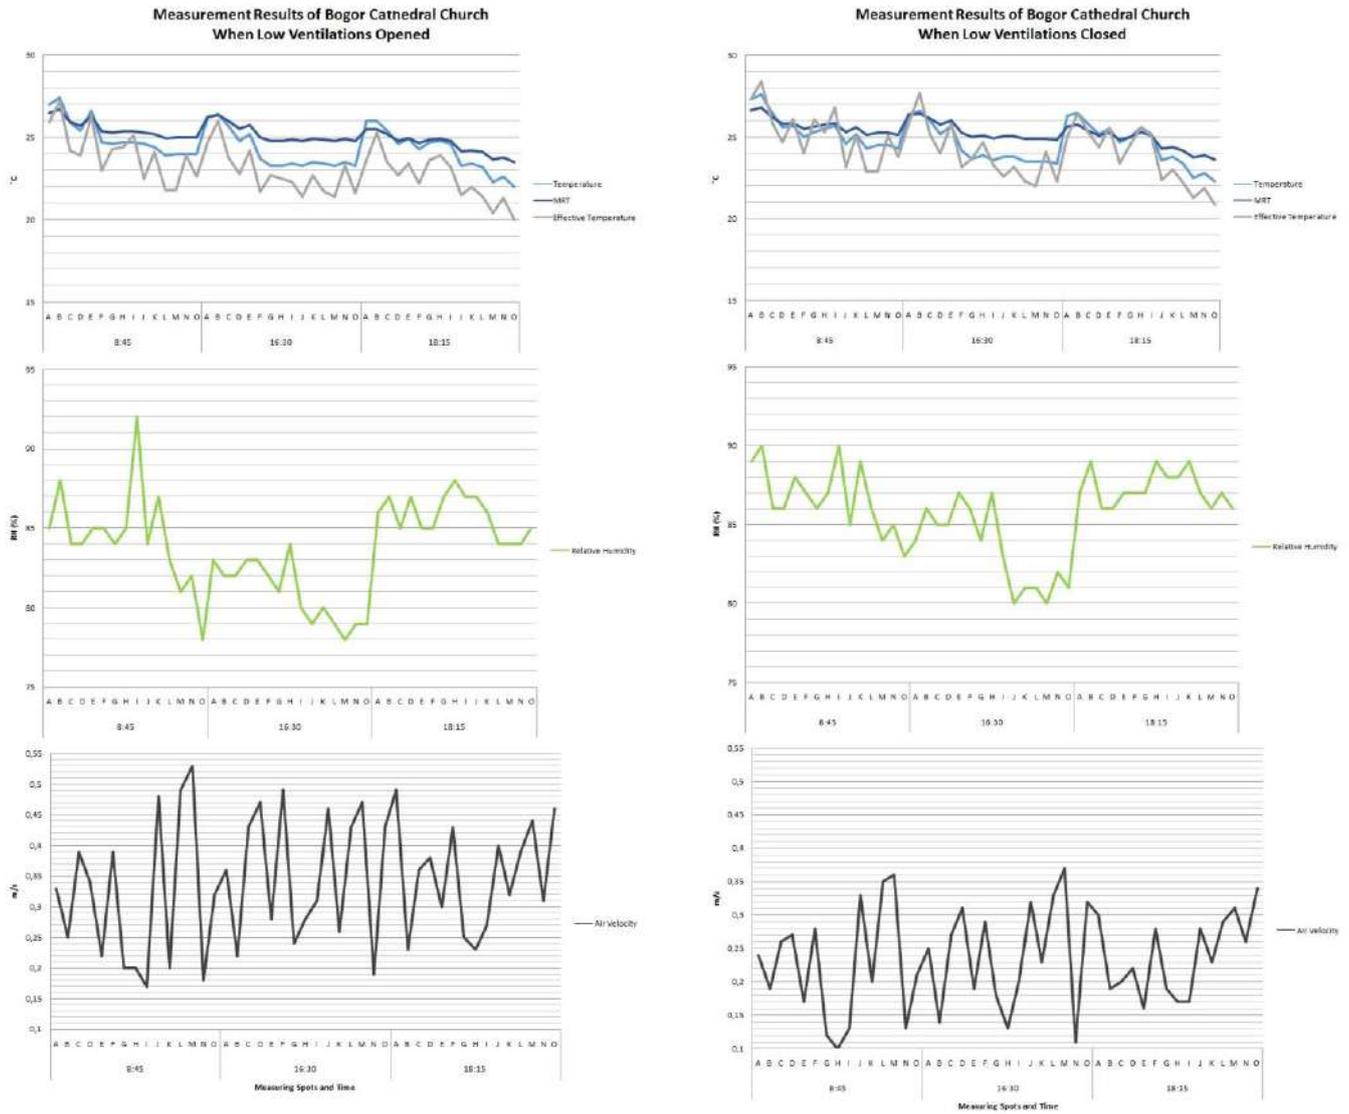
Fig. 10. Graphics of Measurement Results of Bogor Cathedral

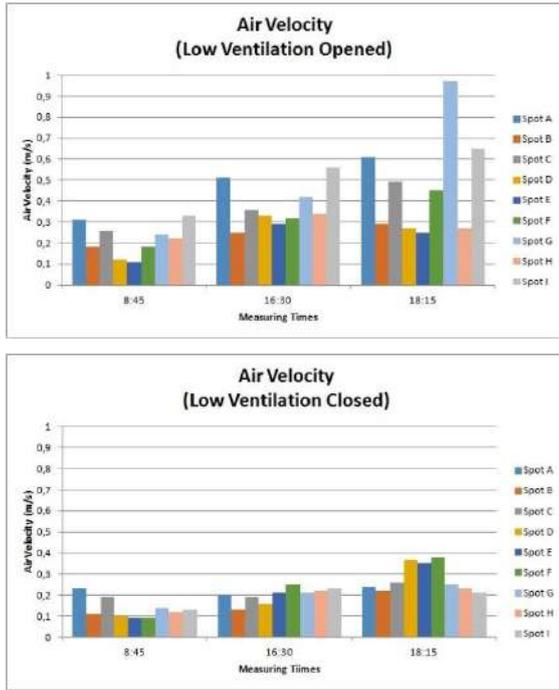
Air velocity is one of thermal comfort factors. It will assist in evaporation process which can lower down the temperature [11]. The comfortable zone of air velocity is around 0.2 m/s – 0.8 m/s [4]. Figure 11 shows air velocity charts of Semarang Cathedral that when the low ventilation was closed, lack of air came into the Semarang Cathedral. There were only few spots at 16:30 and all spots at 18:15 included in comfort zone of air velocity. Otherwise, when low ventilation was open, all measuring times and all spots were included to air velocity’s comfort zone. The highest air velocity entered Semarang Cathedral was at 18:15. The A, C, G, and I spots located near low ventilations had higher air velocity compared with the other spots.

Fig. 11. Air Velocity in Semarang Cathedral

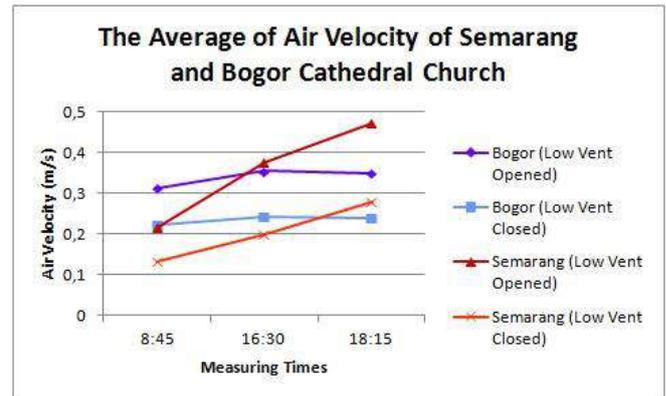
To make it easier, figure 13 shows the average of air velocity of both cathedrals. Both Semarang Cathedral and Bogor Cathedral had the same tendency that when low ventilation was open, air velocity became higher and made thermal conditions categorized as comfort zone. Semarang Cathedral had more significant increase in air velocity than Bogor Cathedral.

Fig. 13. Average of Air Velocity between Semarang and Bogor Cathedrals

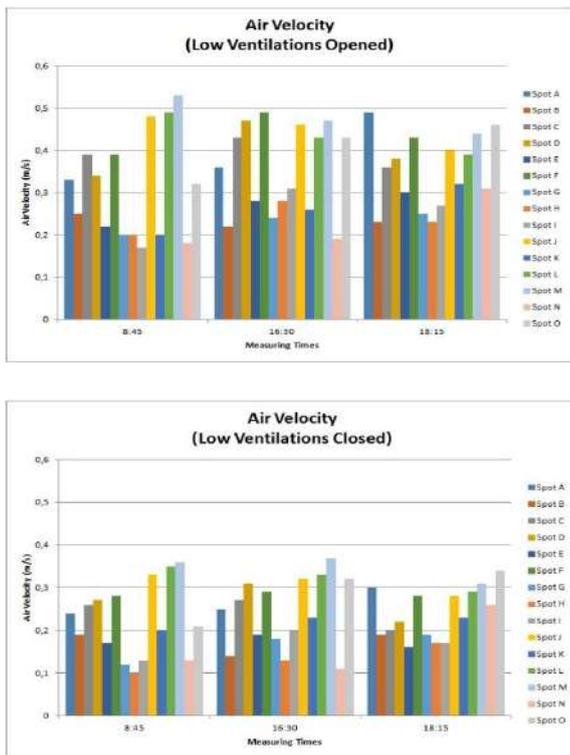
Fig. 12. Air Velocity in Bogor Cathedral (Source: Sekatia 2018)

Figure 12 shows air velocity charts of Bogor Cathedral. It shows that both conditions, air velocity at most of measuring times and spots were included to air velocity's comfort zone. Significant difference happened when low ventilation was open. When low ventilation of Bogor Cathedral was open, air velocity became higher compared to when low ventilation was closed. When low ventilation was closed, there were several spots at each measuring times not included in the

comfort zone. Like what happened at Semarang Cathedral, spots near low ventilations (A,C,D,F,J,L,M,O) of Bogor Cathedral had higher air velocity compared to the other spots.

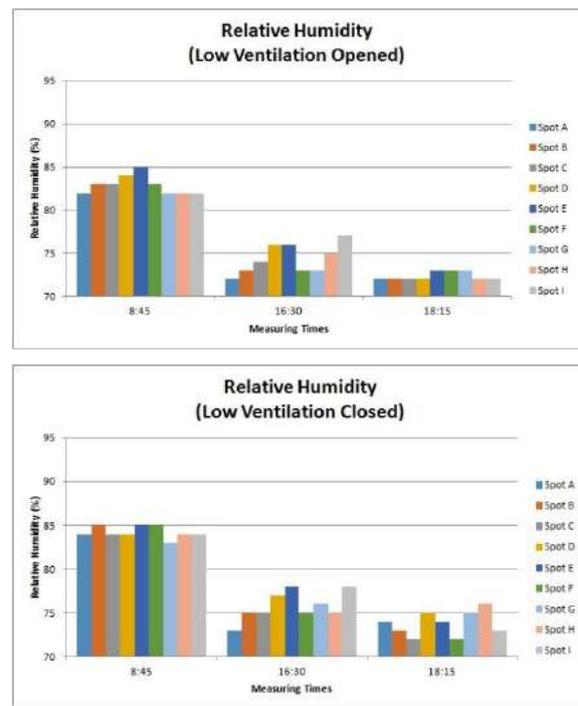
Fig. 14. Relative Humidity in Semarang Cathedral

Comfort zone of RH is around 30% - 90% [12]. Figure 14 shown RH charts of Semarang Cathedral. RH at both conditions (when low ventilation was open and closed) included into comfort zone. The difference was when low ventilation was closed, RH became higher. It was because when low ventilation was closed, only minimum air velocity entered Semarang Cathedral. The lowest RH was at 18:15. Again, measuring spots located near low ventilation (A,C,G,I) had lower RH than other spots. Figure 15 shows RH charts of Bogor Cathedral. Similar to Semarang Cathedral, that most measuring spots and measuring times at Bogor Cathedral were included into comfortable relative humidity. It was only I spot at 8:45 that had higher than 90% RH which was not included into comfort zone. At 8:45 and 18:15 had higher RH. The spots located near low ventilations (A,C,D,F,J,L,M,O) had lowest RH.

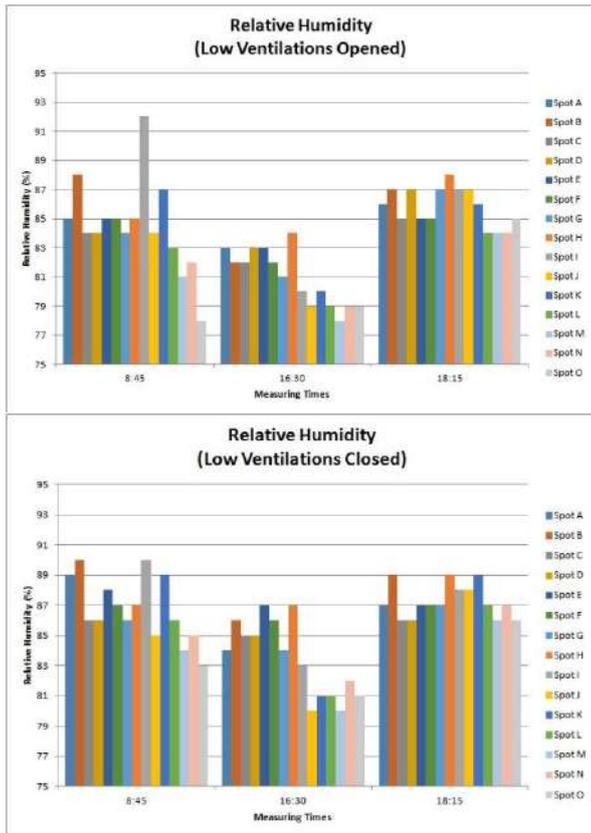
Fig. 15. Relative Humidity in Bogor Cathedral (Source: Sekatia 2018)

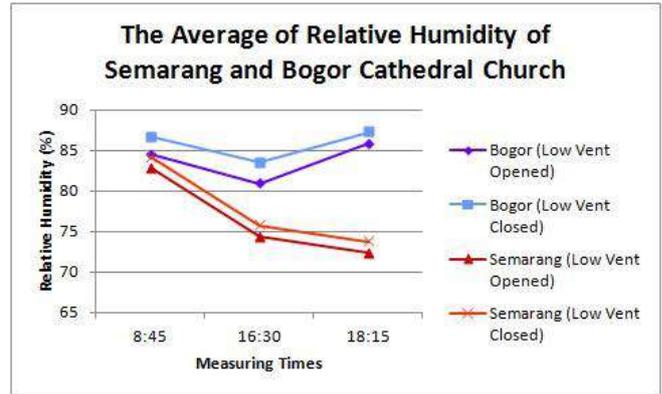
Figure 16 shows the average of RH of both cathedrals. Semarang Cathedral had lower RH than Semarang Cathedral. It was caused by the geographical location of both cathedrals. Semarang Cathedral is located at lowland, otherwise Bogor Cathedral is located at highland. The tendency was same. RH became lower when low ventilation was closed. The difference was the time when RH reached the lowest point. Semarang Cathedral reached the lowest RH at 18:15 and Bogor Cathedral at 16:30.

Fig. 16. Average of Relative Humidity between Semarang and Bogor Cathedrals

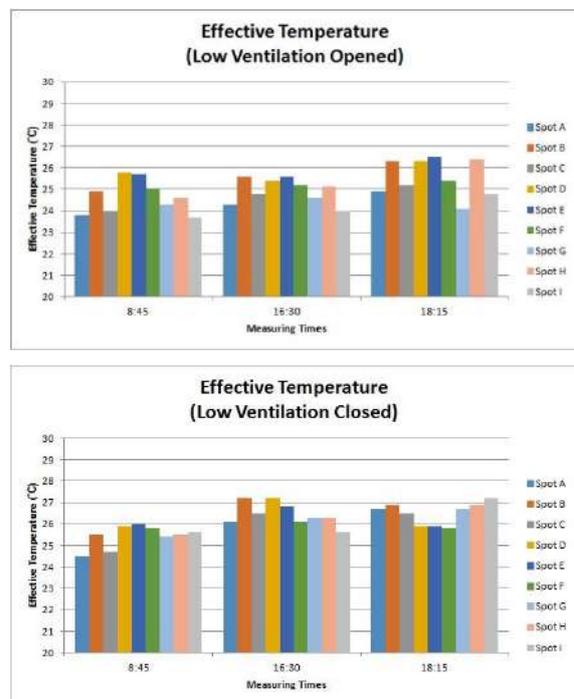
Temperature of not moving conditions (± 0.1 m/s) of saturated air is called effective temperature [13]. The comfort zone of ET is around 23°C - 27°C [6]. Figure 17 shows the effective temperature charts of Semarang Cathedral. It shows that ET at most of the spots in all measuring times and all conditions of low ventilations were included into comfortable zone. It shows that basically, Semarang Cathedral had a comfortable temperature. Shown at Figure 17, ET became the lowest when low ventilation was open. When the low ventilation was opened, the average of effective temperature was 0.8°C at 8:45, 1.5°C at 16:30, and 0.9°C at 18:15. A, C, G, and I spots located near low ventilations had lower effective temperature than the others.

Fig. 17. Effective Temperature in Semarang Cathedral

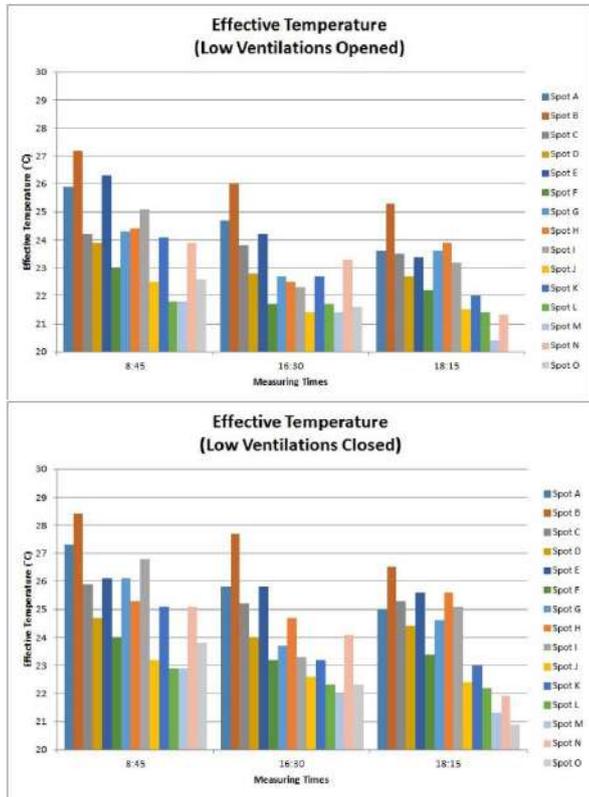
Figure 18 shows the effective temperature charts of Bogor Cathedral. In Bogor Cathedral, ET charts show various dynamics because there were some spots in each measuring time that had lowest temperature than comfort zone. It shows that basically, Bogor Cathedral church had comfort to cool effective temperature. Similar to Semarang

Cathedral, ET became lower when low ventilation was open. The lowest ET occurred at 18:15. It can be seen in figure 18 that 8 from 15 spots had lower ET than 23°C. Spots near the low ventilations (spots A, C, D, F, J, L, M, O) had lower ET from other spots.

Fig. 18. Effective Temperature in Bogor Cathedral (Source: Sekatia 2018)

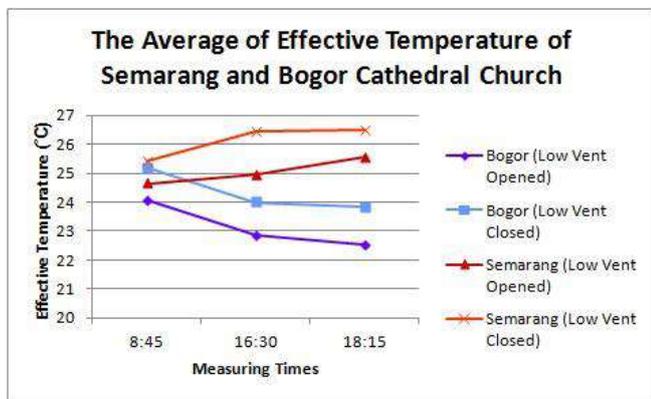
Figure 19 shows the average of effective temperature of both cathedrals. Both Semarang Cathedral and Bogor Cathedral had the same tendency that when low ventilation was open, effective temperature became lower and made thermal conditions achieve the comfort zone. The difference was at Semarang Cathedral the ET was increasing from 8:45 to 18:15 and achieved the highest ET at 18:15. But at Bogor Cathedral, ET was decreasing from 8:45 to 18:15 and achieved the lowest ET at 18:15.

Fig. 19. Average of Effective Temperature between Semarang and Bogor Cathedrals
