Macroseismic Manifestation of Seismic Events of Different Intensity on Territory of Vladikavkaz

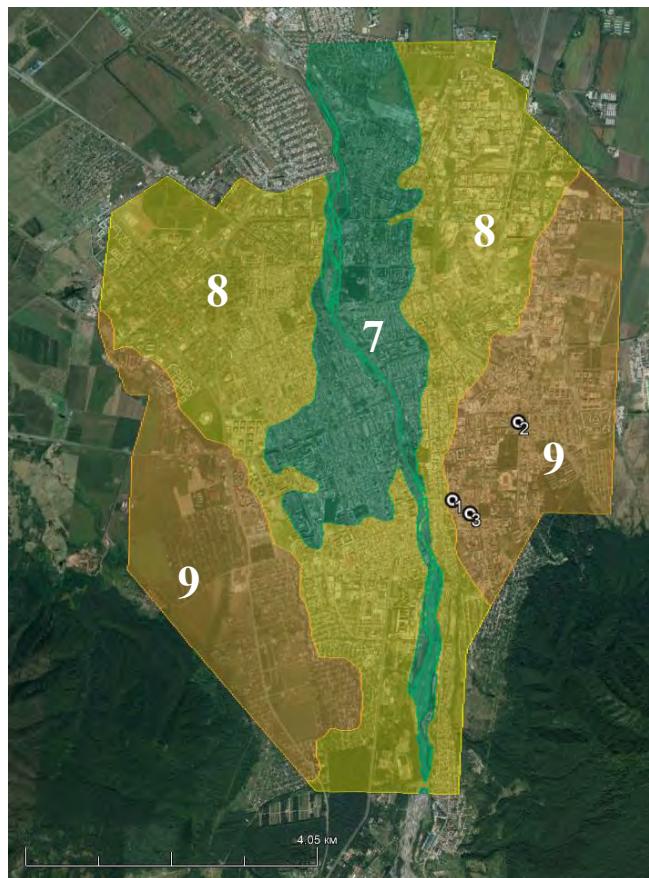
Fig. 1. Schematic map of seismic microzonation of Vladikavkaz, combined with the current building-up; the circles indicate the buildings in which damages caused by earthquakes of 1915 and 1929 were detected: 1 - the Ossetian church; 2 - North Ossetian State Medical Academy (NOSMA); 3 - private two-storey houses in the area of Pavlenko street

The analysis of the obtained data allowed us to construct a macroseismic schematic map, which was compared with the map of seismic microzonation (Fig. 1) [13, 20]. The map was made based on the results of 2009–2012, including the

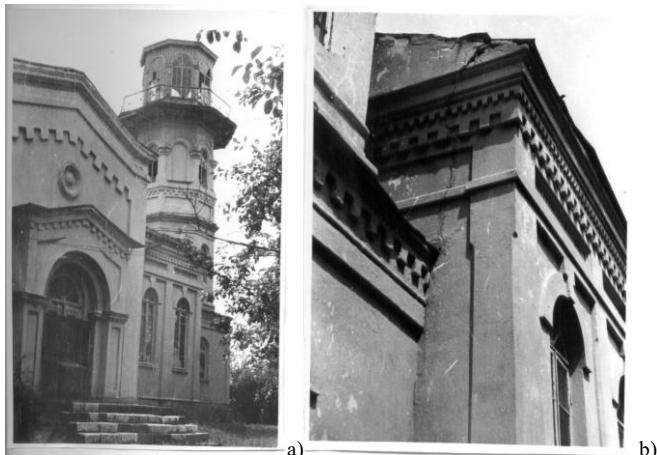
Fig. 2. The Ossetian church of 1803 and its buildings, examined in 1969

The building was constructed on a slope from the Khetagurov street at an altitude of 5-6 meters from the level of the pavement. The north side and the main architectural elements of the building are clearly seen in Fig. 2. The church has rubble stone foundations, the depth of which is about 5 meters. At the base of the structures, dry, highly compressible loams and clays (with a permissible standard pressure at a depth of 5 meters of about 2.5 kg/cm^2) underlie. There is no groundwater at the site in the zone of active influence of the foundations.

With the help of investigation and public enquiry (Khabetsov Radzhi, Ilyin and others) it was found out that the church was damaged as a result of the earthquake of 1929 with an intensity of 6–7 points. As for its state in 1969, the building had continuously inclined through cracks inside the building in the width in the arches and diagonal cracks in the dome from the outside, in the walls at the junction of longitudinal and transverse walls that are developed from above and do not reach the foundation. The latter indicates that the cracks were of seismic nature (Fig. 2 b). In some places due to the uneven foundation settlement, some cracks appeared and were developing “at present” (1970). This became evident from the fact that after a thorough overhaul carried out in 1960 the cracks appeared again in the same place.

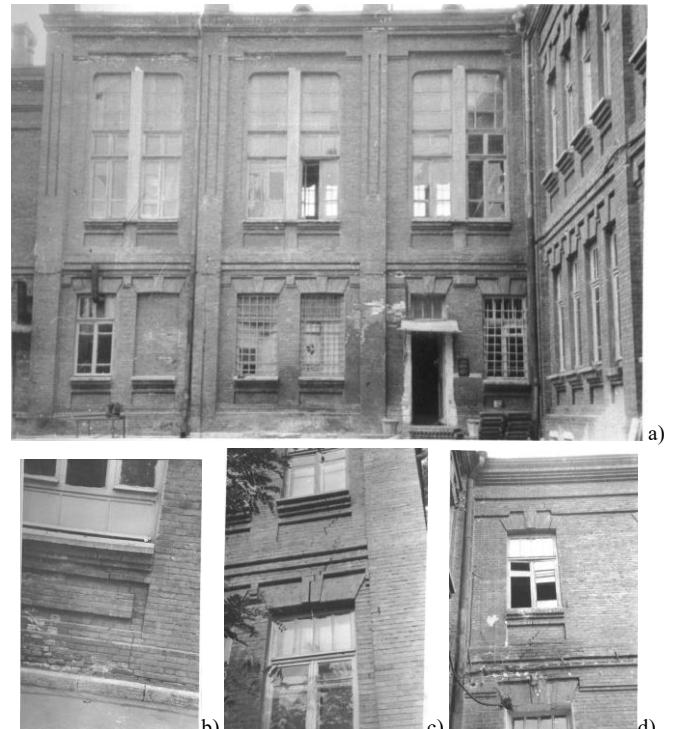
North Ossetian State Medical Academy (NOSMA) is located in the southeastern part of the town along Pushkin Street. The complex of the NOSMA, built in 1902–1910, consists of one-story and two-story brick buildings. Figure 3a shows the two-storey part of the academic building, which is U-shaped in the plan. Next to this building, there is a single-storey laboratory building, to which a two-storied administrative and educational building adjoins. On the north side of these buildings, one and two-story educational and laboratory buildings are located. The floor height of the building is 4–5 m. The walls are built of common burnt brick with a lime mortar. The intermediate floor is wooden and the roof is light made of roofing iron. Depending on an organization of the basement the depth of the foundations is at different levels. Foundation soils are clays of a plastic-hard consistency with a thickness of up to 13 meters. Groundwater is located at a depth exceeding 10 meters under the surface.

Fig. 3. The building of the NOSMA, examined in 1969

It was established with the help of a detailed investigation and public enquiry that after the earthquake of 1929 these buildings had significant damage in the form of cracks in the plaster and walls with chopped off pieces of plaster. Buildings had continuous through cracks of 0.5–2 cm. These cracks can be divided into 2 groups according to their origin. The first group includes cracks caused by uneven settlement of the foundations, due to the local moistening of the soils of basement with atmospheric precipitation (Fig. 3, b-d). The second group includes cracks caused by seismic vibrations of the earthquake of 1929. These cracks are found in almost all the main walls, mainly in the separation walls and in the flat arches. They run from top to bottom along an inclined platform and do not reach the foundations of building, which indicates their seismic origin. According to the seismic scale, the mentioned buildings belong to group B, and according to the degree of damage they are referred to the group “significant damage”.

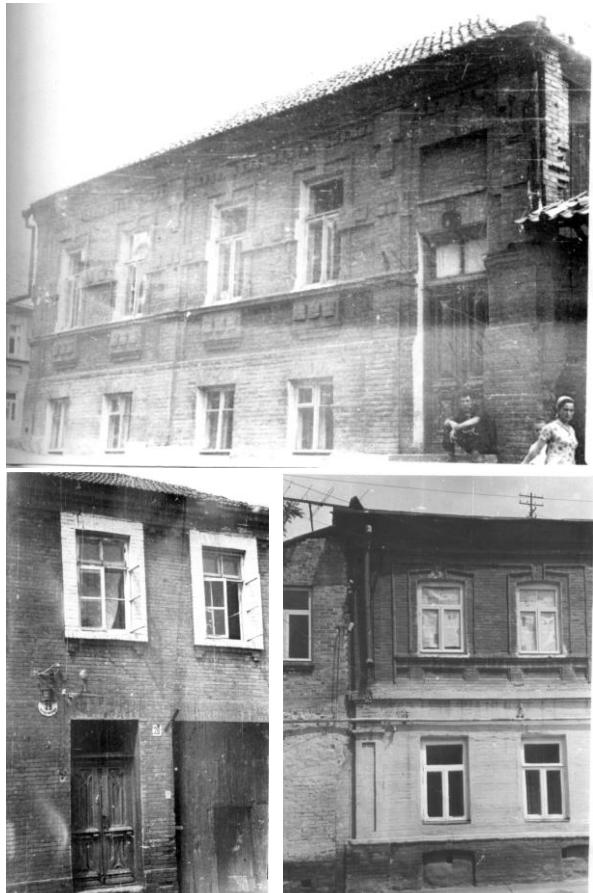
In the southeastern part of the town, thanks to enquiry of local old residents (Abaev Kabibulats Ubilisi, 75 y.o., Kundukhov Vano Vasilyevich, 80 y.o.), who remembered the 1929 earthquake well, one-storey and two-storey typical buildings were examined in K. Khetagurov Str., Tsagolov Str. and Pavlenko Str. The two-storey buildings of the old construction are shown in Fig. 4.

All of them have a symmetrical shape in the plan. Light overlappings and coverings are wooden; the roofs are made of flat tiles. The height of the floors is 3.5–4 meters. The depth of the foundation is between 0.8 and 1.5 meters. All load-bearing walls are made of burnt bricks 50 cm thick on a lime mortar. One of the characteristic features of these buildings is that the roofs made of flat tiles have large slopes and, in the absence of

wooden struts between the rafters, in the case of horizontal vibrations of an earthquake, large horizontal forces are transmitted to the longitudinal walls of the buildings, resulting in cracks and failure in the junction of transverse and longitudinal walls. The above-mentioned buildings have solid inclined cracks of seismic character with a width of 0.5-1.0 cm in "inclined" lintel blocks.

Fig. 4. Typical accommodation buildings common in the southeastern part of the town

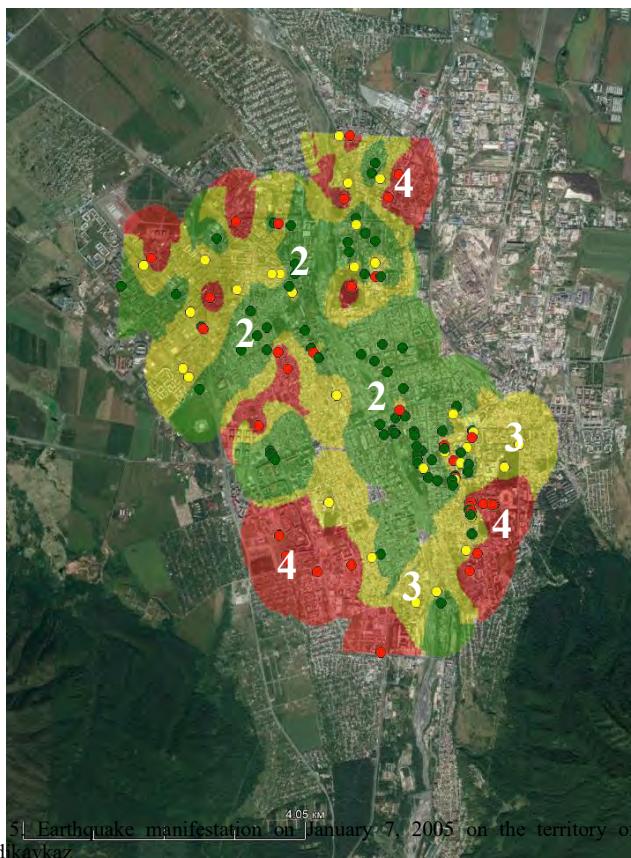
Fig. 5 | Earthquake manifestation on January 7, 2005 on the territory of Vladikavkaz
