Disaster Mitigation Plan Based Flood Event Occurred on January 30th, 2021 in Kuta-Mandalika, Lombok, Indonesia

Atas Pracoyo, Ery Setiawan^(✉), Muh. Bagus Budianto, and Eko Pradjoko

Department of Civil Engineering, University of Mataram, Mataram, Indonesia
ery.setiawan@unram.ac.id

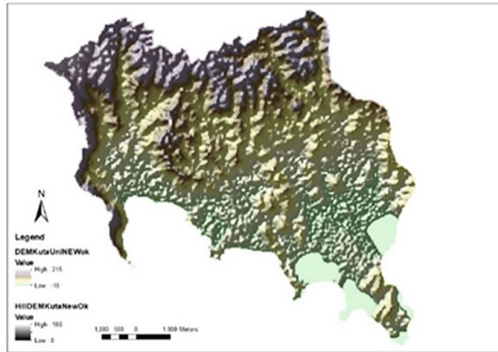
Fig. 1. DEM Kuta-Mandalika Basin, Lombok.

In Fig. 1 show high drainage network density, characterized by a large number of branches in the flow area, more quickly to the inlet, so that flood is getting higher [1].

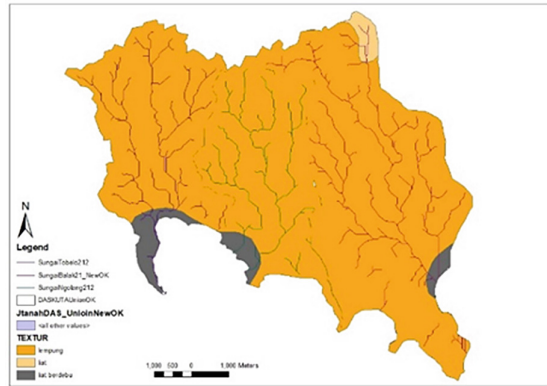
Fig. 4. Map of soil texture in study location (source: KLH-NTB, 2008).

Soil texture and classification in this study are based on soil class and texture maps from Department of Forestry and Environmental, NTB Province (2008). In this study location, soil class represents combination of mediterranean to regusol with clay soil textures in the upstream to middle stream, unless in part of downstream are alluvial (Fig. 4).

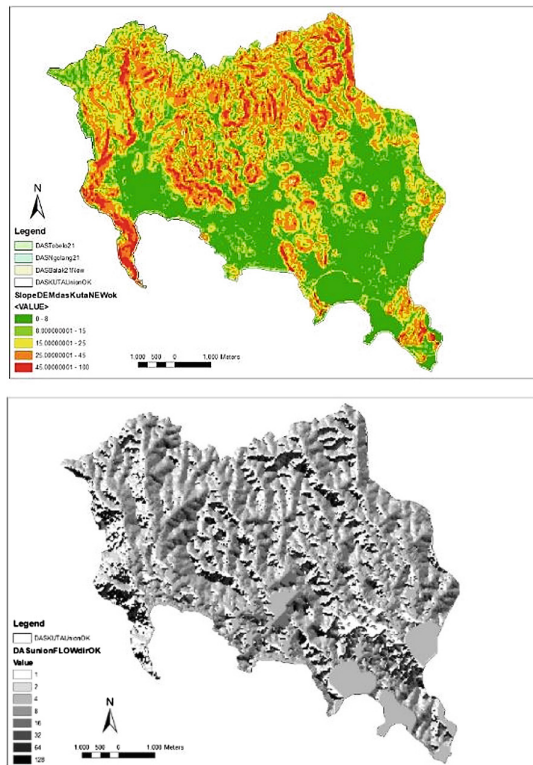
Fig. 5. Hillslope and flow direction Map in study location.

One of factor affecting flood is landsystem. In this research, landsystems consist are hillslope and flow direction in this study that can generate from the DEM's data with SRTM type and 1-arcsecond resolution (Fig. 5).
