Current Condition in Lowland Irrigation Area Tahai: Challenges and Solutions

Zachlul Zelvi¹ Istiarto^{2,*} Lestari Rahayu Waluyati³

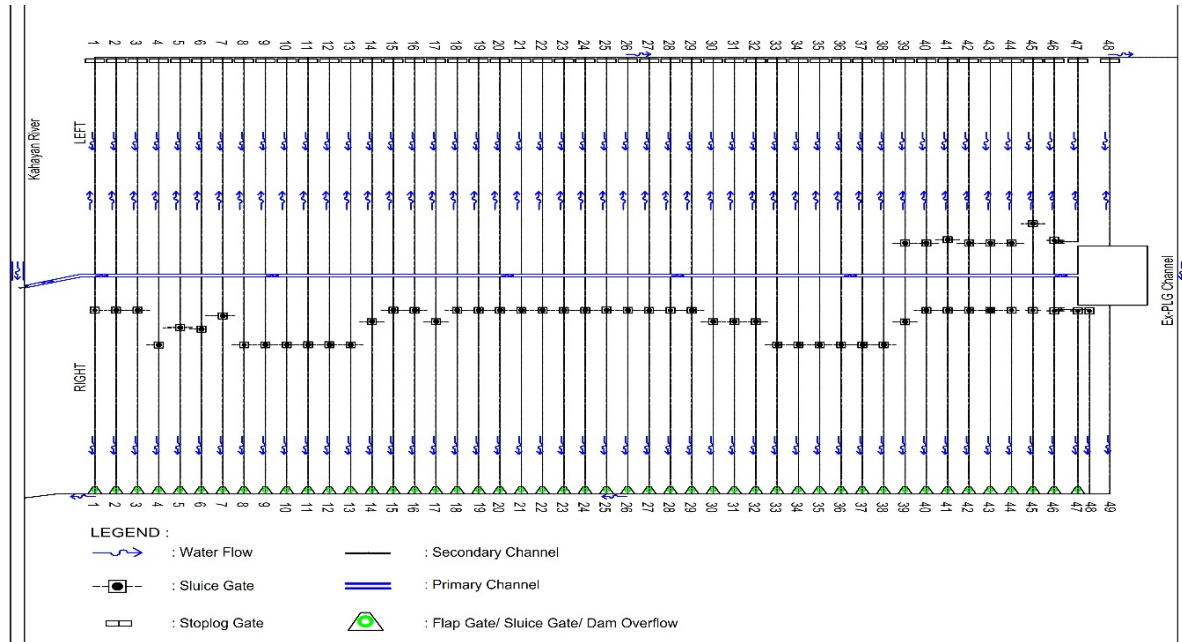
Figure 4 Schematic development plan of DIR (*Daerah Irigasi Rawa*) Tahai.

Currently, normalization still needs to be continued, especially for secondary and collector channels. This approach is essential to restore the channel's ability to drain water. After the normalization of the primary channel, the problem of low water quality remains unresolved. During the two-way flow system, the problem of water acidity will still occur. A one-way water system is recommended to avoid retaining of acid water at the end of the channel [12].

The change of water system to one direction needs to be simulated to find out the effective scenario to be implemented. Suggestion obtained from the farmer can be part of the development plan. The suggestion is to make the right collector channel connected to the river. The goal is that the water does not flow back into the primary channel but is directly discharged into the river. The distance from the right collector channel to the river is about 600 meters (see figure 4).

The arrangement of the gates is important in solving the challenges of water flow from oil palm plantations which goes through the left collector channel. As stated previously, the left collectors are not recommended to go to the river. The stoplog gate is the right type to block the flow of water from the plantation into the left collector channel. By placing this gate at the end of the left secondary channel and setting the log at a certain elevation, the water from the left collector channel is cut off and does not enter the secondary channel. The left collector channel is connected to the south's ex-PLG (Peatland Project) channel. The water in the left collection channel goes to the ex-PLG channel (see figure 4).

channels 39 to 46. The position of these gates are closer to the primary channel (see Figure 4). The deposition of floating sediment becomes less when using a sluice gate. Unlike the stoplog, this gate must be opened from the top, while the sluice gate is opened from the bottom of the channel using a turning steering wheel. Flushing can be done if there is deposition in front of the gate.
