Strategy for Facade Restoration in Case of Craiova's City Hall Building

Andreea Gabriela Trif¹ (✉) and Cristian Oliviu Burada²

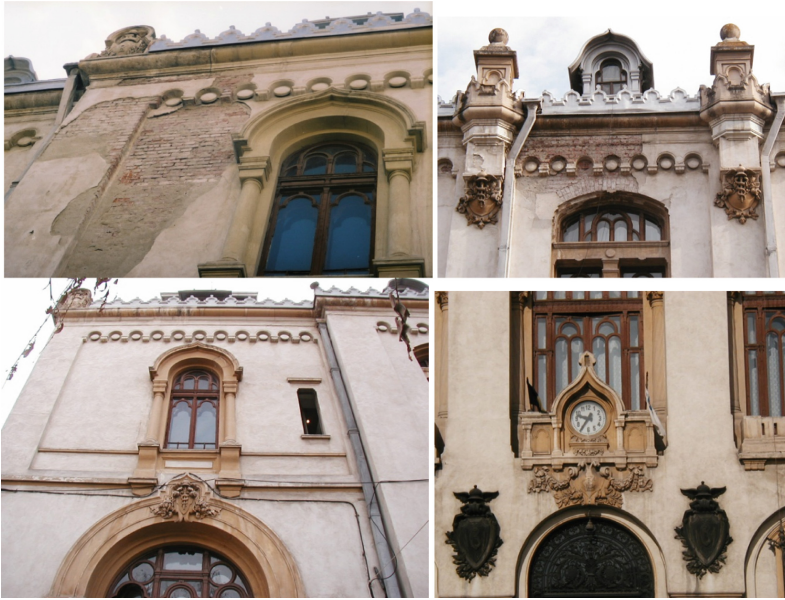
The central area of the western face is marked due to the vertical elements that mimic the window's forms of the upper register. These elements rise above the cornice with the help of consoles treated like the turrets on the main façade. These elements are greatly simplified compared to those of the main façade. The windows of the upper register have no frames and are grouped two by two. Engaged columns with twisted spindles mark the separation between two windows (Fig. 4).

Fig. 4. Facade details of Craiova's city hall personal archive of Getrix S.A., Craiova
