Analysis and Treatment of Cracks in the Francis Turbine Runner of a Hydropower Station

Datang Yunnan Power Generation Co., Ltd., Kunming, Yunnan, 650103, China

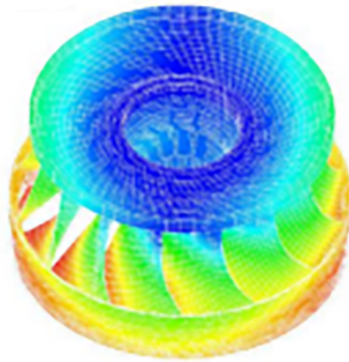
Fig. 11. Finite element meshing of runner dynamic characteristics

Resonance Analysis. I-DEAS (Integrated Design, Engineering and Analysis Software) leverages advanced numerical methods and efficient algorithms to swiftly tackle intricate computational tasks, significantly enhancing design efficiency. During the computation process, the software adeptly handles various complex boundary conditions and material properties, ensuring the accuracy of the results and providing a solid foundation for the design of hydraulic turbine runners. Using I-DEAS software, a complete impeller is selected as the analysis model (Figure 11), and the Block Lanczos method is used to analyze the natural frequency of the impeller(Figure 12). The calculation results are shown in the following table 2. From the calculation results, it can be seen

Table 2. Self frequency analysis

Natural frequency of the rotor	Frequency in air (Hz)	Frequency in water (Hz)	The product of the rotation frequency and the number of guide vanes
Torsional Vibration	40.9	35.58	57.16
Swing (pitch diameter = 1)	52.12	41.7	
Swing (pitch diameter = 2)	60.13	42.09	
Swing (pitch diameter = 3)	97.55	69.26
