# Safety Assessment of Road Railing on UB–Nalaikh Road

Dashdavaa Tuvshintur<sup>1</sup>, Sungchil Lee<sup>2\*</sup>, Odbileg Norovrinchen<sup>2</sup>

**Abstract.** Road traffic accidents along the Nalaikh–Ulaanbaatar road have raised serious concerns regarding the adequacy of existing safety measures, particularly the effectiveness of safety railings. This research investigates the structural integrity and performance of these railings with the aim of enhancing road safety and reducing accident severity. The study employs a mixed-methods approach, including on-site assessments, consultations with local authorities and road safety experts, and an in-depth review of international safety railing standards. The evaluation reveals that while the current railings comply with certain Mongolian national standards, they fall short in effectively mitigating accident impacts due to shortcomings in design, material durability, and maintenance practices. Based on these findings, the study proposes a series of improvements, drawing on advanced international design standards and advocating for stricter maintenance protocols. These recommendations aim to improve the railings’ ability to prevent

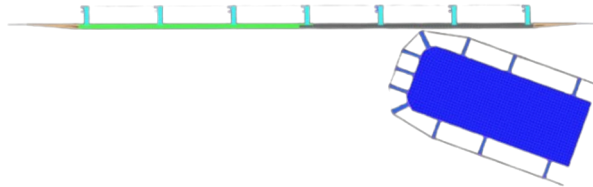
**Fig. 4.** The base model for simulation.

Figure 4 describes the impact simulation before colliding. The simulations modeled typical impact scenarios involving different speeds. Key parameters such as vehicle mass, impact velocity, and collision angle were defined to reflect the diverse range of accidents historically recorded on the Nalaikh-Ulaanbaatar road. In addition, environmental conditions—including road surface wetness and temperature variations—were incorporated to evaluate their influence on the performance of the safety railings.

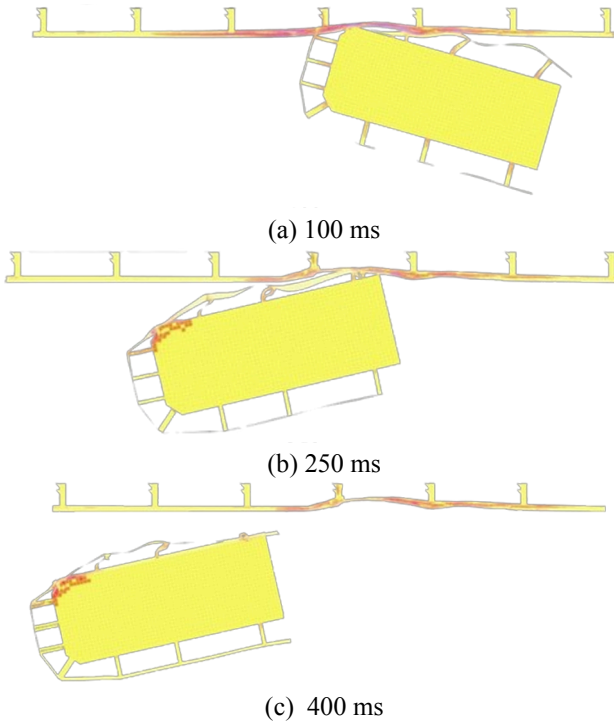
**Fig. 5.** Simulation results: velocity of 80km/hr (22.23 m/s)

Figure 5 shows the simulation results with the car speed of 80 km/hr. The deformed shape of the safety railing after impact by the two different car speed of 80 km/hr and 100 km/hr are shown in Fig. 6. First case simulation results can be observed the behavior of the guardrail and impactor at 80 km/h initial velocity of the impactor, at three-time phases of 100 milliseconds, 250 milliseconds, and 400 milliseconds. The maximum value of the von Misses stress is 612.3 MPa. The kinetic energy curve begins at an initial value of 370,726 joules and remains constant for the first 5.5 milliseconds, corresponding to the moment before the impactor contacts the guardrail. Following this point, the kinetic energy steadily decreases until approximately 145 milliseconds, during which the impactor and the W-beam undergo deformation due to the collision. After 145 milliseconds, the kinetic energy curve exhibits a gradual decline, reaching 119,054 joules at 307 milliseconds. The crash simulation concludes at 400 milliseconds, by which time the safety barrier successfully deflects the impactor back toward the roadside.

Simulation results indicate that the existing guardrail design provides sufficient resistance under standard impact conditions. However, during high-speed collisions, the railings often fail to prevent vehicle override or penetration. Simulations incorporating enhanced material properties demonstrated notable improvements in performance, effectively reducing the risk of severe accidents.

The implications of this work are far-reaching for road safety management in Mongolia. Key recommendations include the adoption of more durable materials suited to local environmental conditions, the implementation of systematic maintenance protocols, and the exploration of sensor technologies for real-time condition monitoring. Additionally, targeted educational campaigns and policy reforms mandating certified construction standards could further enhance road safety. By implementing these strategies, Mongolia has the opportunity to modernize its safety infrastructure, reduce traffic-related injuries and fatalities, and align with international best practices. Although the majority of simulation results were consistent with theoretical predictions and empirical data, certain deviations—particularly in high-angle impact scenarios—suggest that further refinement of current modeling approaches is necessary to fully capture the complexity of real-world crash dynamics.
