## Effects of Laser Cladding on Thermal Tensile Property and Fracture of Gas Turbine Engine Blade Material GH864

**Keywords:** Laser cladding, Gas turbine engine, Reheat crack, Blade, GH864 superalloy

**Abstract.** The consecutive layer of a nickel alloy was deposited onto a GH864 nickel-based superalloy gas turbine engine blade using laser cladding. To ensure the performance of blade, the gas turbine with laser cladding repaired blades worked two weeks and a detailed measurement and investigation were performed on chemical composition, mechanical performance, microstructure, macro-fractography and micro-fractography. The results indicate that the cracks at the inlet edge part of blade were caused by reheat crack. An inappropriate technology of laser cladding can result in the formation of incomplete fusion interface between the laser clad coating and substrate, or reheat cracking along the coarse grain boundary in the heat treatment zone. Tensile specimens were tested at both room temperature and elevated temperature. The results correlate to the conclusion that the reheat crack is the main reason for the performance degradation of the restored blade.

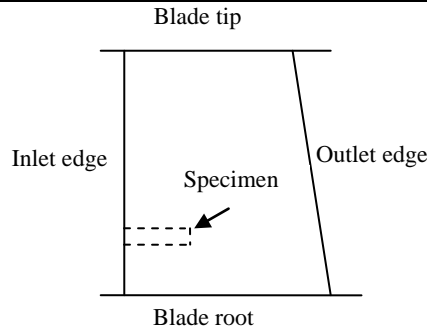
Fig. 1. The sketch of turbine blade.

Specimens for microstructure observation are machined from restored gas turbine engine blade with laser cladding repaired blades. The samples are cut from the vicinities of blade basin of turbine blades at inlet edge, as shown in Fig.1.

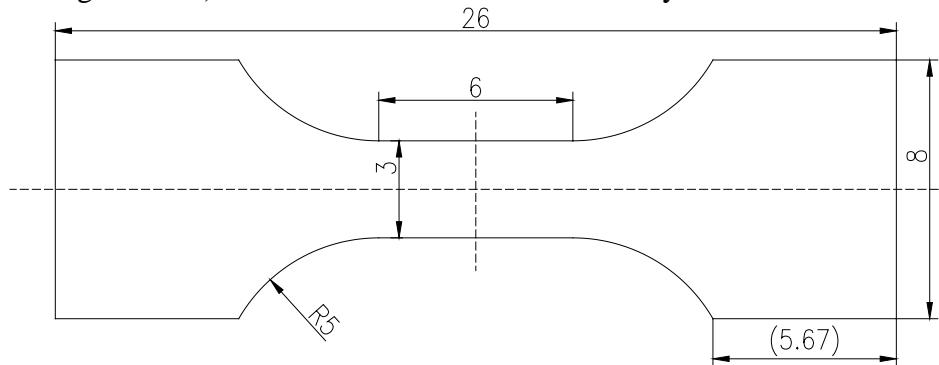
Fig. 2. The sketch of tensile test sample.

Tensile tests are carried out using MTS880 100kN hydraulic servo materials testing machine at both room temperature and elevated temperature, with a constant strain rate of  $0.5\text{mm/min}$ . The heating process of elevated temperature tests is conducted by chamber electronic furnace installed with the testing machine. Tensile sample is designed as Fig.2. Tensile samples are divided into two types, one type is blade material GH864 and another type is GH864 restored by laser cladding (The thickness of coating is  $1\text{mm}$ ). Fracture surfaces are examined by SEM.

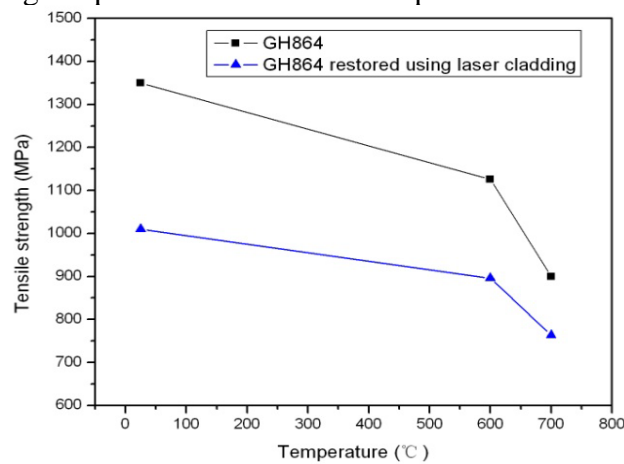
Fig. 7. Tensile test results of GH864 alloys.

Tensile tests of GH864 alloys were carried out at both room temperature and elevated temperature. The results are shown in Fig.7. Tensile strengths of GH864 and GH864 restored using laser cladding with 1mm laser clad coating are prone to reduce with temperature increasing.
