Emergency Repair of Xushui River Bridge in the Expressway around Zhengzhou

Abstract—An safety accident of Xushui River bridge in the southwest expressway around Zhengzhou city occurred in July 2014. Due to the accumulation of building waste materials near the bridge, one of pier columns was broken up by accidental horizontal load. Key technology for emergency repair construction of the bridge was concerned in this paper. Firstly, the repair plan and difficulty was carried out. Then the main construction steps were described in detail. In the end, main characteristics of the emergency project were summarized based on the whole repair process.

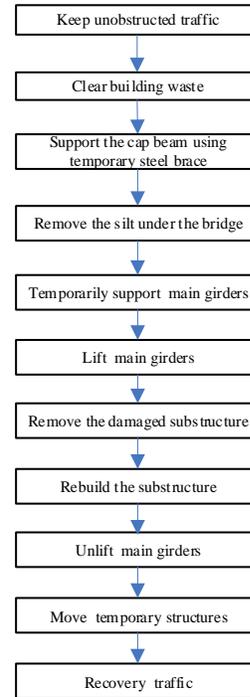
Figure 4. Flowchart for emergency repair

As shown in Fig.4, the main process of the repair construction plan can be described as: (a) clear the building waste; (b) stable the damaged pier column and cap beam using temporary support; (c) remove the silt under the bridge; (d) temporarily support the superstructure; (e) remove the damaged substructure and rebuild the substructure; (f) clear all temporary structures and finish the repair construction.

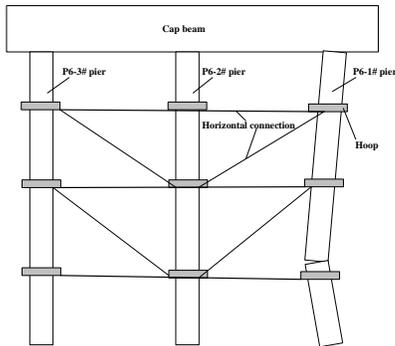
Figure 10. Schematic diagram of horizontal connection for column

In the construction of the pier columns, a hoop bracing plan was considered. As indicated in Fig. 10, three hoops were installed in every column, and these hoops were connected with each other using lateral and inclined steel braces.

In the process of removing damaged columns from top to bottom, the corresponding hoops were also one by one moved out until the removal construction was completed. Fig. 11 shows the site photo of removal of the columns.
