# Analysis and Prevention of Tubeburst in Rear Platen Superheater of Boiler

**Keywords:** Boiler; Water blocking; Rear platen superheater

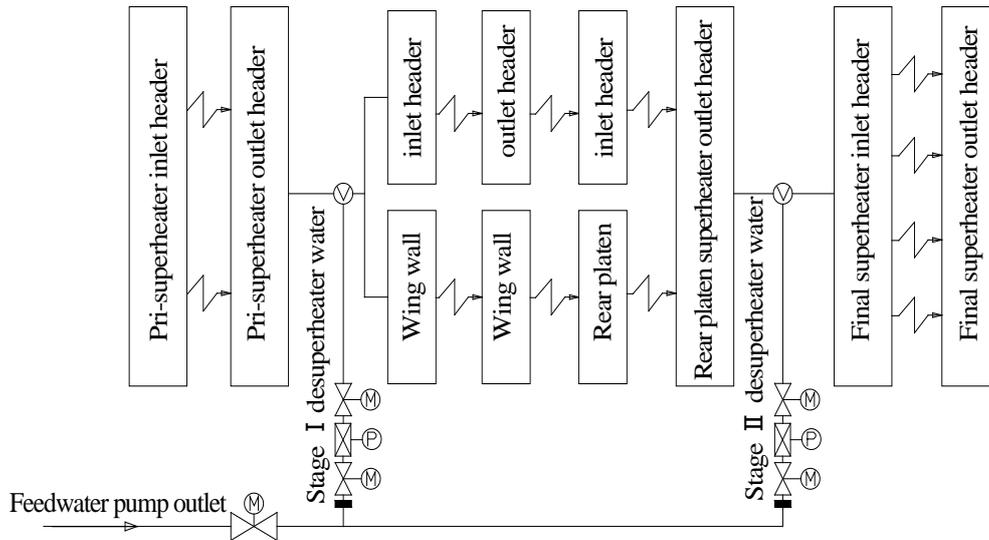
Fig. 1 Part of the main steam system diagram

The superheater system consists of five grades, namely, the top and the steam-coated tube, the low-temperature superheater (the primary desuperheater), the divided platen, the rear panel, the secondary desuperheater, the final superheater, as shown in Figure 1. The rear panel superheater is arranged behind the divided platen with a total of 20 pieces. Each piece is composed of 14 parallel tubes, as shown in Figure 2. The outer diameter of the outermost heating tube is 60 mm. The outer diameter of other inner tubes is 54 mm and the transverse pitch is 684 mm. The bottoms of the outermost three circles and the innermost wound tube use the stainless steel, and the rest uses 12Cr1MoV, SA213-T91, 15CrMo alloy steel.

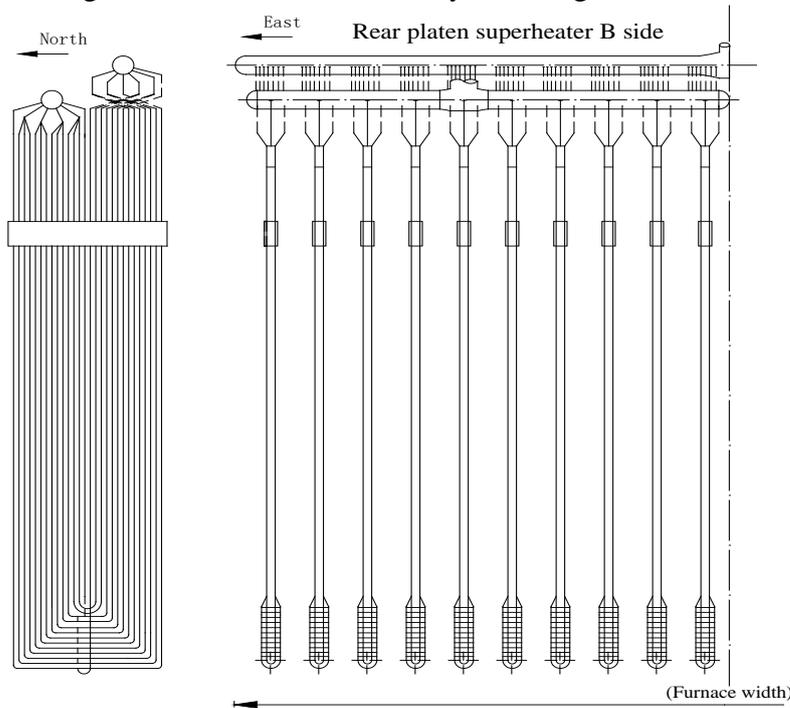
Fig. 2 Layout diagram of the rear panel superheater's single side and B-side tube panel

No oxide skin or other foreign matter was found after the further inspection of the rear panel tube. There was a lot of liquid water in the tube when the damaged tube was cut. The specific situation was as shown in Table 1, Table 2 (the water height in the tube is its distance from the elbow). The layout of the B-side rear panel superheater was shown in Figure 2. The heating tubes were named from north to south as the first, the second, .... The No. 1 elbows in the north of No. 41, 42, 43 rows in the east of the final superheater were found to have no water stored, and the wall thickness was normal.

From Table 1 and Table 2, it can be known that there was more water in the Panel 4 (East 1-4) near the explosion mouth, with the highest being nearly 2.0m. There was a small amount of water in the holding tube in the west side and there was no water in the elbow. Under normal circumstances, when the unit was shut down, there will be some condensed water in the platen superheater, but it is abnormal that there is such a large amount of condensed water. It can be seen from Figure 1 that, the rear panel superheater is not directly connected with the primary desuperheating water, so the primary desuperheating water cannot reach the rear panel by going across the platen superheater. The secondary desuperheating water can only be leaked to the final superheater. So the possibility that the leakage of the desuperheating water causes the accumulated water can be excluded.

Through the several water plug tube explosions in this plant, it can be known that it is necessary to open the atmospheric relief valve and the drain valve of the superheater during the starting and stopping of the boiler in time. Drain the condensed water in the superheater so as to avoid the water plug tube explosions. In addition, the leakage of the desuperheating water is also an important cause to the water plug tube explosion of the superheater. When the superheater behind the desuperheating water valve explodes due to the water plug, it's essential to check whether the desuperheating water control valve is tight or not first.
