Comprehensive Detection Technology In The Application Of Transformer Insulation Diagnosis

The power generation company has the 500 kV main transformer that is single-phase and rated capacity is 210 MVA, with which two high-voltage and low-voltage windings, high rated voltage is 530 kV and low voltage is 20 kV. The transformer was put into operation successfully in November 1991 .

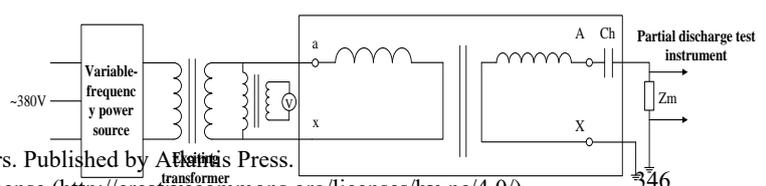
Figure1: Transformer partial discharge test connection

which couldn't find abnormalities. Transformer partial discharge test connection^[7] was shown in Figure 1 .
