Analysis on A Case of Marine Hydraulic Steering Gear Failure

Abstract: The hydraulic steering gear is an important equipment of the ship and its failure could contribute to navigation unsafely. With regard to the failure of a certain hydraulic steering gear and inspection of the steering mechanism, this article specifies reasons for the failure of the steering gear and puts forward methods including control to the design, selection and manufacture and enhancement to the watch-keeping and ship-repairing so that the similar accidents could be avoided. In this case, the analysis and treatment to the failure of the marine hydraulic steering gear could result in the prevention and elimination to the failure.

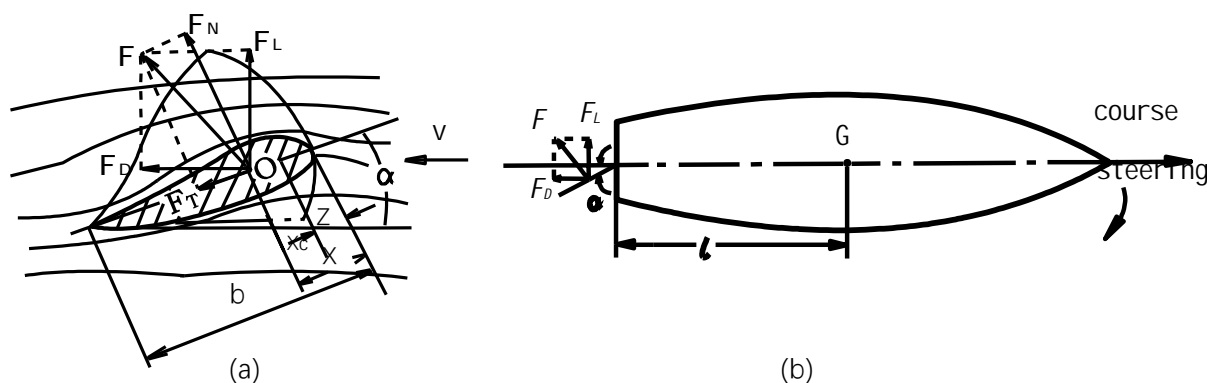
Fig 5 Water Force to the Rudder & Effect on the Ship

As shown in Fig.5, when the rudder blade diverted to a certain rudder angle α , the resultant force of the water pressure acted on the rudder blade is expressed by F_N , and the friction F_T which is consistent with the rudder blade center line occurred between the water stream and the rudder blade. The total force of the water is F which is the resultant force between F_N and F_T . The water force F can also be decomposed into a lift F_L which is perpendicular to the direction of the water flow and a resistance F_D which is parallel to the direction of the water flow.
