## Research on the Fire Evidence Identification Method of Electric Water Heater

**Abstract.** With the presentation of a fire accident caused by the improper use of electric water heater, this paper introduces how to use the metallographic method to judge the state of the electric water heater before the fire broke out. This method is simple, reliable and efficient, which can not only help fire investigators improve the accuracy of the fire cause identification, but also provide the necessary help and support.

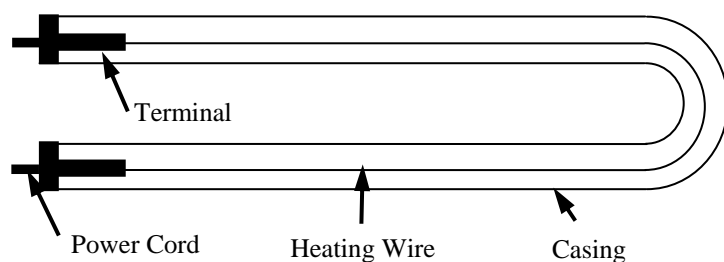
Figure 1. Basic structure of electric water heater

Electric water heater is a kind of immersing liquid heater, mainly consisted of casing, heating wire, terminal and power cord, shown in Figure 1. The casing is usually 6 ~ 8mm thick stainless steel pipe or copper with spiral heating wire inside, and filled with insulation materials such as quartz sand or magnesium oxide powder, the pipe terminal is sealed with silicone or epoxy, as shown in Figure 2. Electric water heater is made by the heating wire fever principle, and the heating process is actually converting electrical energy into heat energy, i.e., after the heating wire convert electrical energy into
