Failure Analysis and Detection Technology Research of Hub Bolts of Aircraft Main Wheel

Abstract—The hub bolt of the main wheel of a large civil aircraft is an important bearing part in the take-off and landing process of the aircraft. The bolt will be detected by fluorescence or magnetic powder in each tire disassembly process. It is found in the application that even if some bolts pass the magnetic particle detection, they will still break in the process of use. Bolt breakage not only increases the probability of tire damage, but also seriously endangers flight safety. In order to find out the cause of bolt fracture and put forward the corresponding solutions. In this paper, damage bolts are taken for failure analysis, and it is found that most of the fracture positions of threads are located at the root of the fourth thread. According to the characteristics of the fracture, traditional ultrasonic method was used to carry out in-service detection research. The results showed that the shear wave probe with a frequency of K2.2 and 2M could detect 1mm deep cracks at the end of the thread. This method is simple to operate, does not need to dismantle the bolt, can respect the spot con

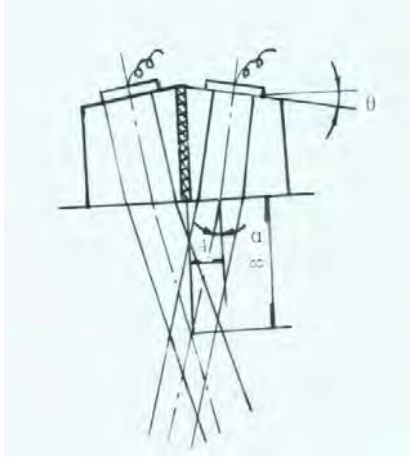
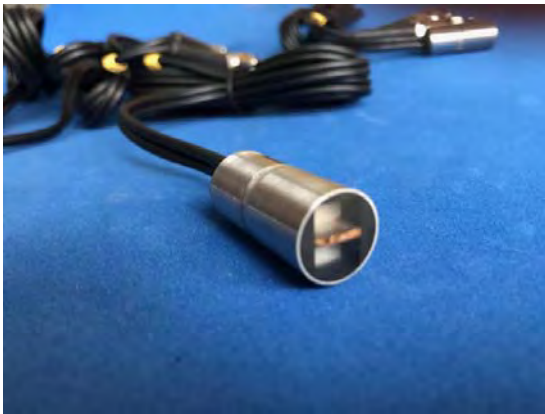
FIGURE IV. SCHEMATIC DIAGRAM OF TWIN - CRYSTAL PROBE AND TWIN - CRYSTAL PROBE

for amplification, the blocking phenomenon is overcome and the blind area of flaw detection is greatly reduced, which is very beneficial to the detection of near-surface defects. In addition, two piezoelectric wafers form a rhomboid region, as shown in Figure IV.

The probe is shown in Figure IV. The reflection signal in the rhombus region is strong, which solves the flaw detection problem in the near region. In the actual flaw detection, the appropriate inclination Angle B should be selected according to the thickness of the workpiece under inspection, so that the focus of the two piezoelectric wafers falls on the part where the defect of the workpiece under inspection is prone to occur. The smaller the Angle B is, the deeper the focus distance from the detection surface and the longer the rhombus region will be. The larger Angle B is, the shallower the focal distance from the detection surface and the shorter the rhomboid region is, which is conducive to the detection of thinner workpieces. This kind of bolt is often broken 21 to 23mm away from the upper surface, that is, the nut and the workpiece joint, here is the maximum bearing part of the bolt, generally for the entire bolt bearing 60-70%, but also the maximum stress area. When we develop the probe, we put the focus of the probe at 20 + or + 3mm, which is the optimal value, so that the defect can be

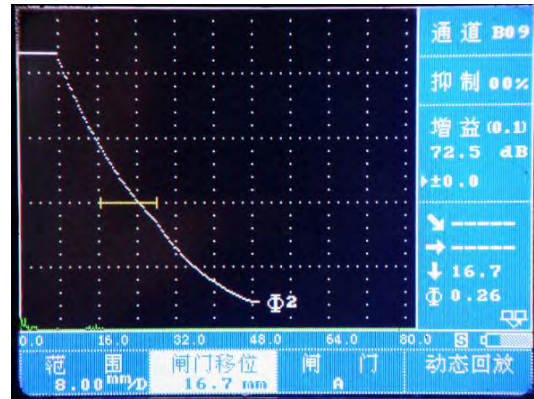
FIGURE V. DAC (DISTANCE AMPLITUDE CURVE) FOR TEST

Good will probe to connect to the instrument is used after 80, 60 mm two steps to adjust the scanning speed, find $\Phi 2$ flat bottom hole, respectively, on the flat surface to a depth of 10, 30, 50 mm $\Phi 2$ flat bottom hole at the reflection of equivalent draw distance amplitude curve as shown in Figure IV can be tested. Figure V shows the cutting of 1mm groove waveform at 22mm of the actual bolt.
