# Electrostatic Precipitator Failure Analysis Using FMEA Method on Steam Turbine Electricity Generation (PLTU Banten 2 - Indonesia)

**Abstract**—In electric power generation, reliability of each equipments is important in order produce optimal electrical energy. Unreliable units will influence to other cost due to an expensive production losses. So, it is very important to know the reliability on each system. In this case study, an Electro Static Precipitator (ESP) failure analysis was performed using the Failure Mode and Effect Analysis (FMEA) method and found the potential causes issue was came from the Output Voltage Lack ESP # 1 alarm. The Risk Priority Number (RPN) is obtained from identifying the potential causes of failures that occur on the machine / equipment and then for corrective action, we use the 5W + 1H analysis method. Based on FMEA analysis and cause and effect diagrams, the potential failure factor for alarm Output Voltage Lack ESP # 1 is an abnormal ash transporting factor with the value up to 57% or an RPN value is 648. After improvement to be implemented, the results of corrective action can be described as follow as: Before improvement the ESP # 1 damage caus

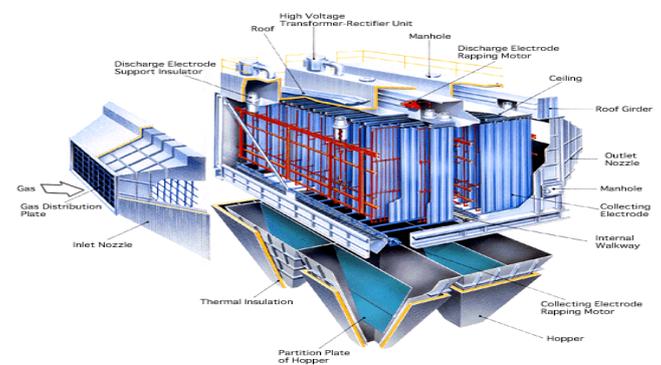
Fig. 1. The Electrostatic Precipitator (ESP)

All parts of the machine are required to operate continuously in order supply of electrical energy is not interrupted. Boilers consist of various systems function as like as: fuel supply systems, water supply systems, combustion air systems and exhaust gas systems. Included in the flue gas control system, the Electrostatic Precipitator (ESP) is a boiler exhaust air filter that is mostly used, and part is also required to be operated properly for 24 hours per day without interruption. Please find the ESP on Figure-1 below :

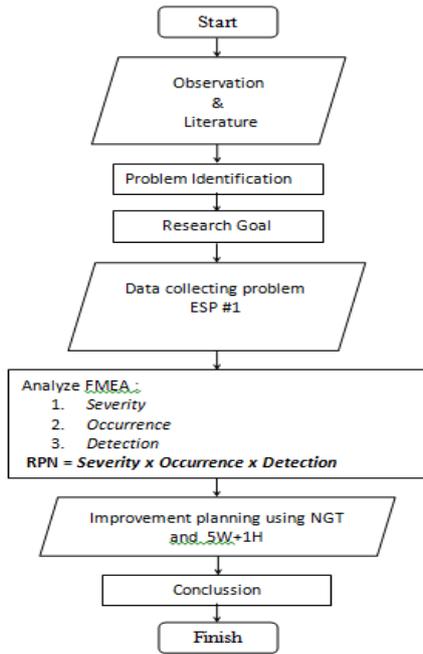
Fig.1. The research flowchart

This analytic description research uses the Failure Method Effect Analysis (FMEA) method, which is a method of failure analysis of machine work functions. From the failures data obtained, it is calculated the value of  $RPN = Severity \times Occurrence \times Detection$ , where *Severity* is a warning of the seriousness of the risk of failure to function the machine, *Occurrence* is the frequency of malfunctioning events and *Detection* is the extent to which the failure is initiated or equipped with a detection or warning function before the event. In addition to the RPN number, another analysis tool used is the NGT which is an analysis based on judgmental the ESP from experts involved and then for the proposed improvement using 5W + 1H method. The research flowchart can be described as shown below:

The research flowchart can be described as shown below:
