Analysis and Research on Icing of OPGW Optical Cable

Abstract. This paper analyzes the influence scope, emergency disposal, fault causes and risk characteristics of Jilin snow disaster, and discusses the means of emergency disposal. The paper summarizes the operation years and icing history of optical cables in Henan Province, excavates the causes of icing, analyzes and studies the prone to icing in west, north and central Henan from the perspective of geographical environment, analyzes the relationship between icing and optical cable aging from the perspective of operation years, and focuses on preventing 9 optical cables in the above areas. Combined with the weather change, the emergency detour scheme of icing optical cable is revised in a rolling way, and come to the conclusion of using multiplex protection to facilitate the emergency detour of channels, and increasing OTN coverage rate to facilitate the emergency detour of optical path, so as to cope with the risk of icing optical cable during Winter Peaks.

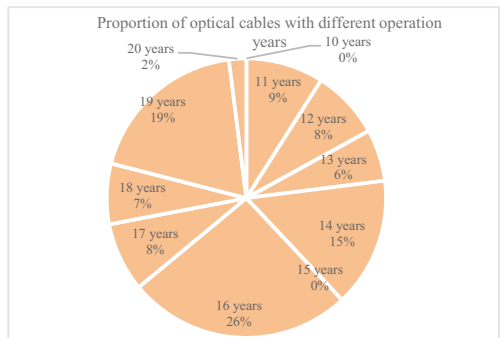
Fig. 1. Proportion of optical cables with different operation years.

The optical cable formed by rewiring is still calculated according to the operation life of the original optical cable due to its short π connection section. All cable types are OPGW [1], and the number of 24 core optical cables accounts for the largest proportion [5]. The proportion of optical cables with different operation years is analyzed, as shown in Fig. 1.

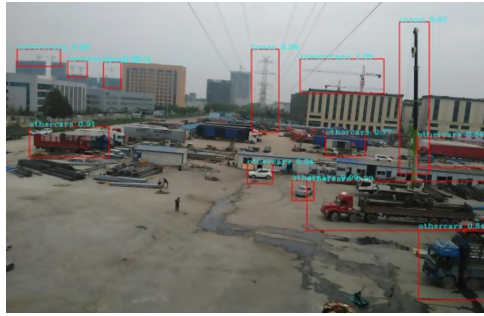
Fig. 2. Visual line monitoring platform.

Use new technology to improve the safety of line optical cables, respond to severe weather, monitor and warn in advance, prevent failures, and reduce the pressure of manual monitoring and repair. Line operation and maintenance units have installed visual monitoring platforms on several lines, with a certain degree of intelligent auxiliary early warning, and can cooperate with communication scheduling to strengthen ice coating monitoring during ice and snow weather and reduce the workload of manual line inspection (Fig. 2).
