Review of the 2018 Lombok Earthquake, Indonesia, and Its Impact from Previous Studies

Achmad Fajar Narotama Sarjan^(✉) and Ismail Hoesain Muchtaranda

Department of Civil Engineering, Faculty of Engineering, University of Mataram, Mataram, Indonesia
afana@unram.ac.id

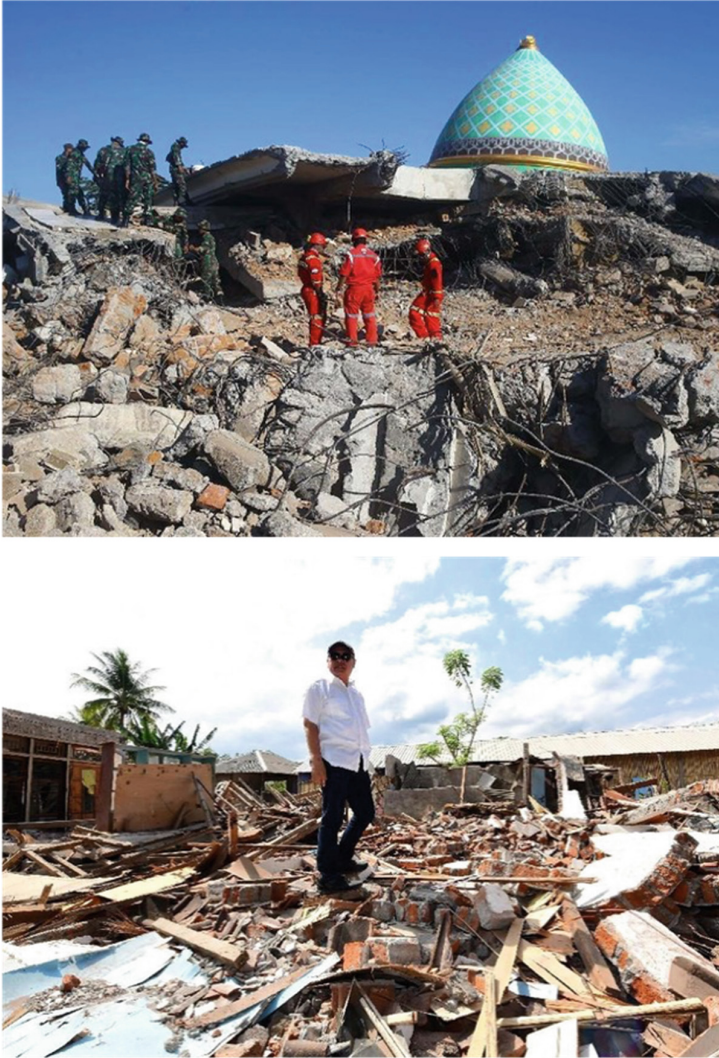
Fig. 2. The impact of Lombok Earthquake on 2018 which damaged most of the resident's houses in North Lombok [15].
