Characteristics Mechanical Properties of Polyester Composite Reinforced Musa Acuminata Stem Fiber with Filler Carboxyl Terminated Butadiene Acrylonitrile

Abstract. This study investigates the impact toughness, tensile strength and morphology of the polyester matrix composite material reinforced with Musa acuminata stem fiber (MASF) and carboxyl terminated butadiene acrylonitrile (CTBN) filler. The fiber used was taken from the outer layer of the pseudo-stem banana species *Musa acuminata*, which came from Tanjung, North Lombok Regency, West Nusa Tenggara Province, Indonesia. The results showed that the addition of CTBN caused the MASF-reinforced polyester matrix to decrease its tensile strength, but increase its impact toughness. The reason is that CTBN is elastic so that it can increase the ductility, the impact toughness of the specimen increases. Based on the results of the SEM test, the bond morphology between polyester, CTBN, MASF is good.

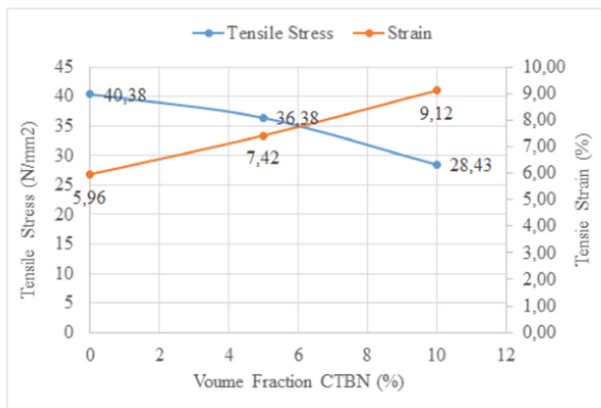
Fig. 2. Effect of addition CTBN on the tensile stress and strain changes

From the tensile test results Fig. 2. It is seen that there is a decrease in stress and an increase in tensile strain, due to the addition of the CTBN volume fraction. Decrease in tensile stress: 40.38 N/mm^2 , 36.38 N/mm^2 , and 28.43 N/mm^2 , increase in tensile strain: 5.96%, 7.42%, and 9.12% respectively occurred in addition of fraction CTBN volume: 0%, 5% and 10% respectively.

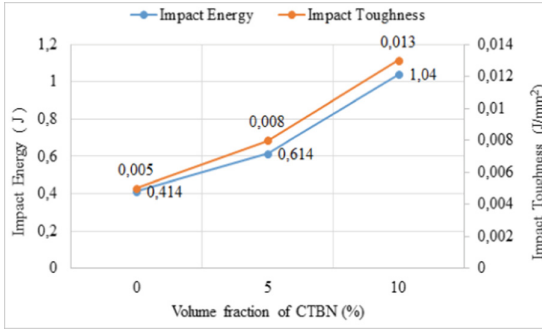
Fig. 3. Effect of addition CTBN on the impact toughness changes.

Based on Fig. 3. The results of the impact test show an increase in impact energy and impact toughness, due to the addition of the CTBN volume fraction. The increase in impact energy: 0.414 J, 0.614 J, and 1.04 J, the increase in impact toughness: 0.005 J/mm^2 , 0.008 J/mm^2 and 0.013 J/mm^2 occurred with the addition of the CTBN volume fraction: 0%, 5% and 10%, respectively.
