Mitigating Geotechnical Challenges Associated with Marshland Restoration in the San Diego Bay

Abstract. Coastal marshes provide many benefits to local communities, including increased habitat, coastal protection, and recreational use. The Otay River Estuary Restoration Project (ORERP) aims to restore disturbed marsh wetlands for the benefit of fish, birds, and other coastal species native to habitats at the south end of San Diego Bay. The project involves the excavation of material from the San Diego Bay National Wildlife Refuge floodplain and the transport and placement of that material in an existing solar salt pond (Pond 15) to establish and restore tidal marshland.

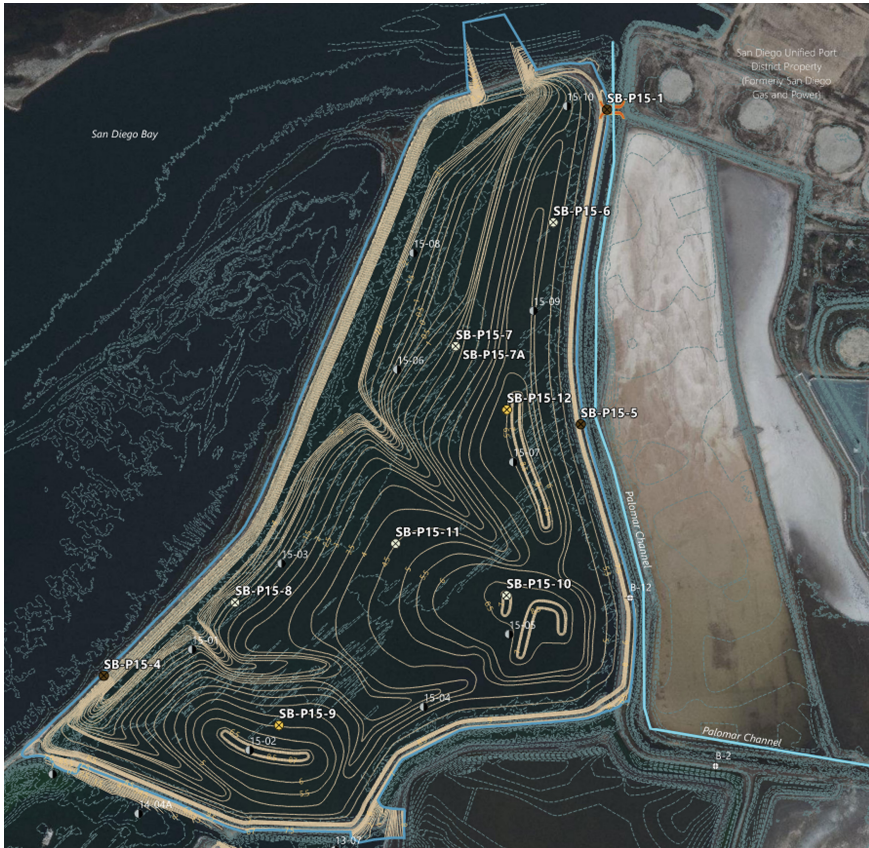
Fig. 2. Subsurface Investigation Map Within Pond 15. Aerial photograph provided by Esri streaming service

A dual-phase geotechnical investigation was performed to collect and characterize sub-surface conditions for each of the ORERP's planned work elements described previously. Eleven soil borings and five cone penetrometer tests were performed through the berm to support slope stability modeling and consolidation and bearing capacity calculations (Fig. 2).

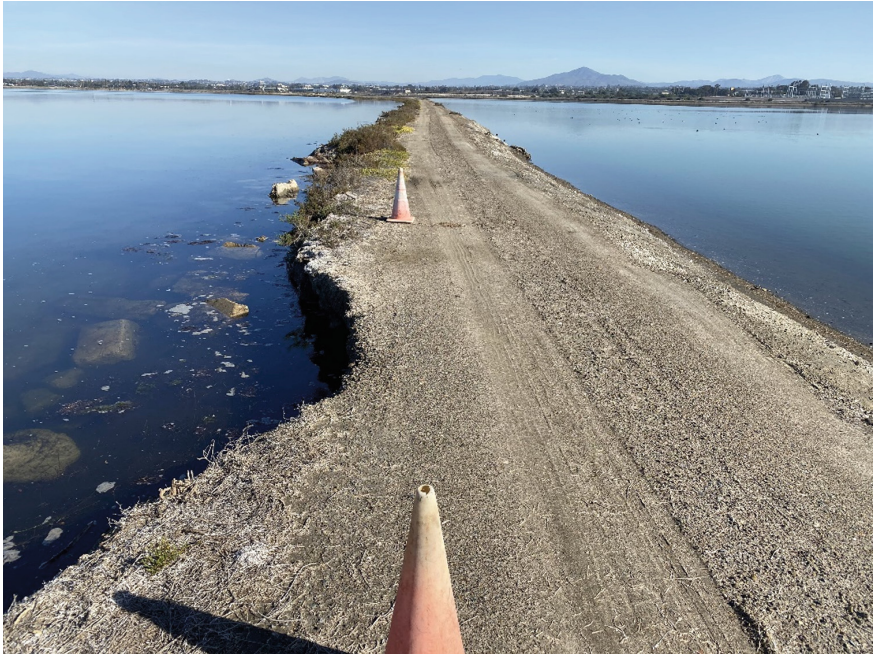
Fig. 3. Site photograph of existing Berm 15

to soft silts and clays. Marine deposits underlying sediment consisted of interbedded finer-grained silts and clays with layers of sand. Bay Point Formation soils consisted of dense sands and gravels deep in the subsurface. A site photograph of the existing berm prior to berm improvements is shown in Fig. 3.

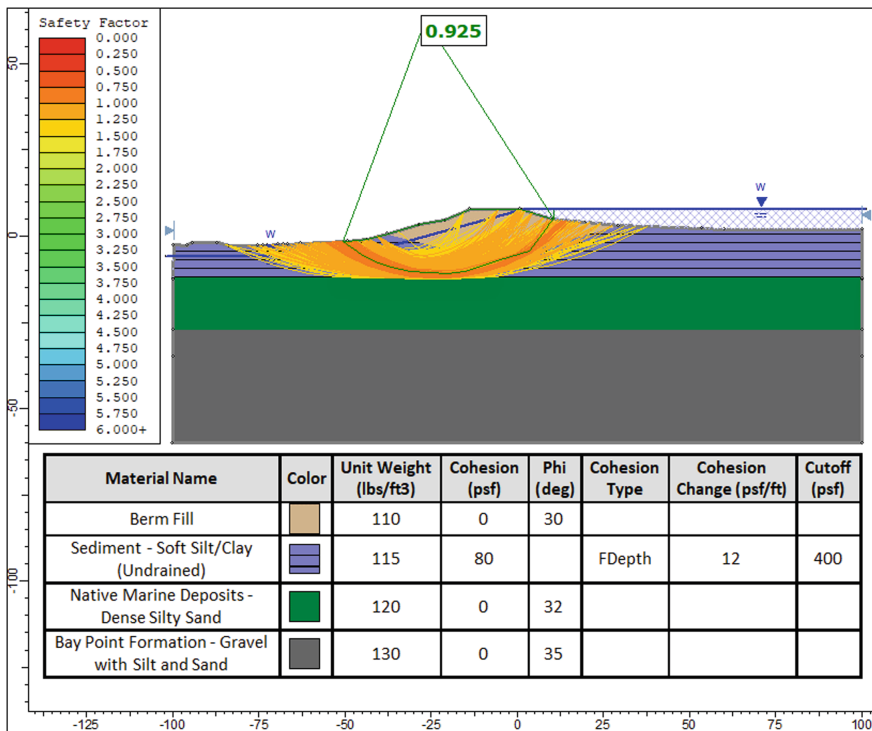
Fig. 4. Example Model Scenario for Dewatered Berm. Slope-stability analysis of the Pond 15 Berm

The results of the modeling indicated that there was potential for global failure of the berm with an unacceptable FOS during temporary dewatering of Pond 15. Under dewatered conditions, modeled factors of safety were as low as 0.8 for undrained scenarios and 1.2 for drained conditions. These low FOSs are largely due to the loss in lateral support provided by ponded water against the berm slope and the low shear strength of the soft, underlying silty clay layer. Additional iterations of modeling for various water levels indicated a direct relationship between water level and FOS (i.e., the lower the water level, the lower the FOS). Following regrading after pore pressures equilibrate and the tidal connection of the pond, the stability is expected to improve to FOSs of 1.5 for undrained slopes and 1.8 for drained sloped, which are above the minimum recommended values.
